LCD LED T.V Panels Modification and Major Repairs

LCD LED Panel Failure and Cure

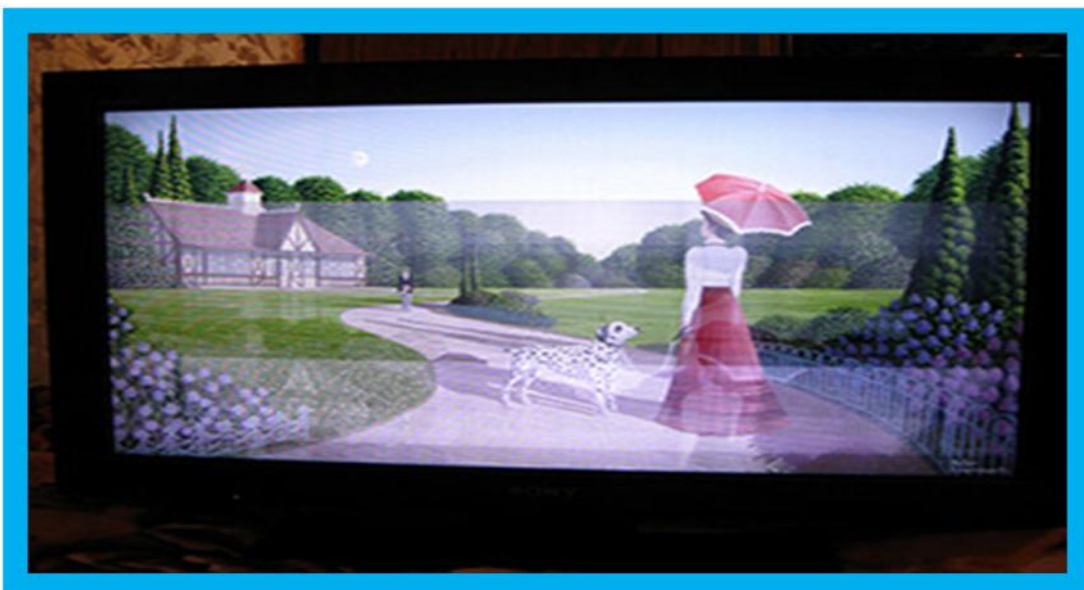
TV - SONY KLV-32EX300 (PANEL) - LTY320AP04

Defect The image is not clear with horizontal stripes.

Solution: Was found On the recommendation by my friend, Cuts the track signals CKV1, CKV2, CKVB1, CKVB2, STVP, and VOFF not planted, artifacts found. Running footage disappeared, increased clarity, some loss of rows left to repair.

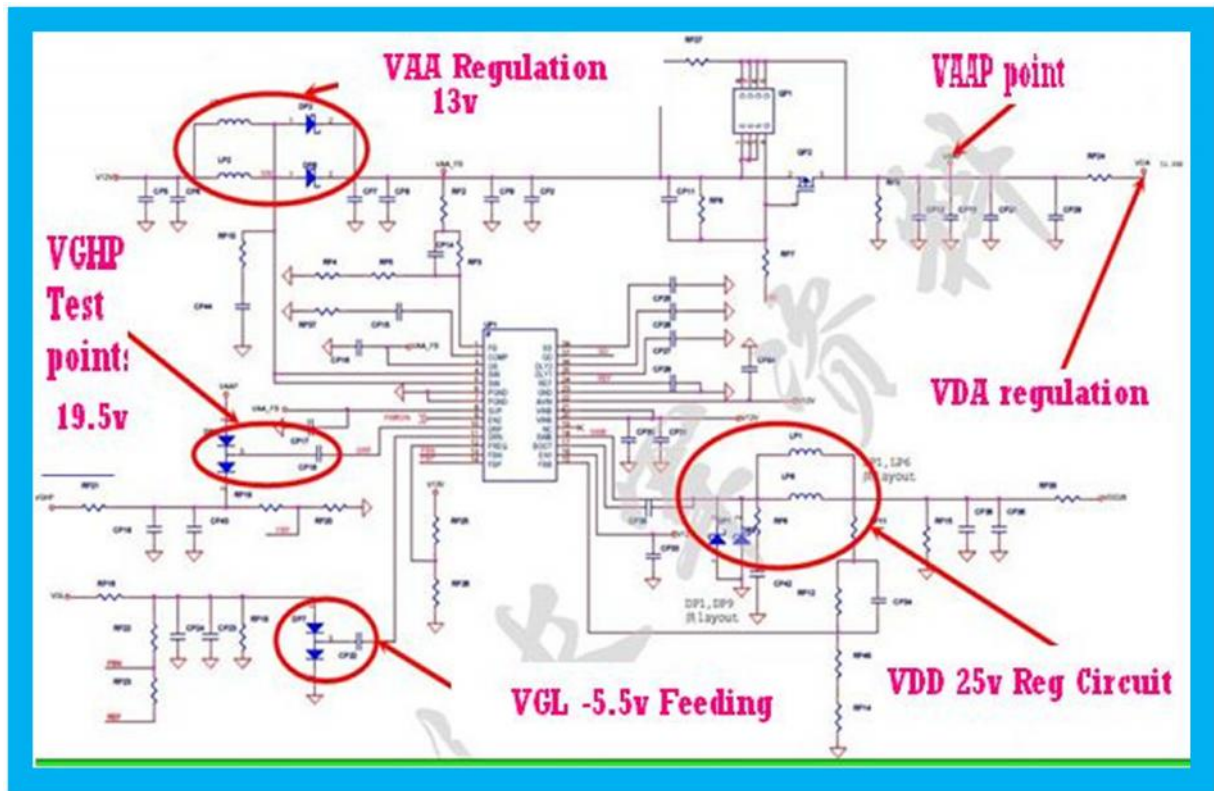
V420H1-C07 logic board picture Model: TLM40V68P Movement: LCD LCD-MST6M68FQ.

Symptoms: Test Case of LCD, LED white screen.

First detection logic board the road powered, found **VGHP** detection points no voltage, and normally this detection points due **19.5V** voltage, again measuring other several detection points voltage normal, remove logic board, measuring **VGHP** voltage output end on to resistance for 0 volts, apparently this problem is due to no **VGHP** voltage caused, dang remove filtering capacitor CP19 , complex measuring **VGHP** output end on to resistance recovery normal, will logic board loaded back original machine, boot fault remained, again measuring still no **VGHP** voltage.

Formation because the failure analysis VGHP voltage is provided to gate-level of high potential, which opens the gate-level voltage, when LCD LCD screen loses the voltage will cause internal TFT LCD LCD screen is not working properly with this type of fault.

Test UP1 pin forward normal **DC 5V** output **2.25V** and communication, **VAA 13V** normal voltage detection point, led to the identification of **VGHP** voltage is for DP5-free way, Directly after the replacement boot test after normal **19.5V** voltage **VGHP** voltage output, machine back to normal.

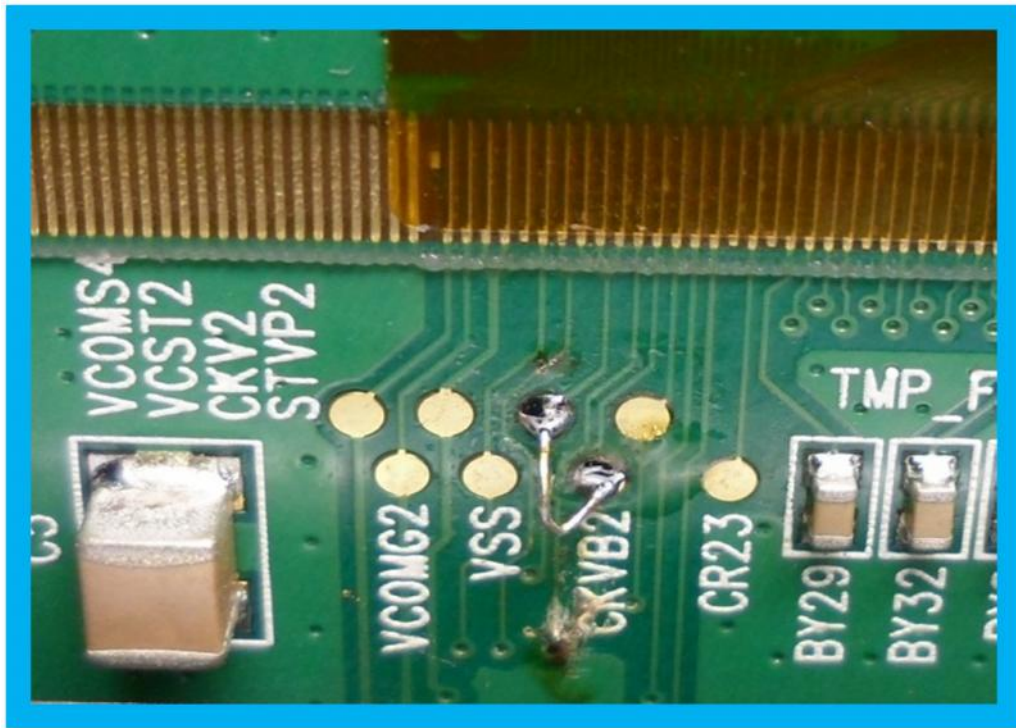
LTA320AP02

Fault: 3/4 bottom image shows the distortion, the top band is the norm.
T-CON: 320AP03C2LV0.1, Sharp: 320AP02S2LV0.1

Defect: The screen is divided almost in half, top normal, low distortion.

CURE: first tried to loop tape slapped: CKV2, CKVB2. The image became normal, the band was not, but began to show artifacts (toffee), and only on the schedule! When the graph disappears, and a minute later they disappeared. From static channel icons did not show up. Finally on the right side strap cut the conductors: CKV2, CKVB2 and put them together. Artifacts were gone, out. Normal, but there was a band barely noticeable. (Most on a blue background)

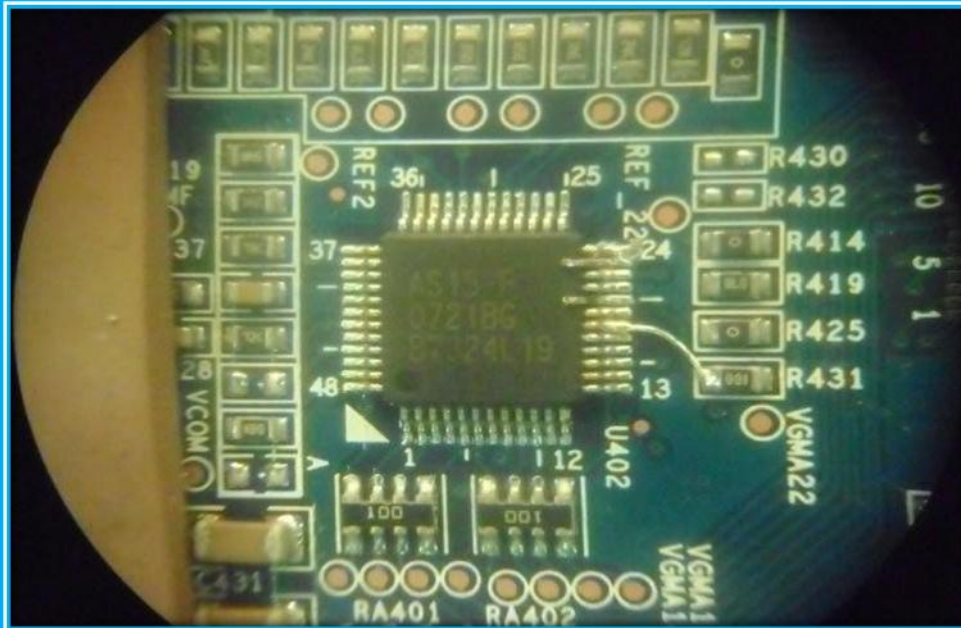
Modification of AS-15-F IC in Sharp LCD TV

Problem: Picture shows like a green Ghost all over the screen also OSD shows with Green Shadow.

Timing control T-Con that uses ICAS15G Damage occurred in the T-Con block we use hot air for replacing this I.C.

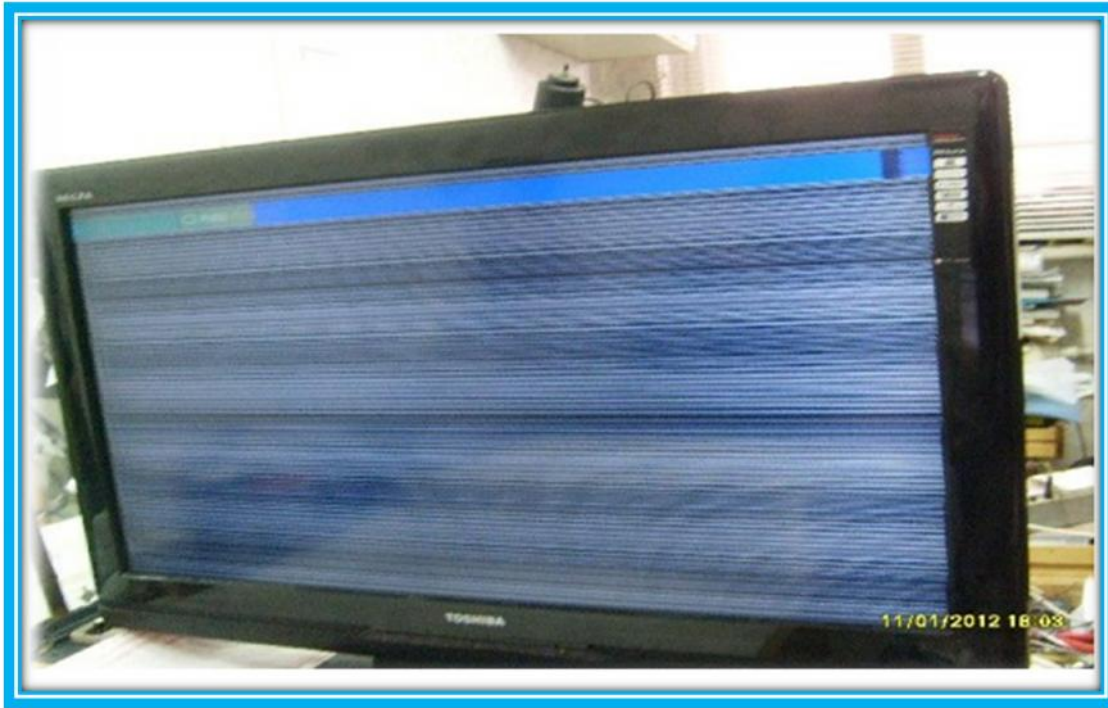
Some Times Problem similar types like a bad T-con or a Bad Panel but in Toshiba 32AV500PSG we Found Bad eeprom in main board Fault, See this picture.

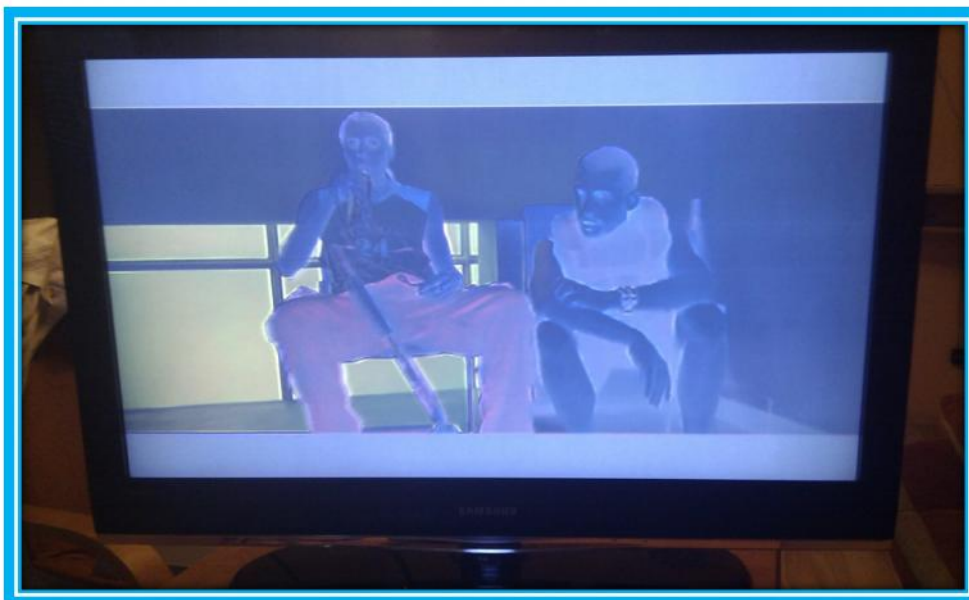
SAMSUNG LE32A430T1XRU model LE32A430T1 version CN04

Defect: low-contrast negative image with a blue-green moiré in the light areas and dark red on. When you turn on AV signal without a dark screen instead of uniformly red. Screen, Have tested T-CON normal (compared with a working t-Con), flashing eeprom (bin with the worker) did not produce results. SDRAM also found good.

Cure: Composition : Panel CHI MEI V315B1-L01 T-CON ,LVDS controller CM2681-KQ

,24LC128 ,AS15-G DC-DC + AT1380AP field researcher sois8 ,SD Ram 2p.EM636165TS-7G Main Board Voltages 2V5, 3V3 are good, Work on resistors from LVDS to CM2681 updated. Replaced AS15-F to HX8915 tested Fine.

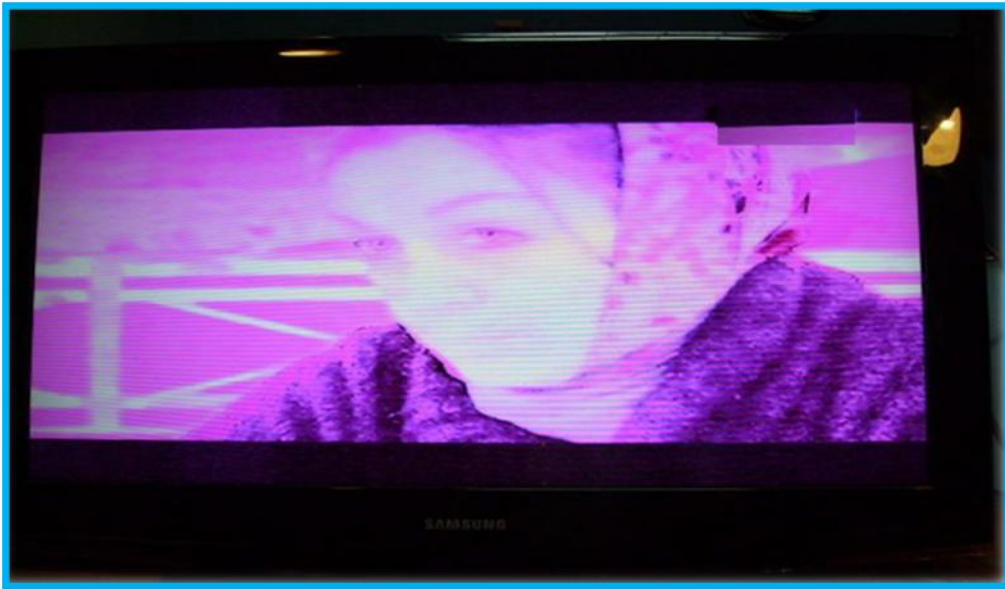
AUO Board

Purple color all over the screen also when you try to enter the setting manually TV reports that "all stored settings will be erased, also replace eeprom but not correct the color problem now check 24v at AUO board its shows low to 18v .

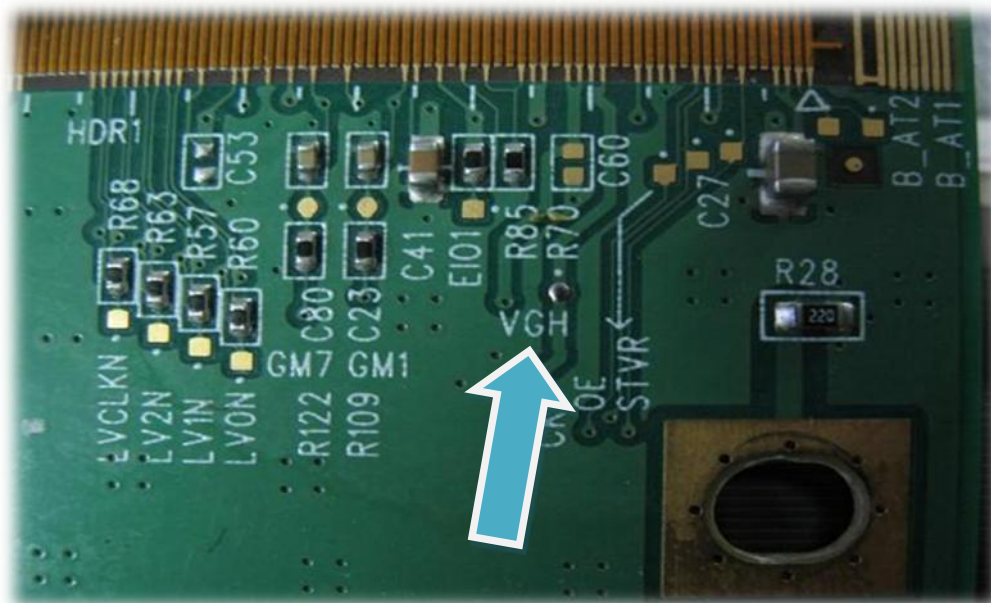
[SAMSUNG LE26C350DW SAMSUNG LE26C350DW and they use Panel T260HA01-DB.](#)

Problem: Plain white screen now **here is I reveal a big secrete for you its Open**
VGH Sold a thin link wire to VGH Side board and Panel VGH point....Happy Repairing Day.

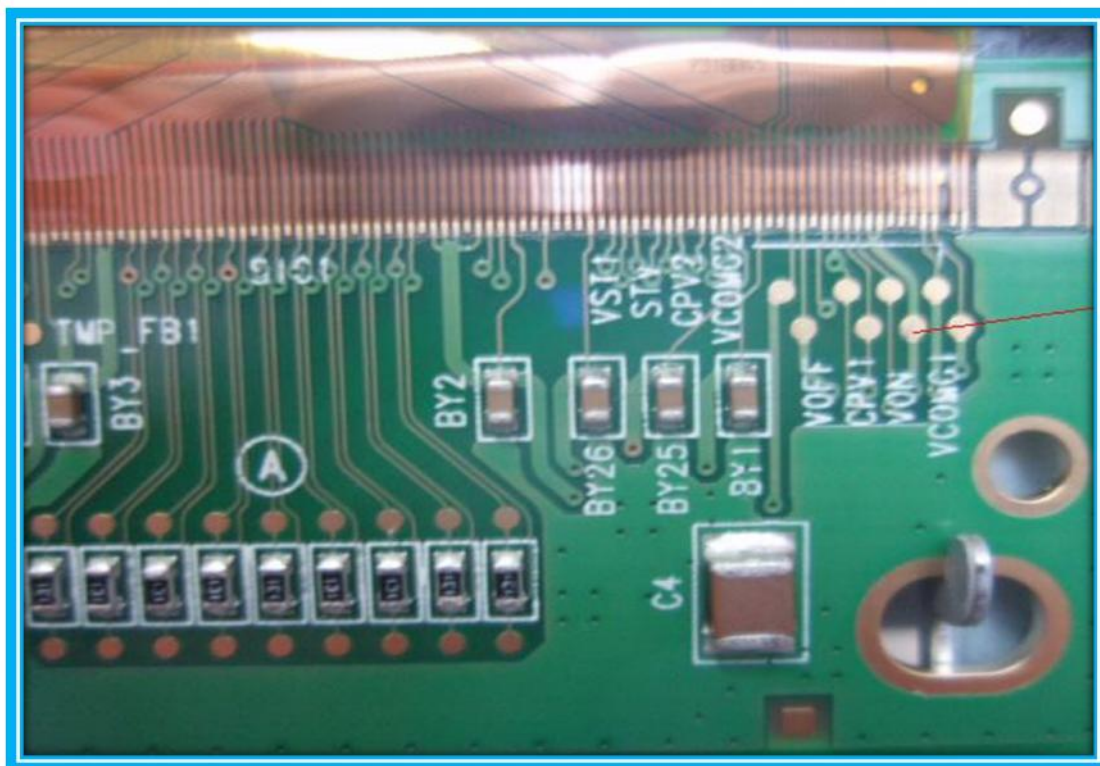
Samsung Panels major problem at No Supply Von-24V to side drive. Its was caused to faint image, some times slow motion picture Von on the panel jumper and the thin wire to circuit board as show in picture

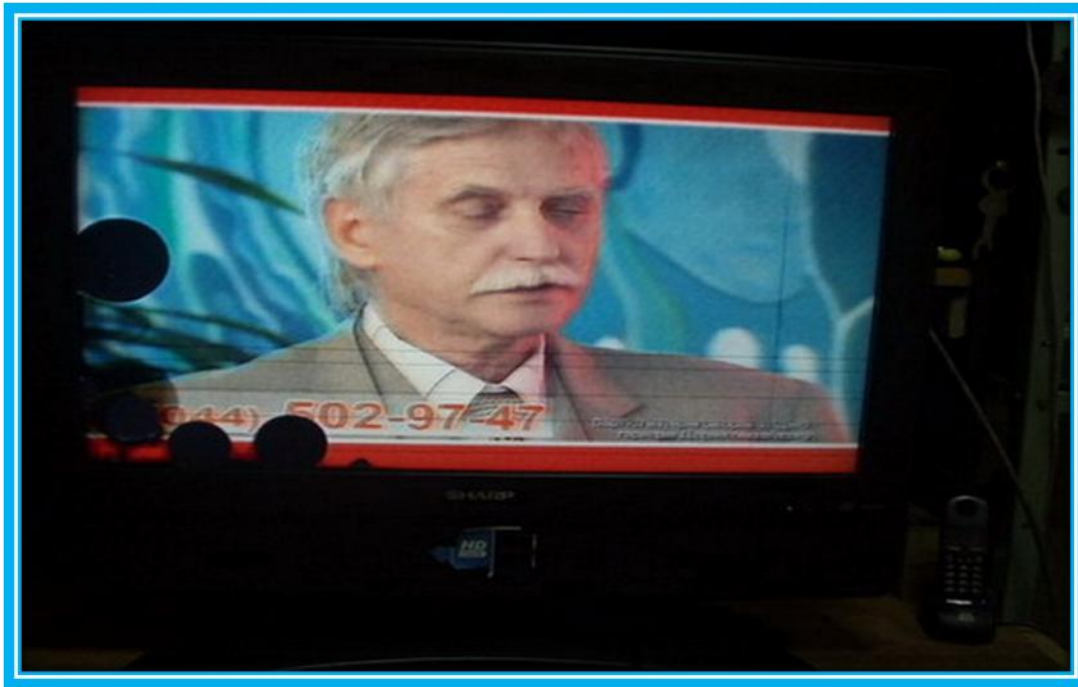
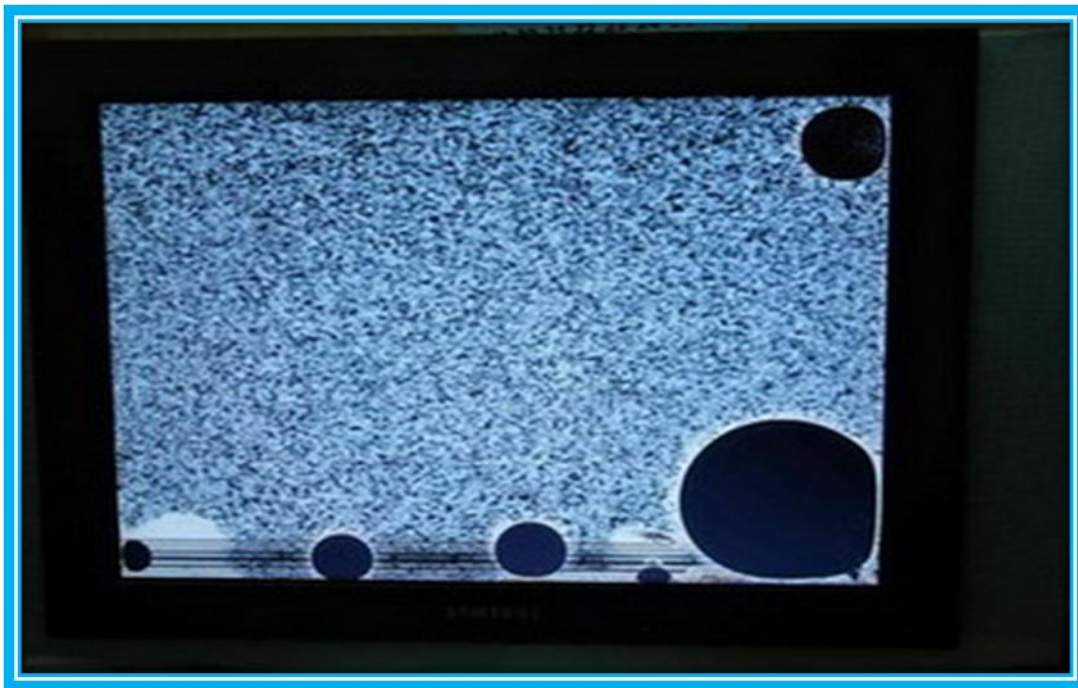
Photos defects panel Not Repairable

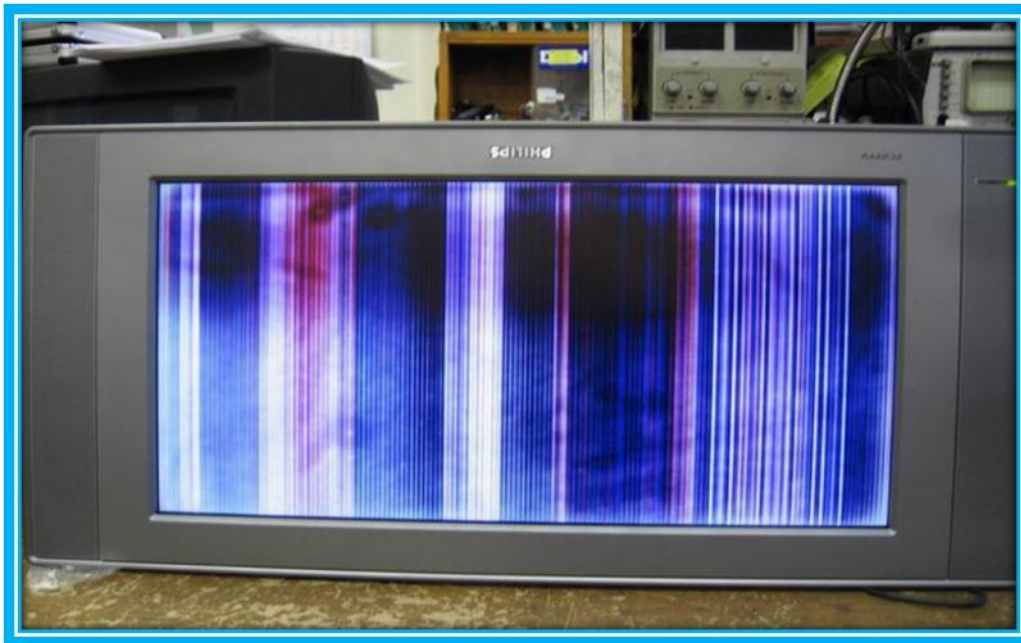
PHILIPS LC4.1EAB DISPLAYS ON QUANTA 26PF3320

Fault: No picture and sometimes colored vertical thin black horizontal stripes across the screen (see photo). problem is caused by the fact that the LCD panel production QD26HL02 QUANTA DISPLAYS INC used signaling and power supply from MAIN BOARD (on the main board on which connector LVDS) for GATE BOARD (board on the side of the panel) on wirings on the glass.

Solution: Allowed to exclude the flat cable between the boards, but if the signal transmission paths acceptable resistance to power is too high and the GATE BOARD is de-energized.

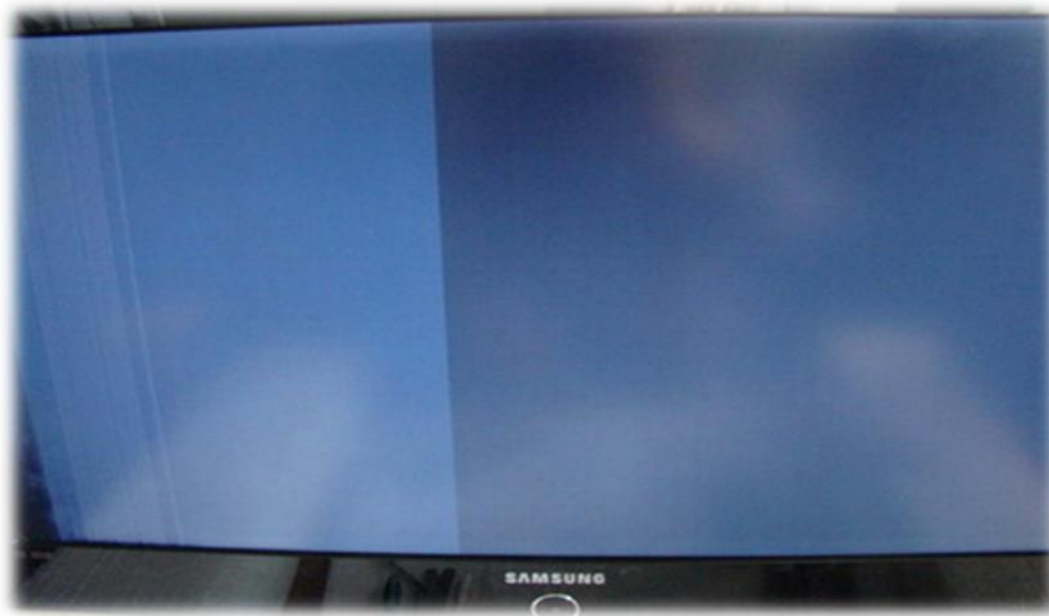
Fault: Slowly illuminates the image, turning into two part .Pre diagnostics detect missing voltage VGH1 (25V) DC / DC converter T-CON.

Solution: Replacement diode assembly D502 in DC / DC converter T-CON

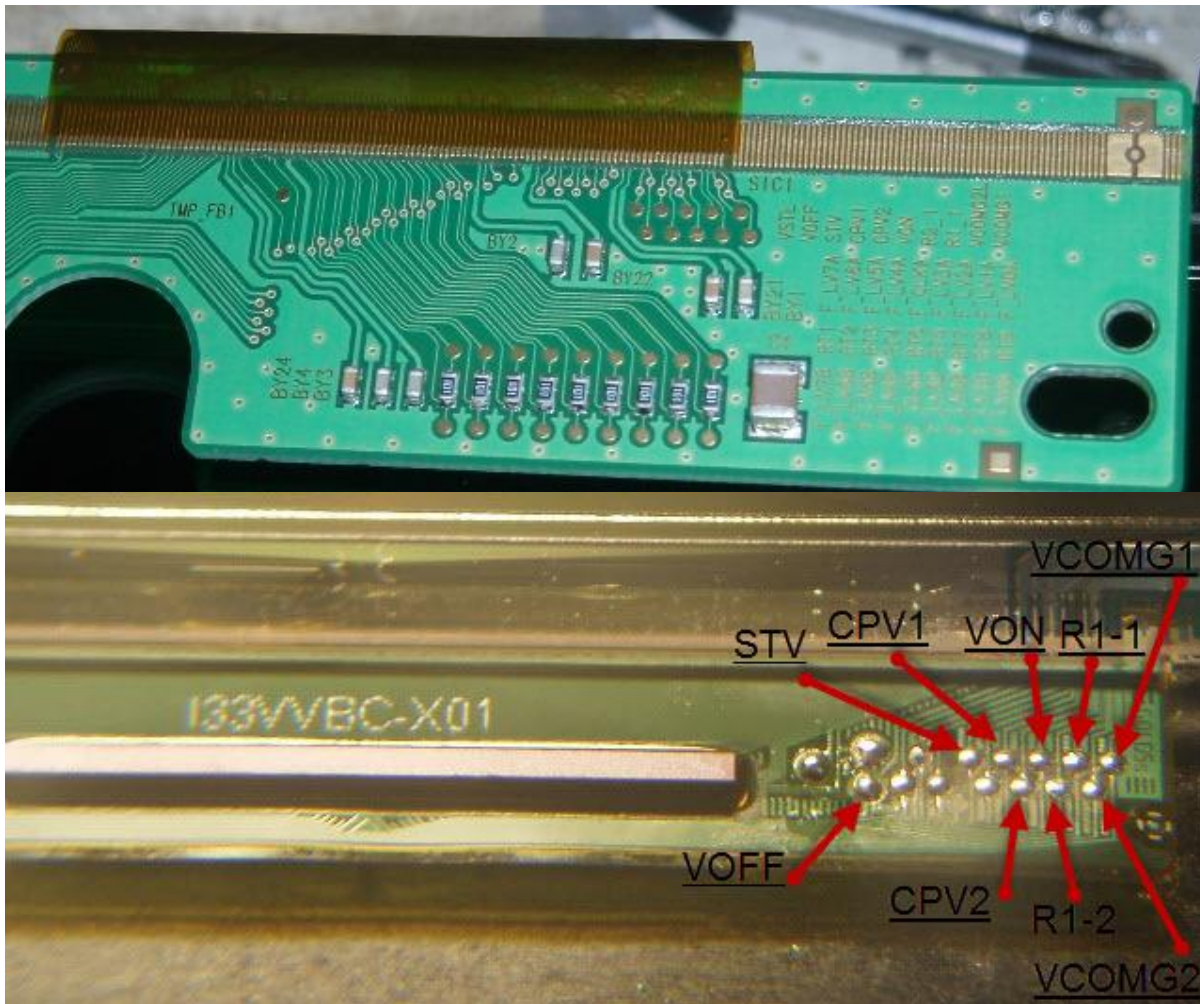
PANEL LTF400HA03 APPENDIX I33VVBC-X01. MAJOR OPEN CONNECTION FOUND.

HERE WE SHOW YOU STV, CPV1, CPV2, VON, VOFF, R1-1,R1-2
CONNECT THESE WIRES WITH SOFT HANDS.

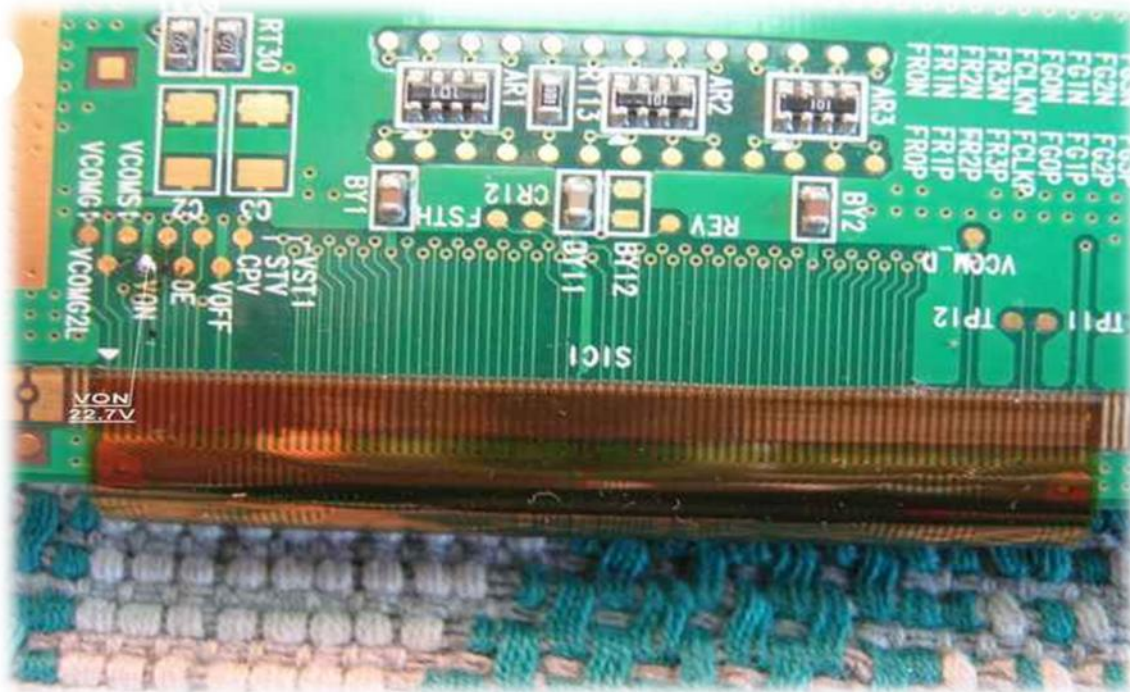
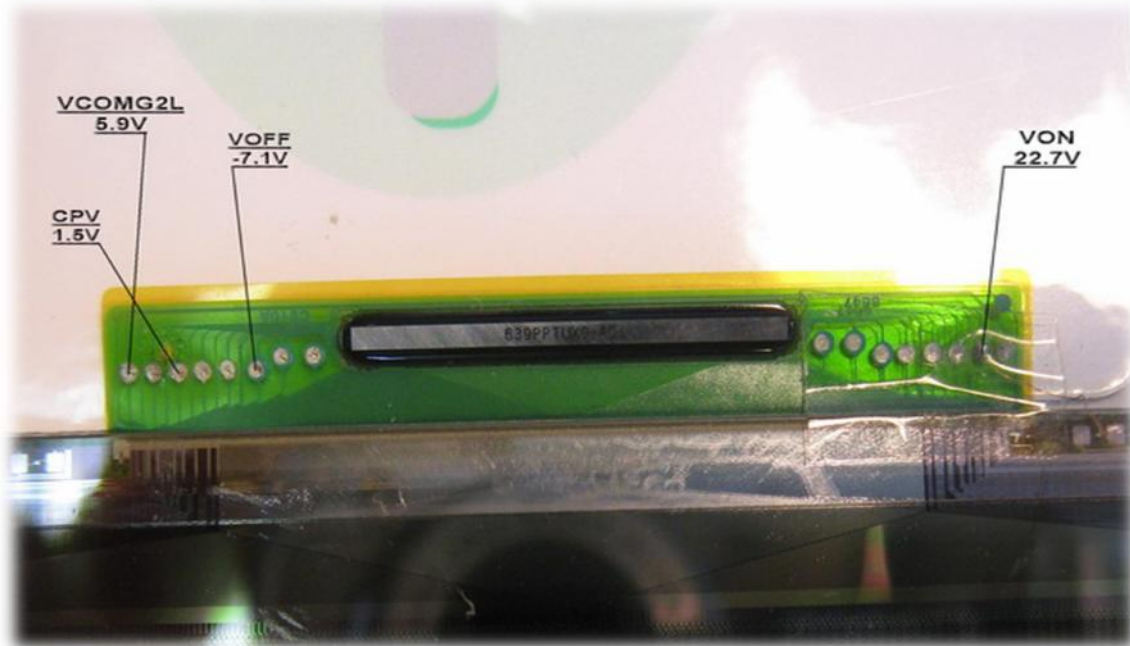
Panel LTA320WT-LF2 VON (22.7V) Missing

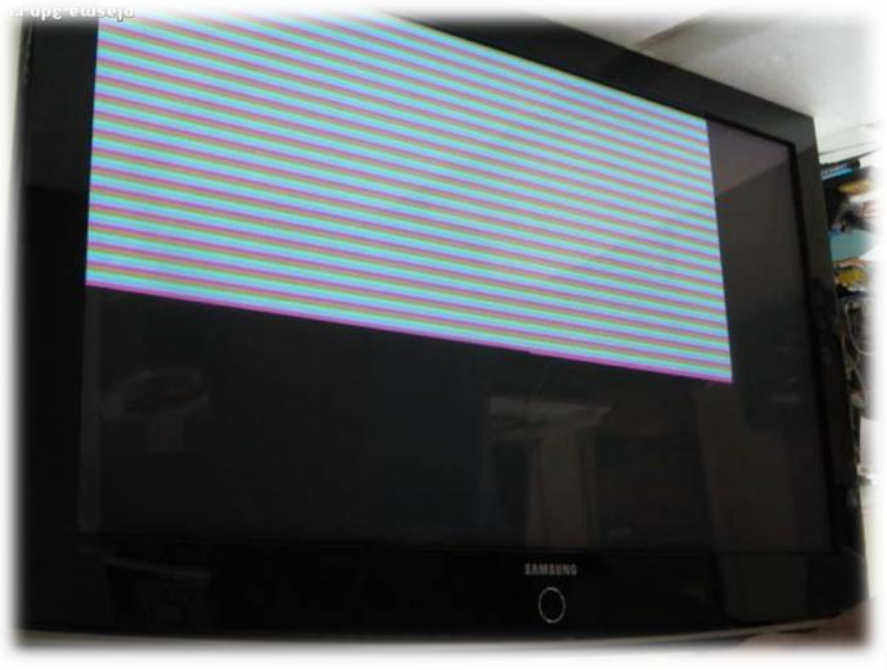
After replacing CX833, CX804, CX810, SX813, CX814, (swollen) in low power +5,3 V and +12 V power supply P-SMPS BN44-00161A, had to change and **BN96-04596A P-LOGIC MAIN**. Defect P-LOGIC on the photo.

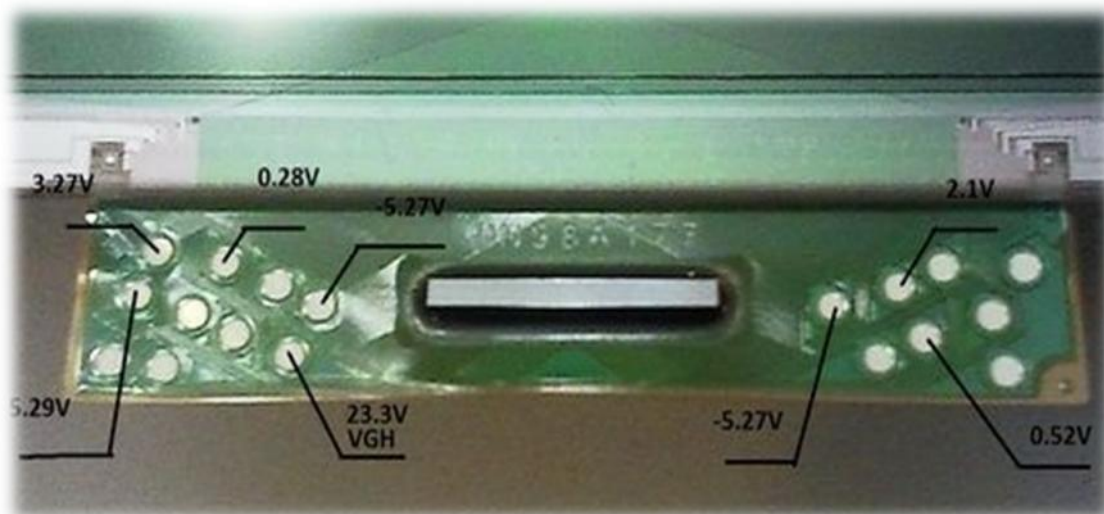
Panel LC320WUE-SAA1 stands in 32PFL5604.

Missing the lower half of the image, with the heating pours milk. Underestimated VGH to 1V on the two side address driver threw jumper panel board. More detailed measurements of stay was not possible, resting visiting relatives, suitcase accidentally left in the trunk before you go to them second such panel this month with similar defects.

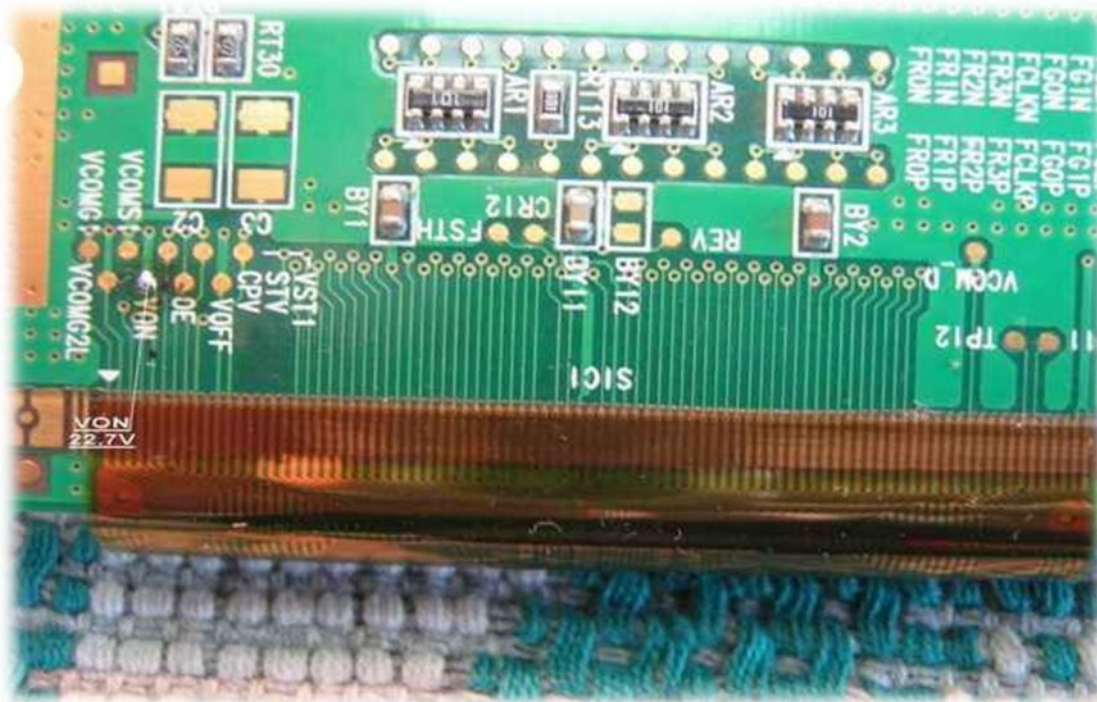
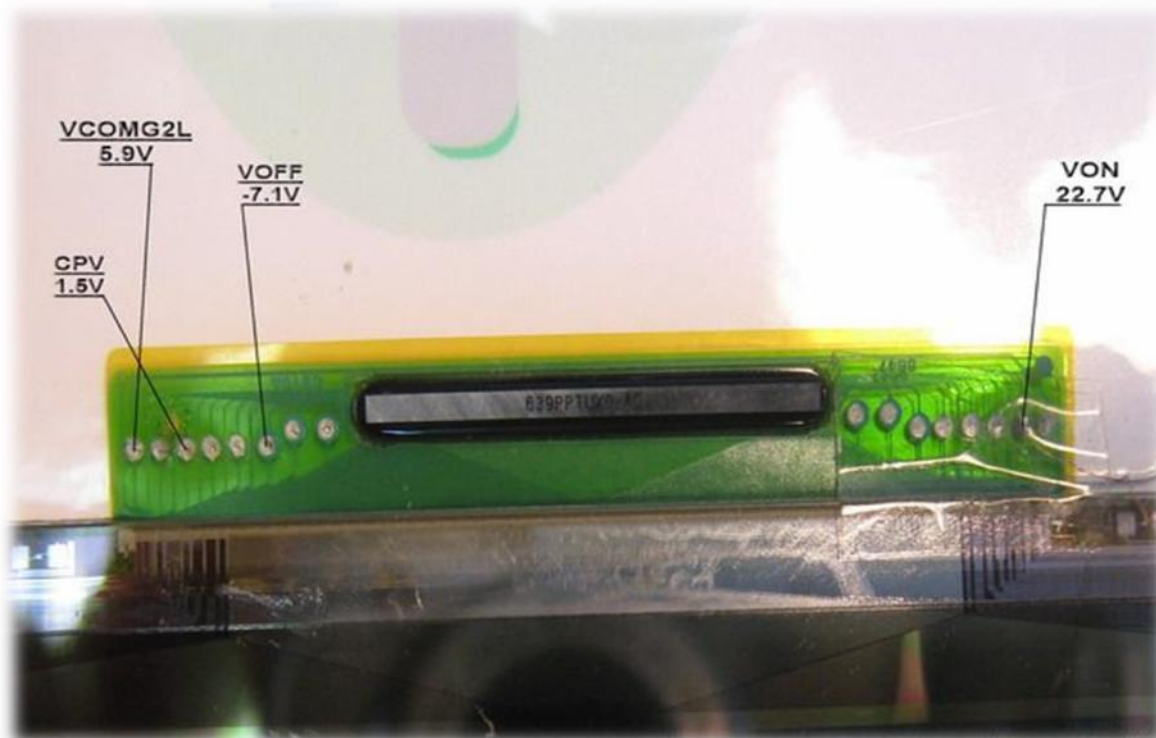
LTA320WT-LF2

Image slows and turns white on the side driver is missing - VON (22.7V).
