LCD LED T.V Panels Modification and Major Repairs

LCD LED Panel Failure and Cure

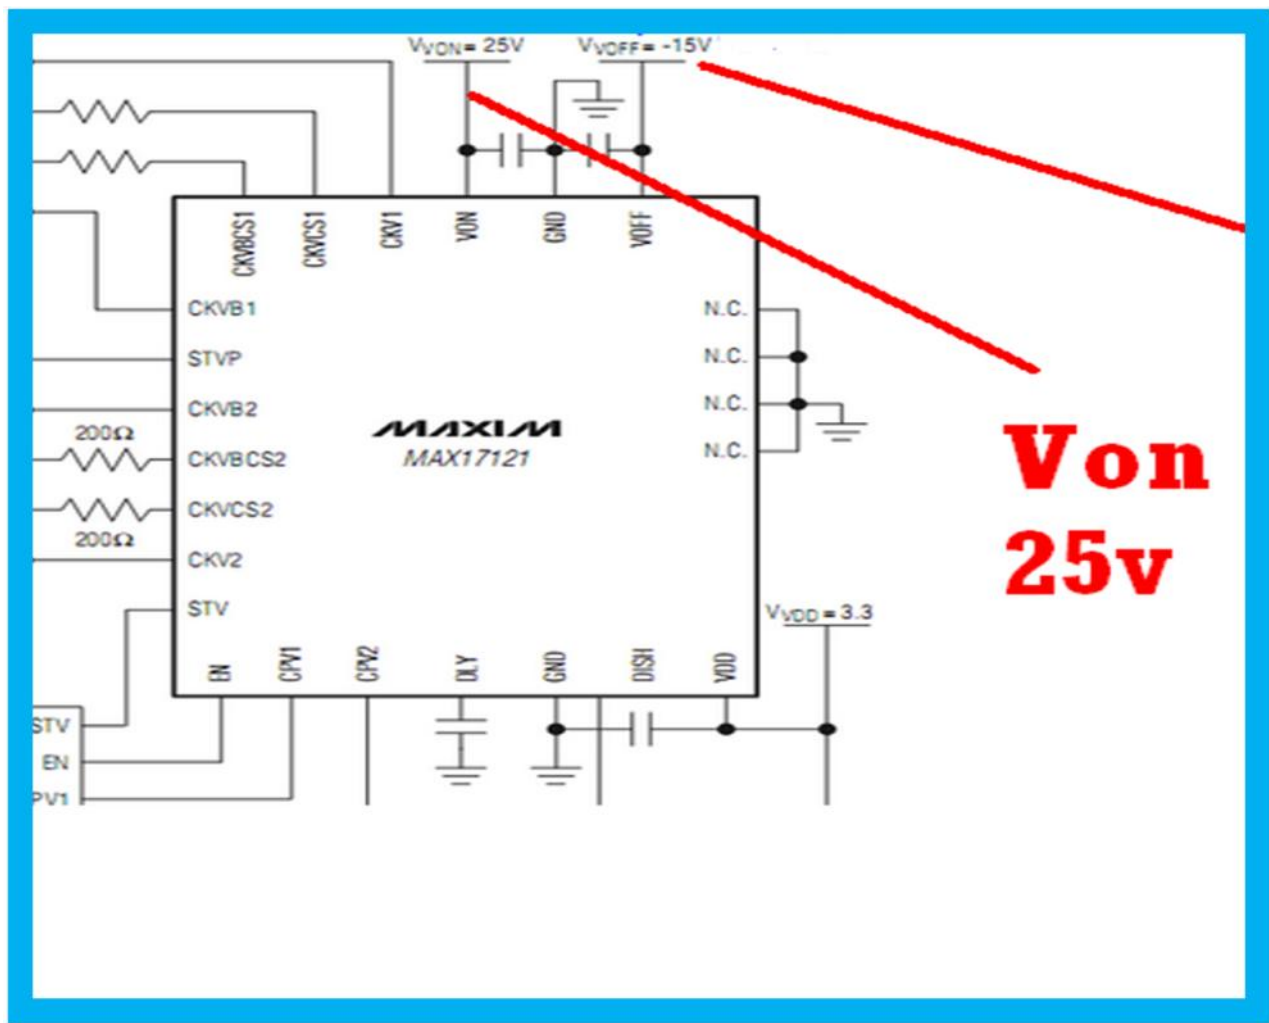
Here is the test Case “Ghost Image with slow motion”
T-con 32” HV32320WXC adopted MAX17126

FAULT: Blurred image and not clear with slow motion like ghost, Check test points at T-con DVDD=3.3v VDD=12v Vcom=5.6v Voff=-8v Vref_FB=1v Gref=12v seems all normal while VGH=11v and Von=0v Now the voltage VGH should be 24v based on the MAX17126 i.c, Now its sure that MAX17126 is faulty.

Solution: As an alternative supply instead VGH and Von I use injection of 24v volts from the back light power supply, to be more safety majors I put up their respective series 100 ohm 0.25watt input, Now set works very good.

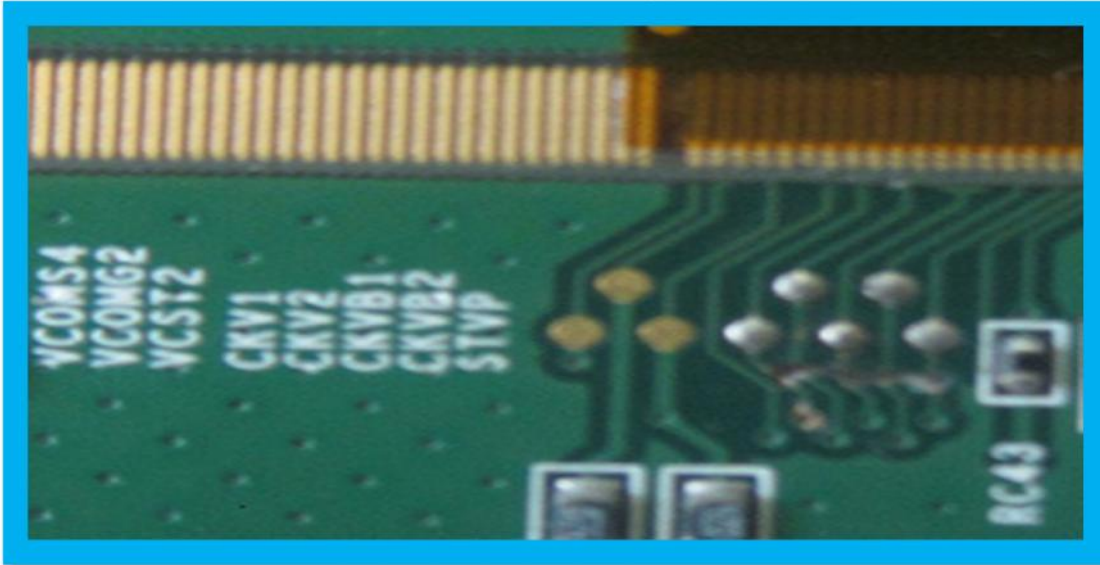
TEST CASE TV - SONY KLV-32EX300 (PANEL) - LTY320AP04 T-CON ON A PLATE: 320AP04S4L V1.7,

Defect The image is not clear with horizontal stripes.

Solution: Was found On the recommendation by my friend, Cuts the track signals CKV1, CKV2, CKVB1, CKVB2, STVP, and VOFF not planted, artifacts found. Running footage disappeared, increased clarity, some loss of rows left to repair.

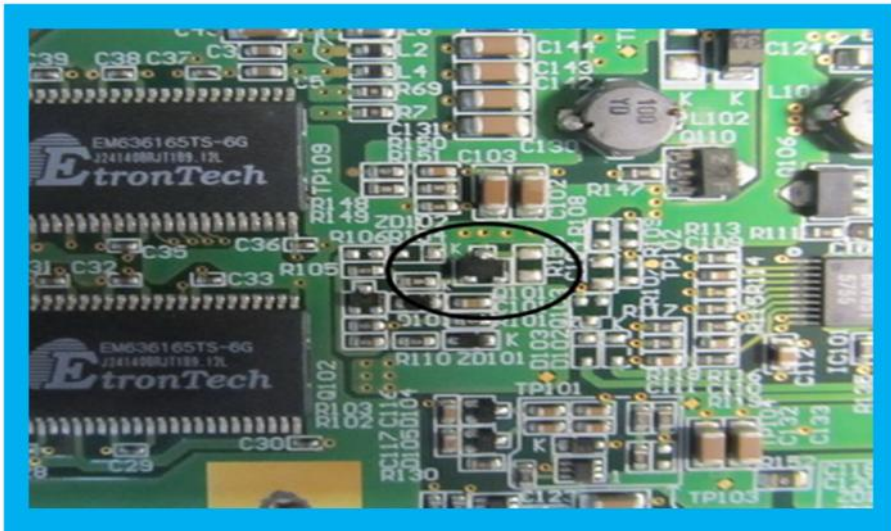
LCD TV Philips 26PF3320 LC4.1EAB.

Philips LCD With long-suffering QD26HL02 Panel Production QUANTA DISPLAYS.

Fault: Black screen When testing regimes on board T-Con, it was revealed that the drain of the transistor Q101, instead of 12 volts in just 0.5. Transistor Q101 (marking WZ) - P-channel field researcher. Through the transistor, organized DC-DC power converter after replacing all return, the picture is back to normal.

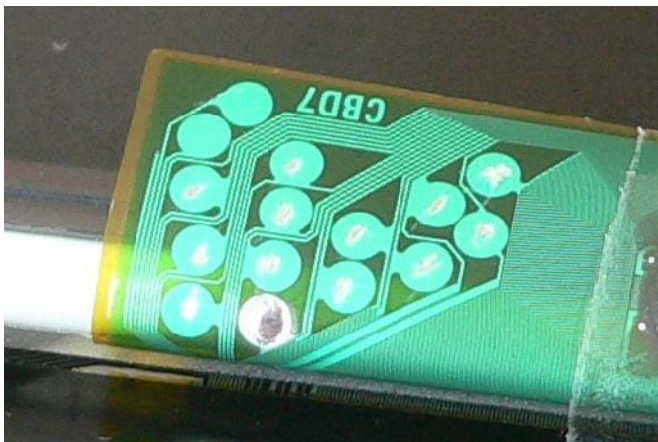
Picture01

The most frequent circuit found interrupted is that one corresponding to pad numbered 10 (P01.jpg) and indicated in P03D.jpg .

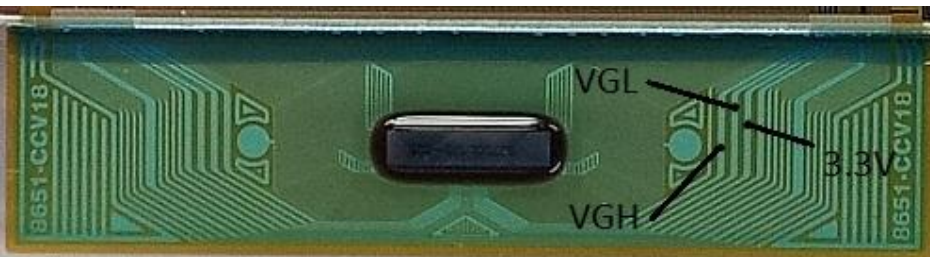
Board1

Panel M260TWR1 Manifestations of the same defect and the reason is similar, Many times we found VGL, VGH, open circuit with the circuit board, Use thin wire for reconnection.

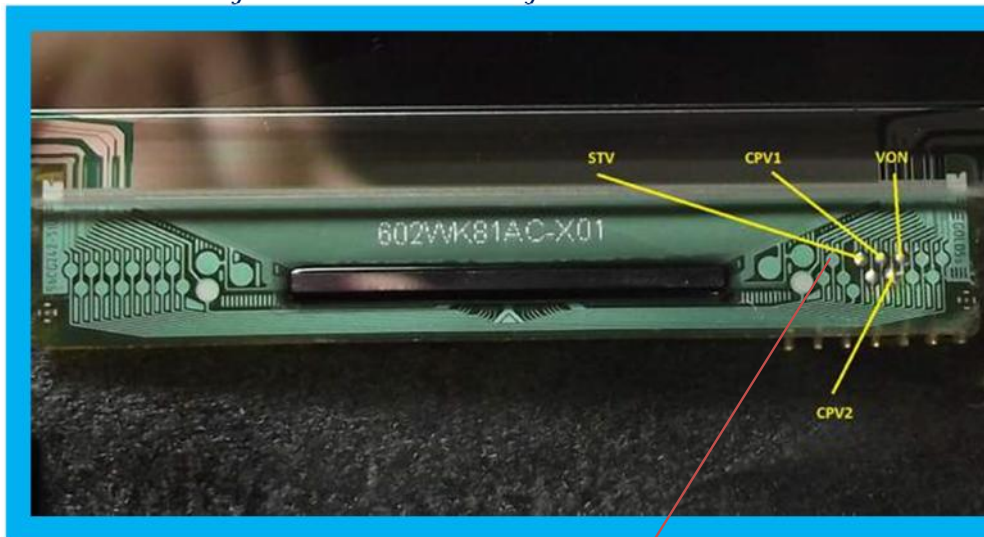
Here we show you connection in yellow mark for circuit board.

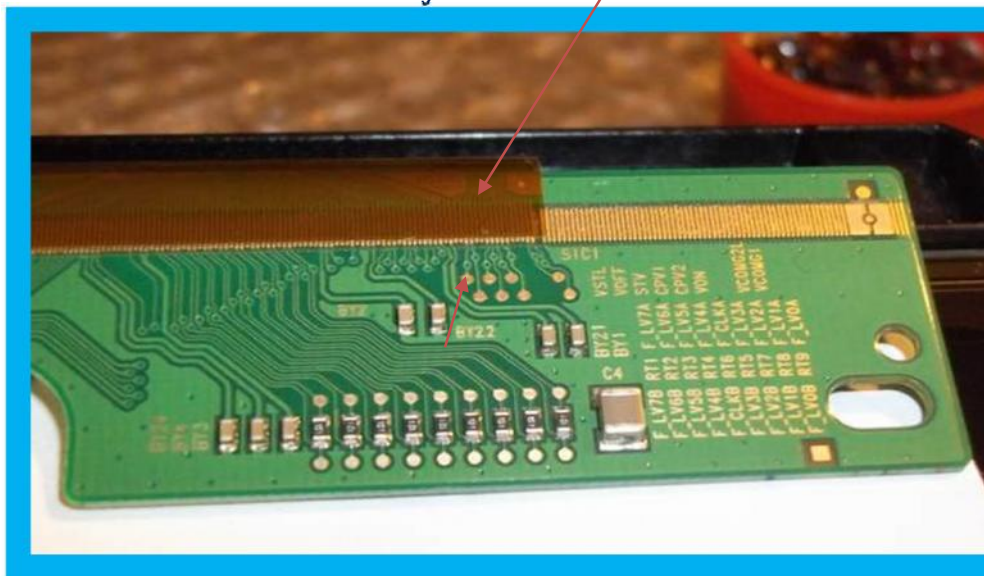
Here is a Circuit board for yellow to red mark connection

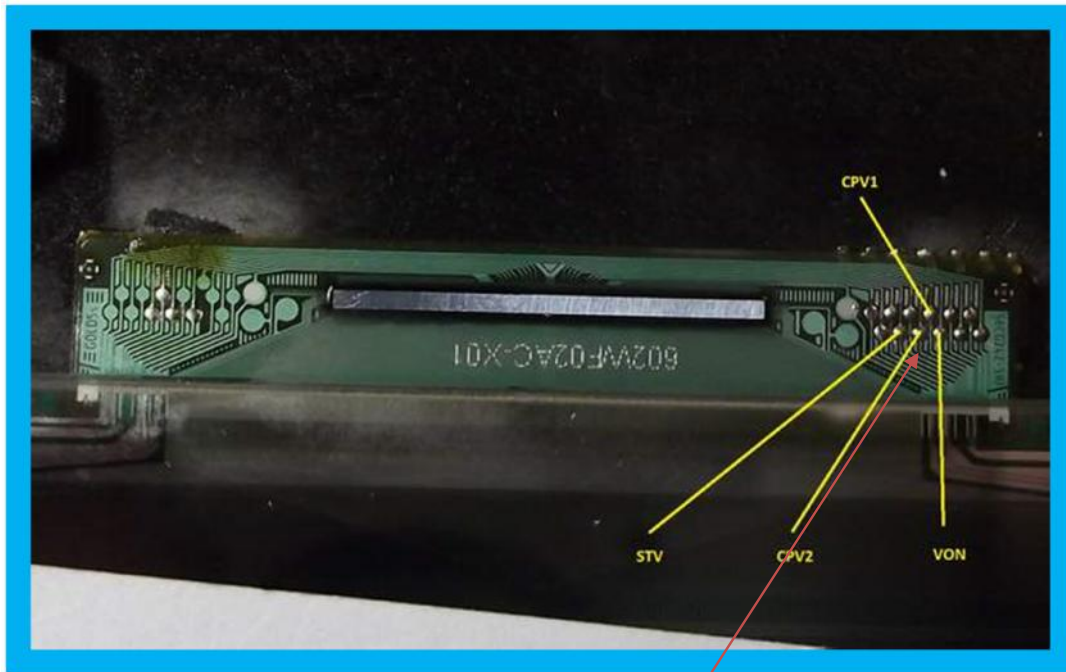
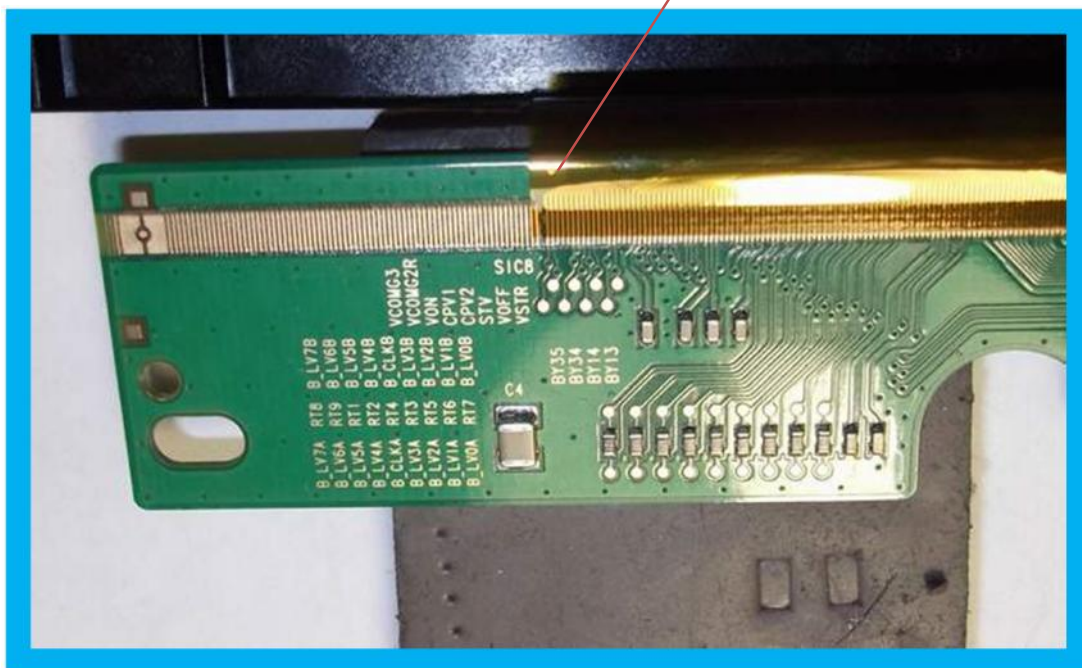
Here is a 2nd side of the side board and main circuit board, use thin wire for this connection

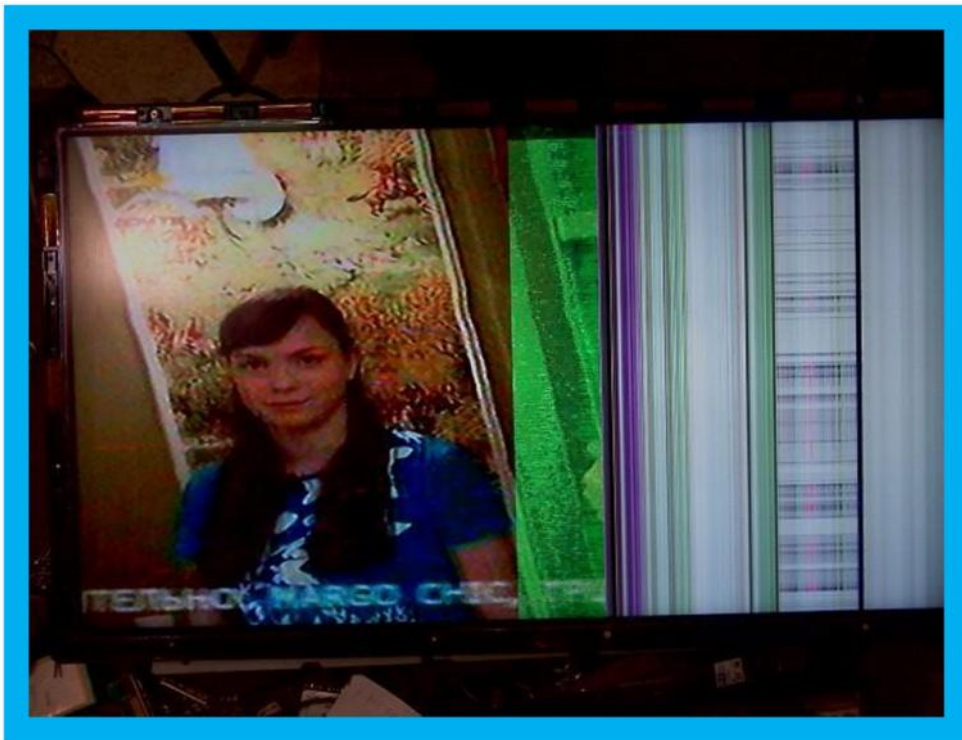
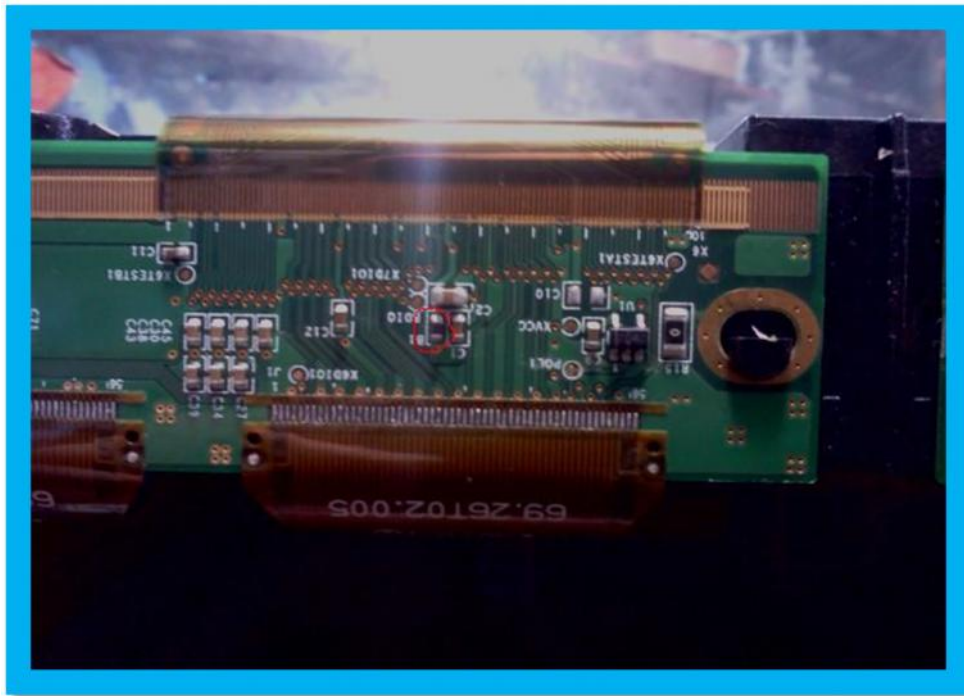
[Samsung LE32T51BX. Panel T315XW01 V.5 T-con](#)
[T315XW01 V5 05A09-1C.In t-con available DC/DC MAX1518E](#)

Symptoms: when you turn on a dark gray background, sometimes turning into white dark gray. May be involved with the normal image if distort plug supply. When the normal image after a while the right half of the mattress can go vertical stripes pillars. When you turn on a gray background, it was revealed the absence of voltage 13,3 V, VGH, VGL with MAX1518E.

Solution: In the end, after three days of suffering with this panel, MAX1518E replacement several times (initially went astray with MAX1518E, panel and lay down mattress I could see only a certain part of the left panel), the throttle PWM entire binding - was identified B1 unpredictable the choke plate on the right mattress for 3,3 V (J3 connector 16-19pin) on decoders, which gave an overload when the MAX1518E and maintenance thereof in protection or the right half of the strip if the throttle broke off after the normal image.

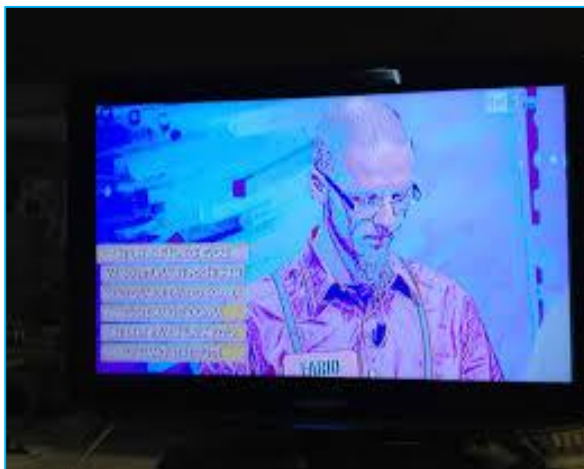
SL1014 Fails

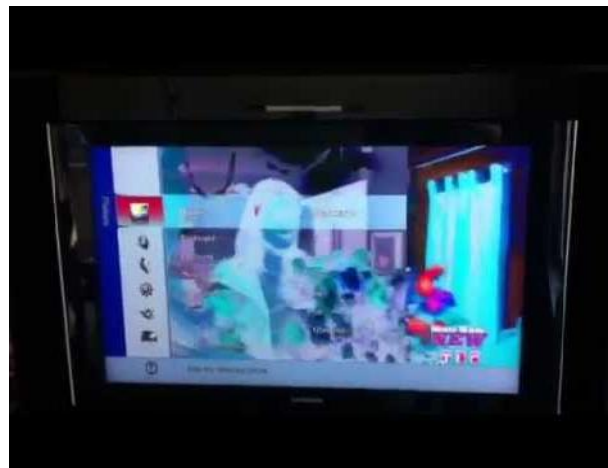
HX8915-A Fails

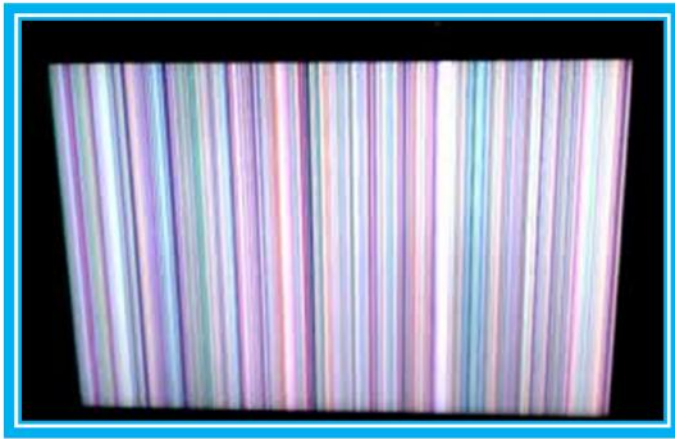
12v Missing

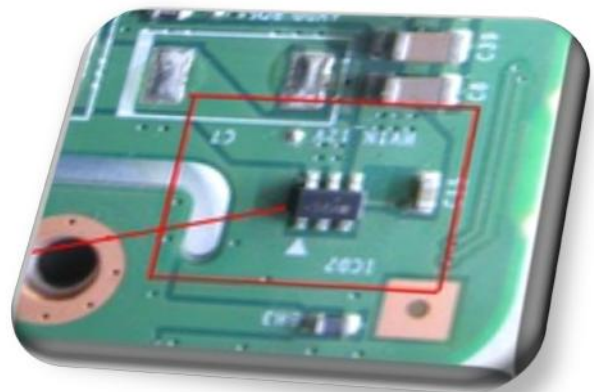
Samsung T-con Faulty SMD

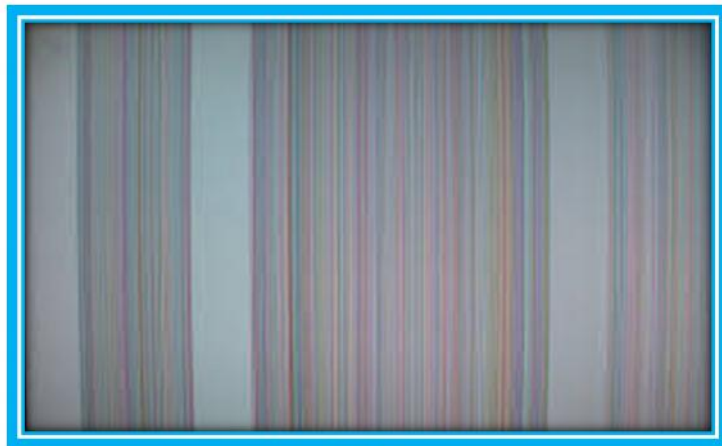
Sharp 46" T-Con Failed X3853TPZ

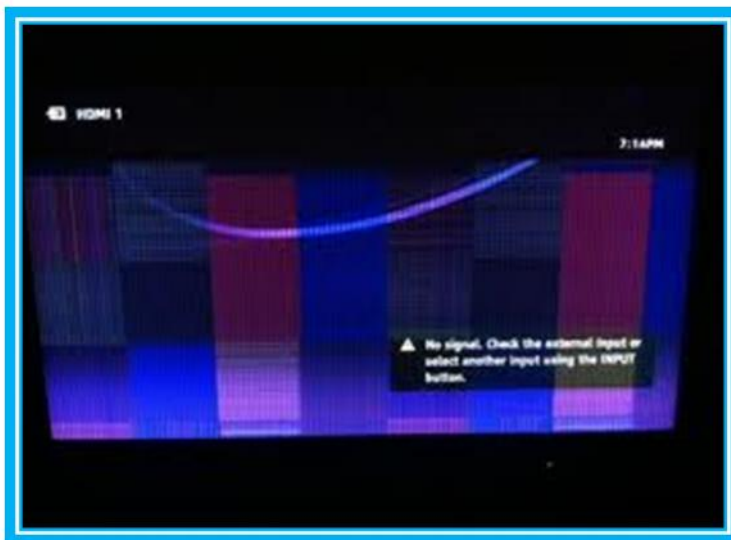
Samsung T-Con Failed

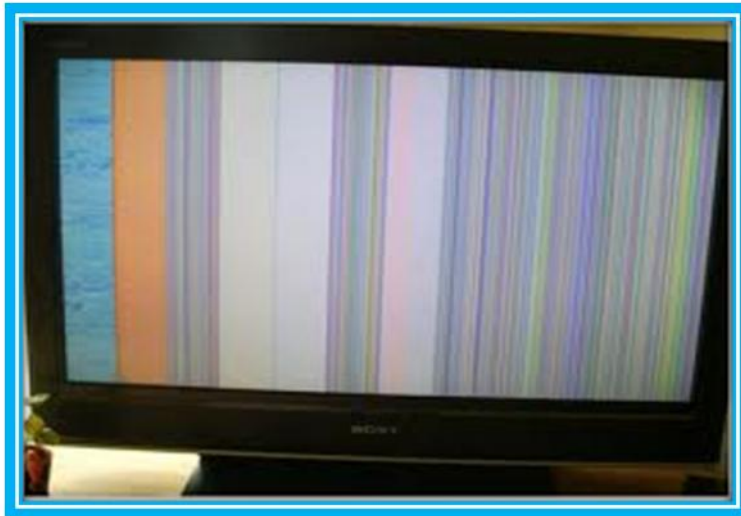
Sony Bravia T-Con Failed

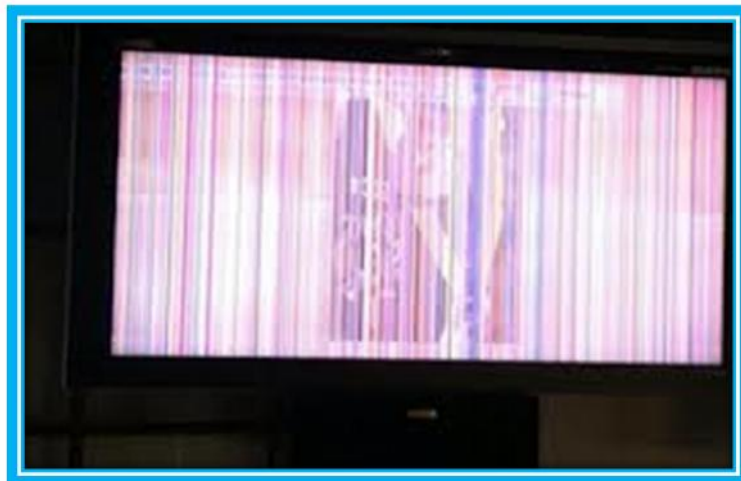
Philips T-Con Failed

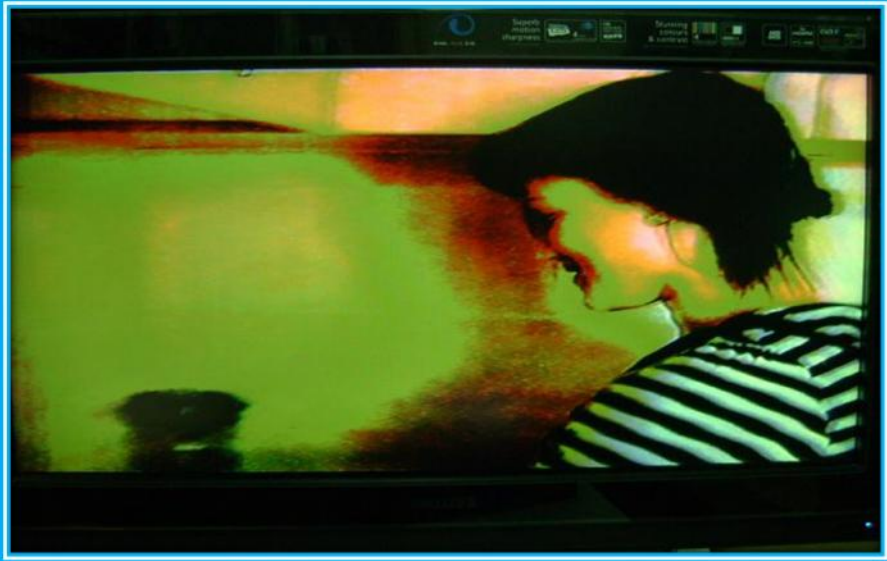
Modification of AS-15-F IC in Sharp LCD TV

Problem: Picture shows like a green Ghost all over the screen also OSD shows with Green Shadow.

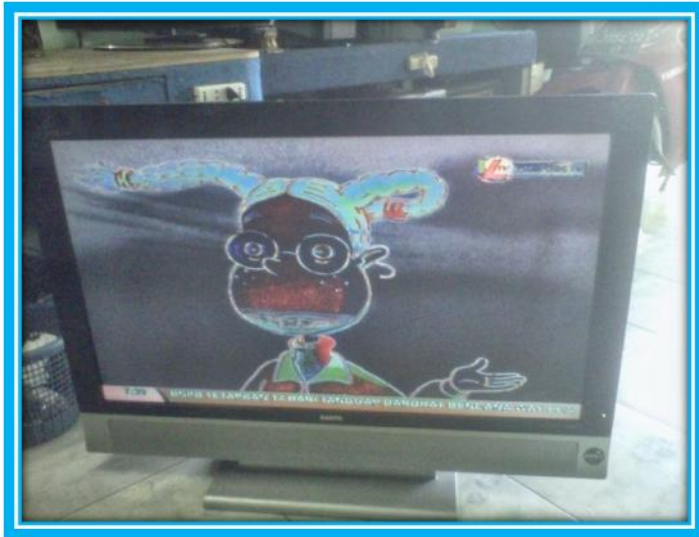
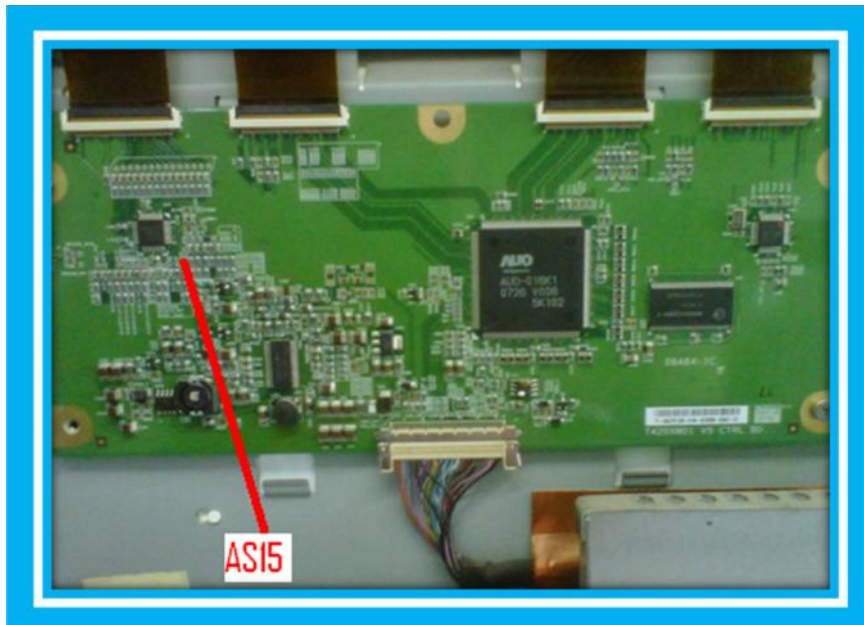
Timing control T-Con that uses ICAS15G Damage occurred in the T-Con block we use hot air for replacing this I.C.

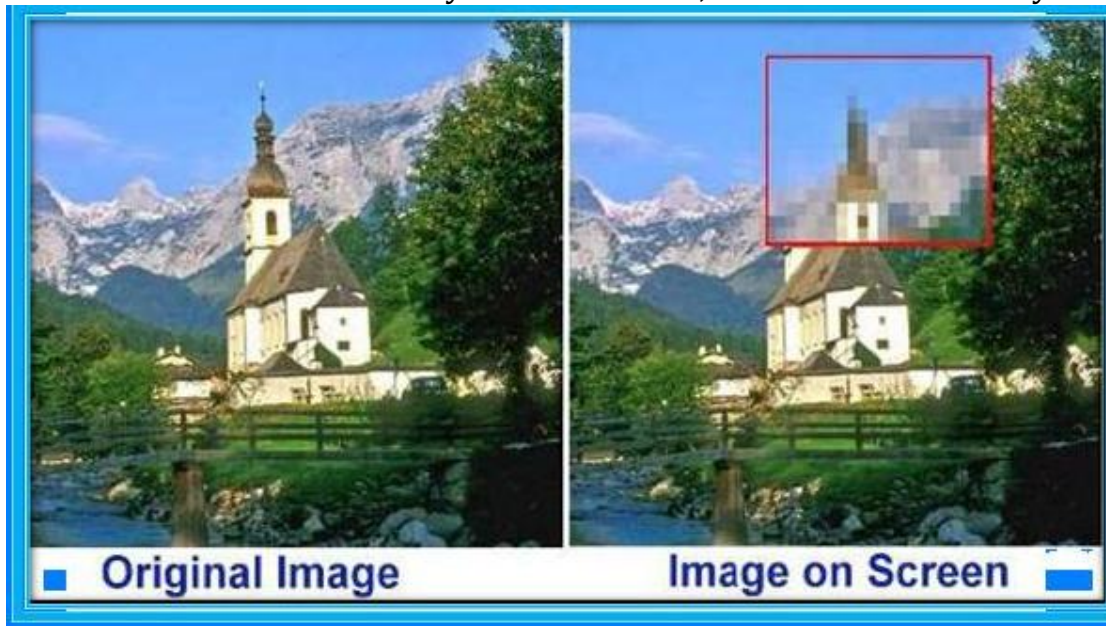
Pixelization can be caused by the main board, but is more commonly a source error

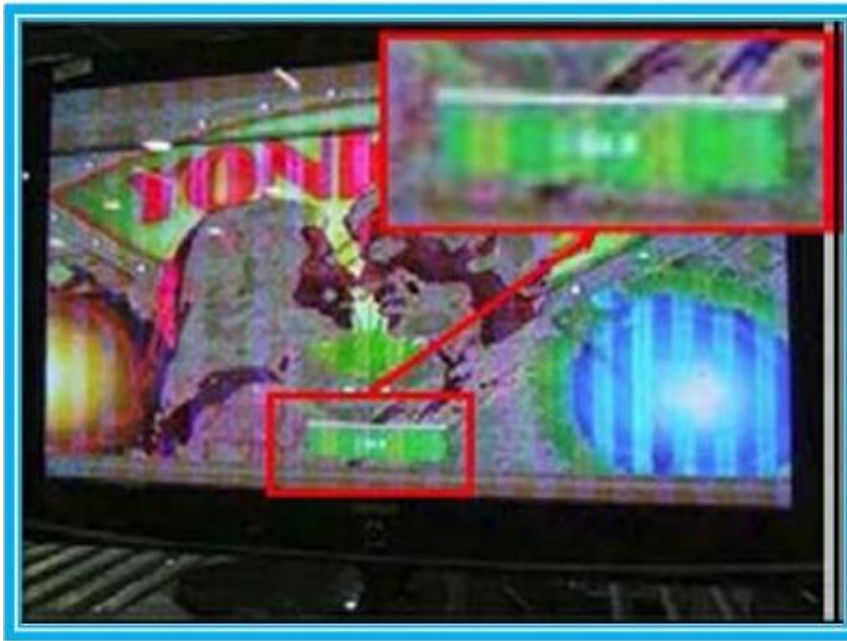
If Picture & Display errors Defective Main Board, LVDS, or T-CON

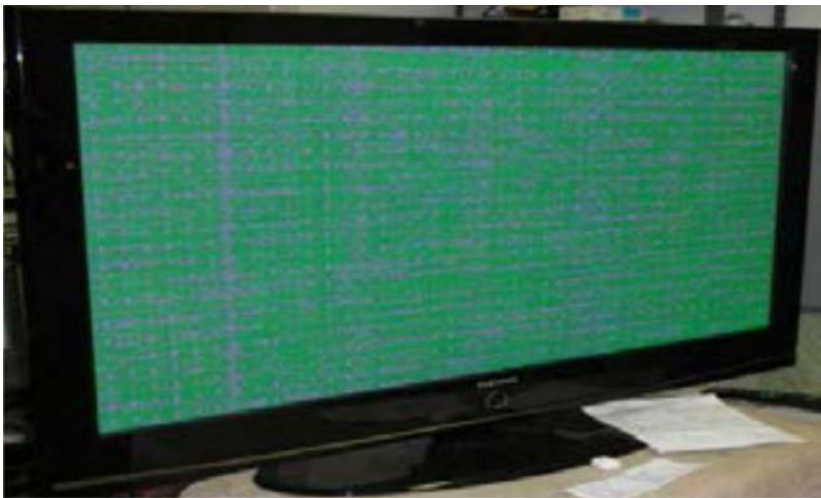
Green lines or a green screen defective main board , LVDS , or T-CON.

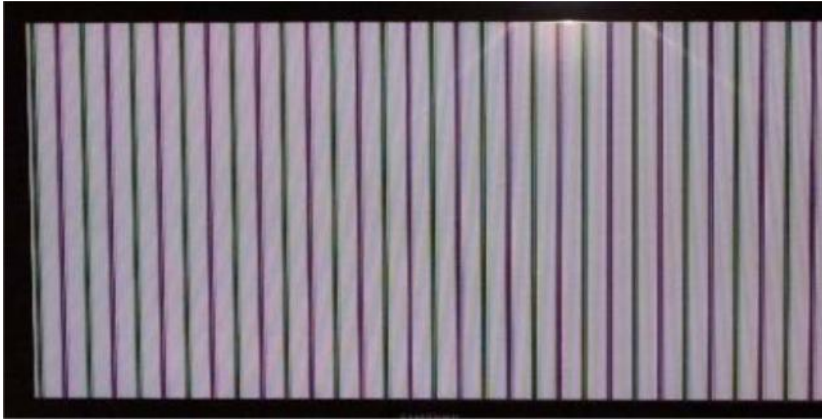
Vertical or Horizontal Lines: Defective Panel likely but also T-CON, LVDS, or Main Board. Use Test Patterns in Factory Service Mode to determine error.

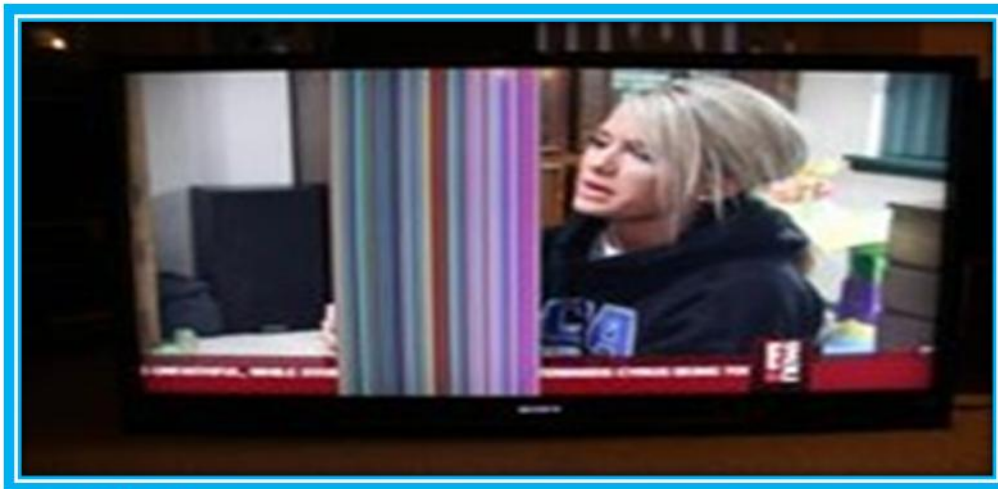
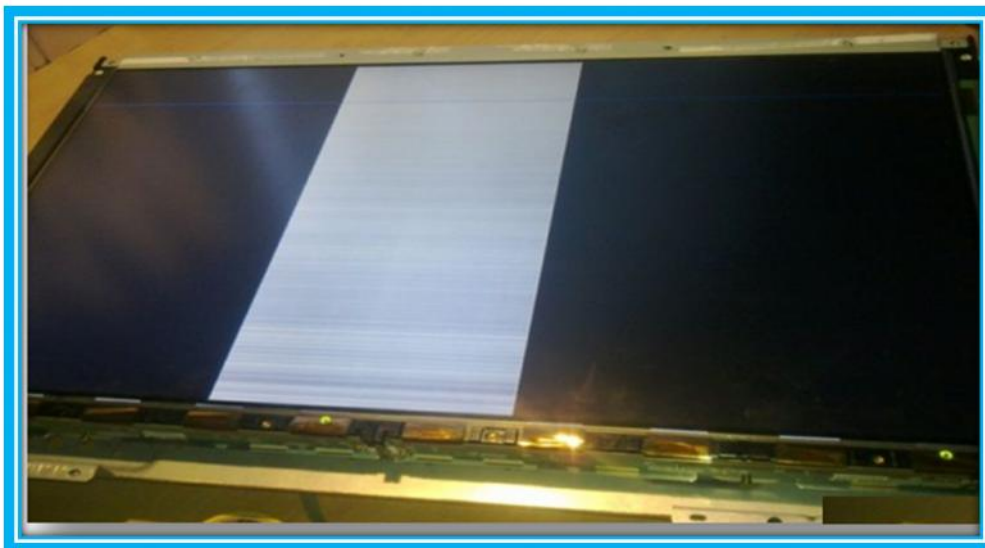
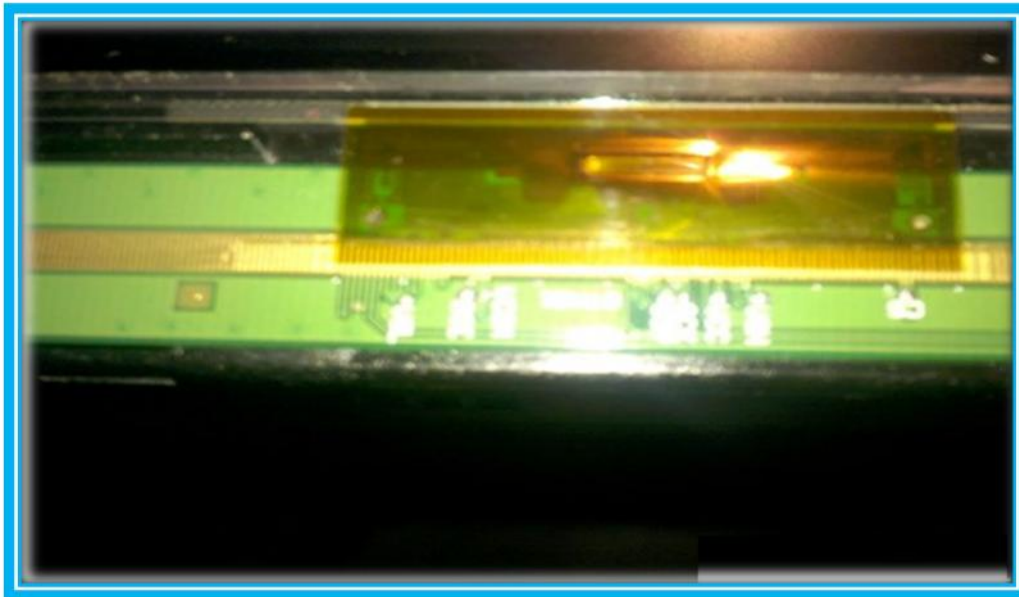
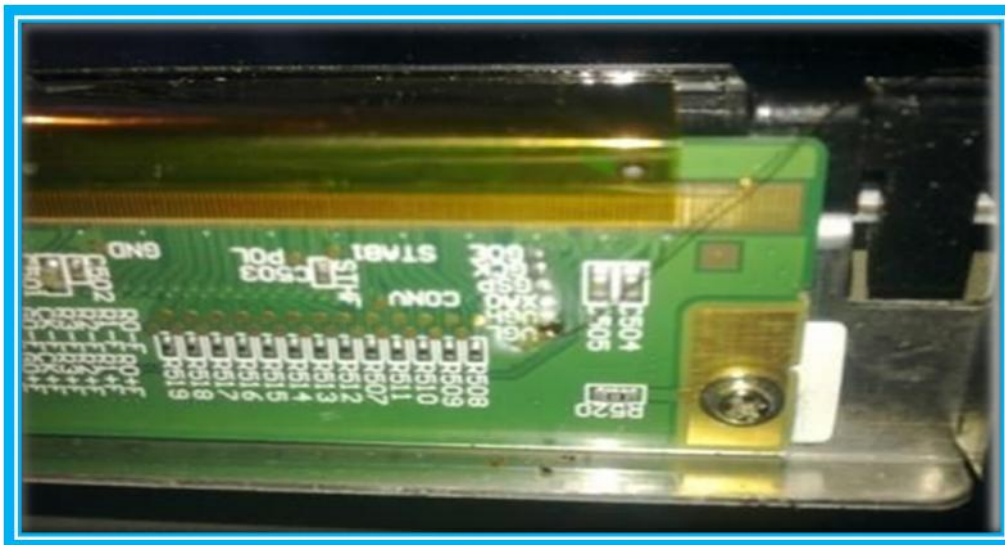
QUANTA QD32HL01, T-CON V32C SF0.17MB15E MAIN-3,BP 17PW15-8

FAILURE: When the screen is dark then (1 min) horizontal bars passing through a couple of minutes in the 1-3 inch vertical column.

SOLUTION: Here is I reveal a big secrete of Panel repairing for you Connect Bracket T-CON side board with matrix checkpoints VGL I use a thin Enameled wire of copper to the end (of course wires) can use the side pad VGL point, Inverter board also had bad electrolytes capacitor and were replaced with new one, Set works like new.

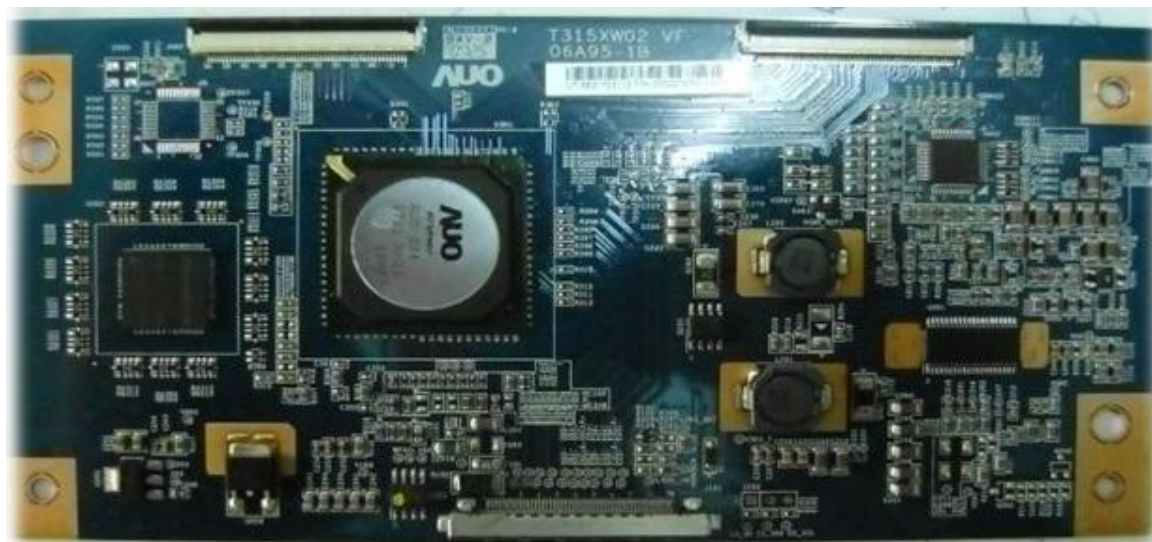
AUO Board

Purple color all over the screen also when you try to enter the setting manually TV reports that "all stored settings will be erased, also replace eeprom but not correct the color problem now check 24v at AUO board its shows low to 18v .

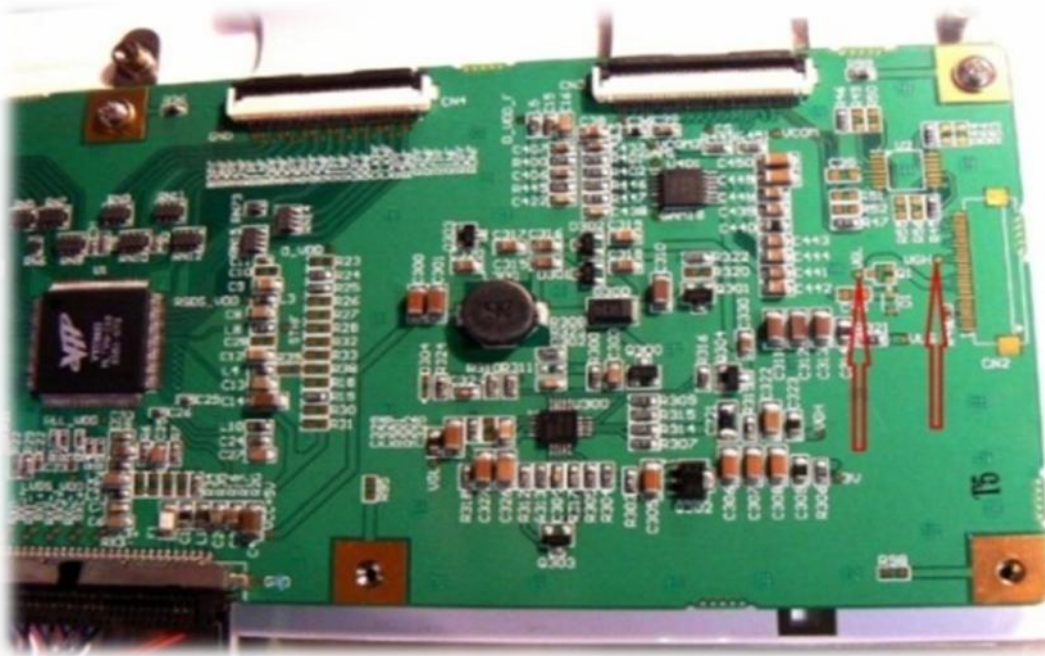
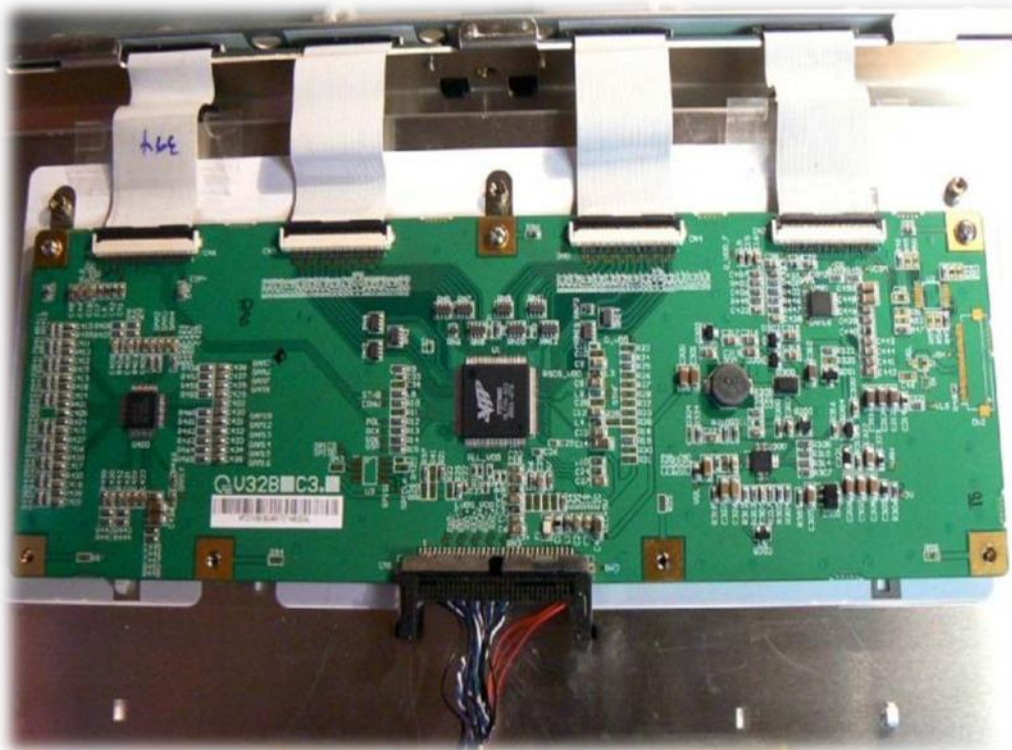
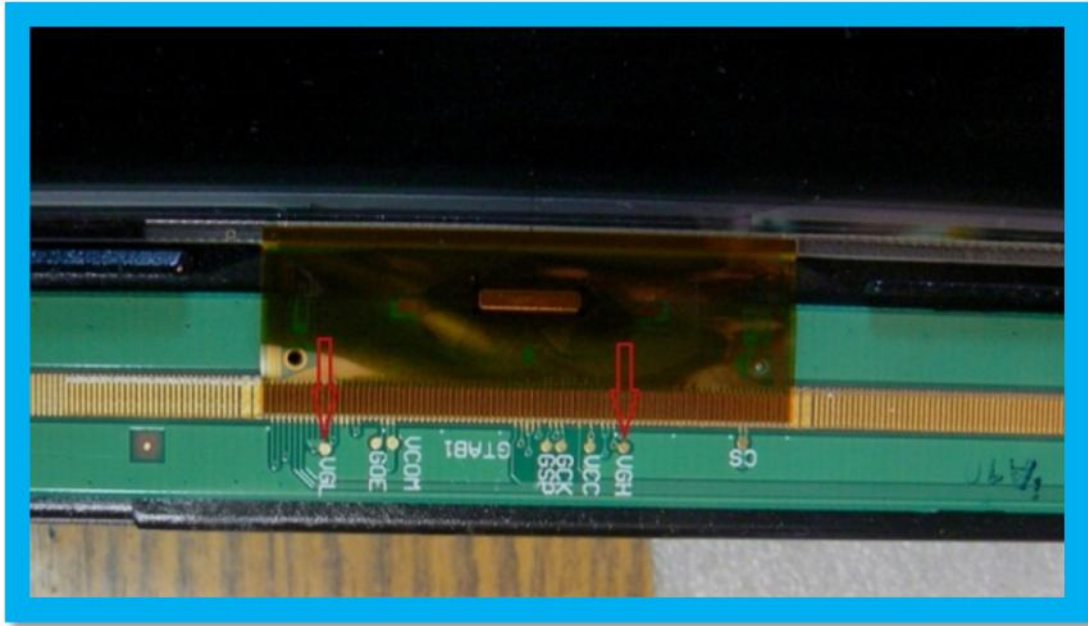
Horizontal stripes Panel Number T315XW01 VC V

This is a **T315XW01 VC V Panel** and its used in many LCDs T.Vs and Very common Fault in this kind of panel famous for open **VGH and VGL** Top Board to Side motherboard of Panel contacts VGL and VGH respectively open when its test by digital meter, I put a two jumper wires between (See Arrow mark) VGL and VGH to side board VGL and VGH points, Now panel Works Fine. I fix many of them.

See Red Arrow Marks on Side Board VGL and VGH.

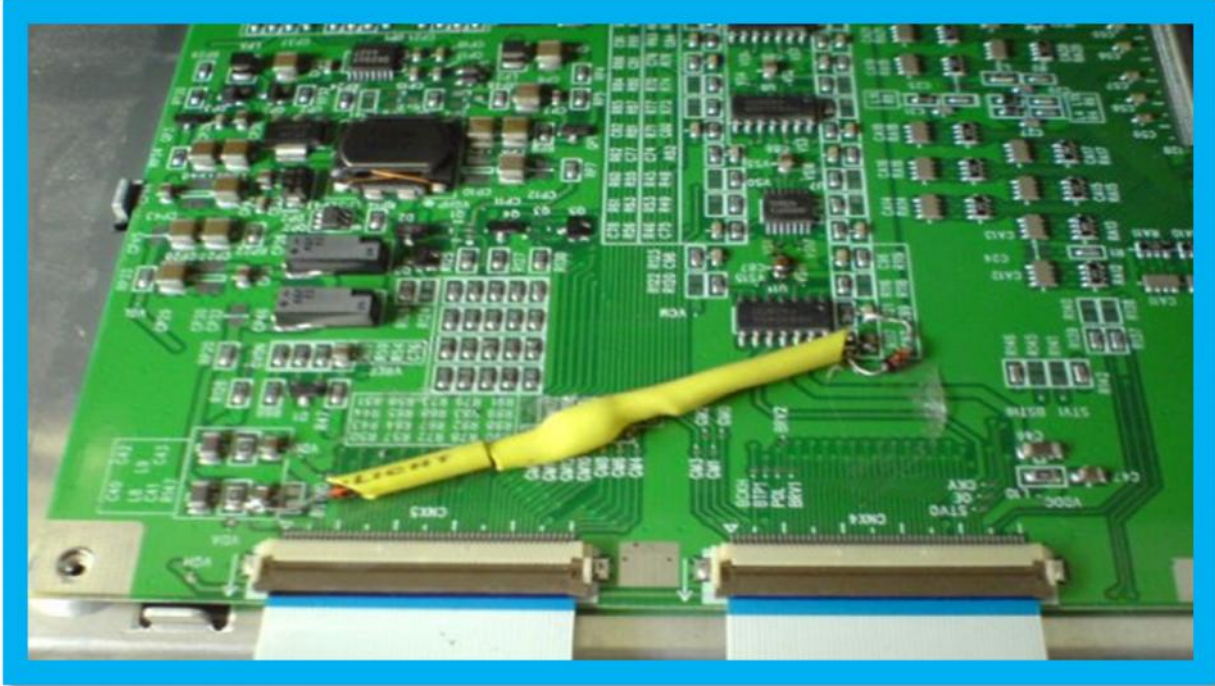
LCD LC-32A1 PanelV296W1-C1 X7 ,T-con V296W1-C1 X7

Problem low contrast, whitish image

By Measurements on T-con showed VGL -5.5V, VDA 13.3 V, VGH 20.2 V, VDD 3.3 V, and Here VCM 3,2 V instead of the 5,6 V. removing R117 and icing diode resistor chain from the point to point VCM VDA and is limiting zener voltage of 5.6 volts the problem was

solved.

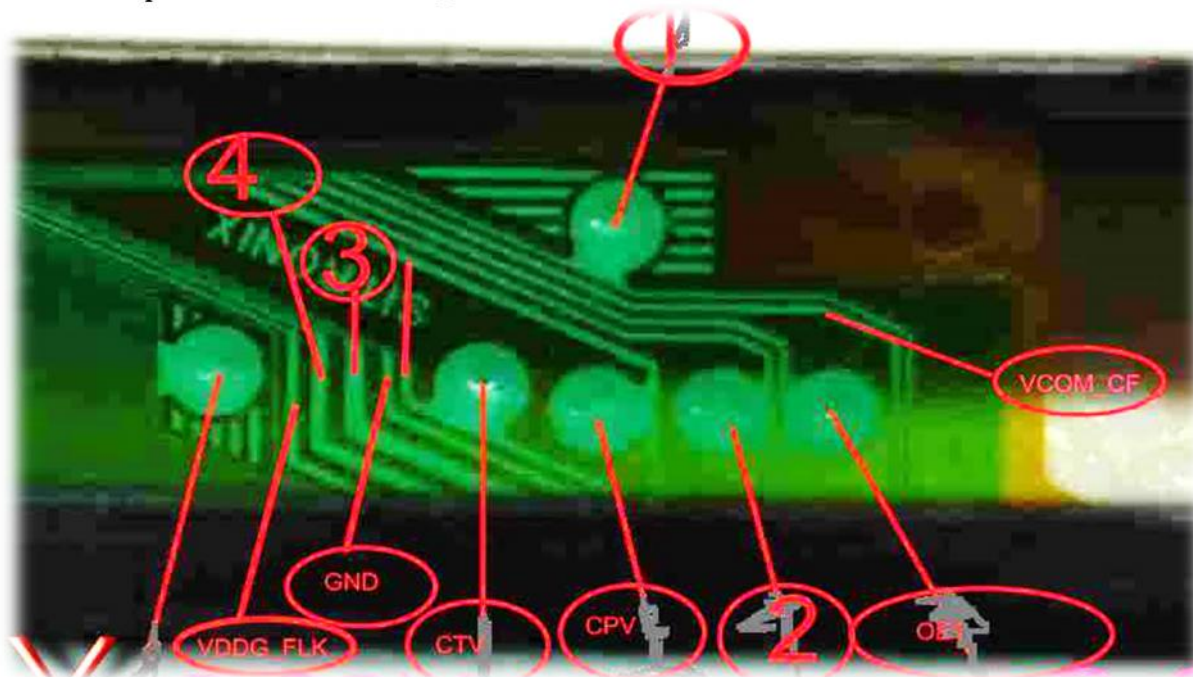
Here is I reveal a big secrete of LED Panel CLAA215FA04S

LED panel CLAA215FA04S As it turned out, the problem is quite typical for these panels open signal VDDG_FLK. Only problem is only that the "pads" no checkpoint VDDG_FLK, which can be soldered, link wire directly to the track. Here I can show you the check points Solder VDDG_FLK to Board.

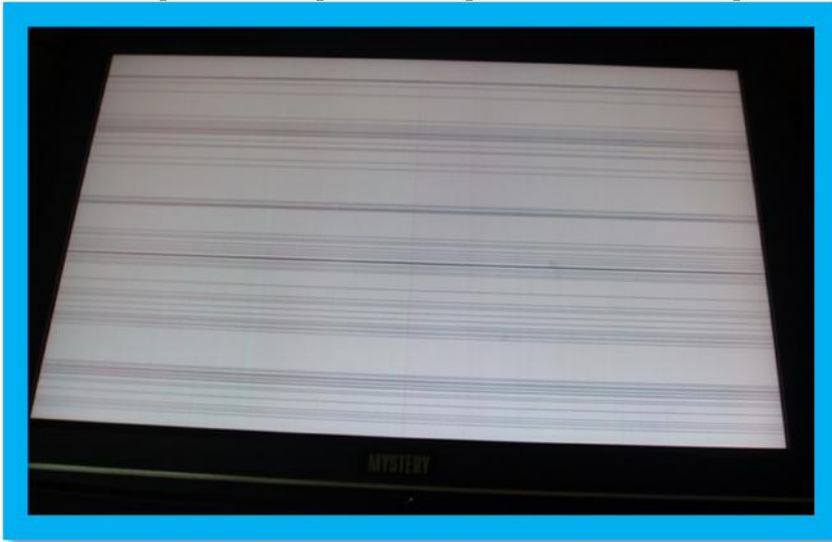
In the diagnosis of detecting the absence of VGL And understated VGH (18V).
Now Here is **I reveal a big secrete** of this fault its Periodic open capacitor C45 1,8nF connect to processor pin 41. Replace with new capacitor restore the original picture.

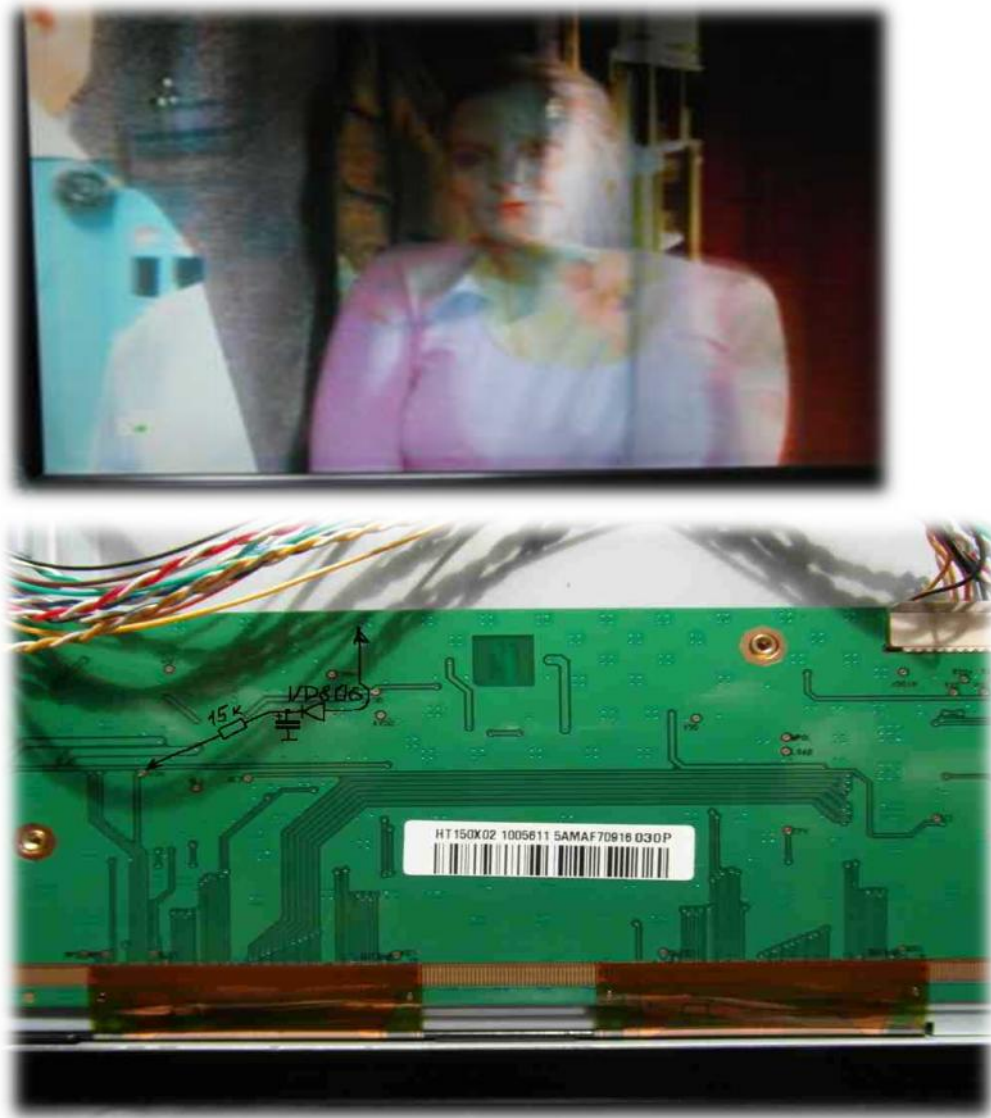
Problem: Ghost image on every channel you can see the picture of culprit.

There is NO voltage on the T-CON at the point of V ON, Must have +20 to +24 V.

Now I Pick a piece of insulated wire and soldered point V ON ,the T-CON board via resistor 15k ohms with +20 V (VD806, C817 +) on plate -PLT 203-2 BP + inverter.(See the modification Method in picture two).

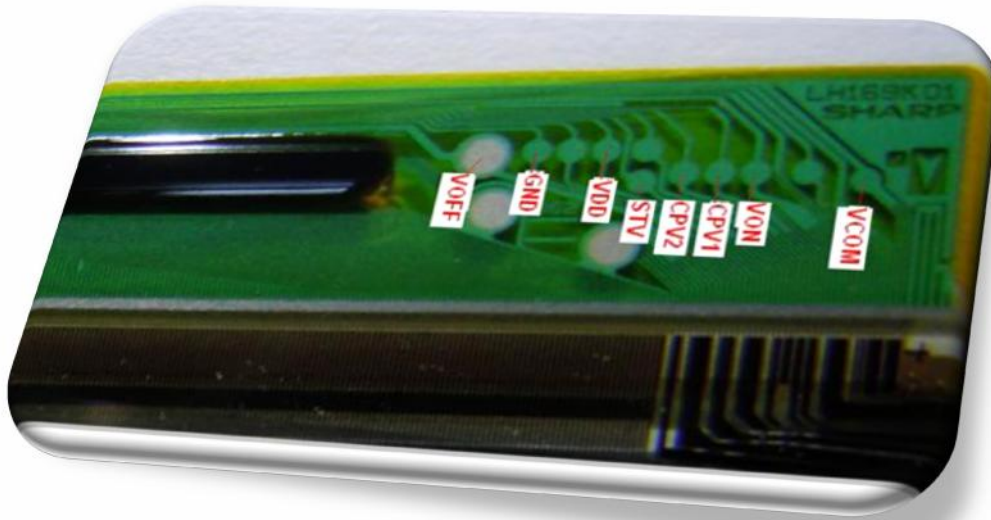
Fault: Some times pictures comes and went blank with black screen, **Here is I reveal a secrete for** you, this is just because of interment open links von,vcom,cpv1,cpv2,stv,vdd,voff, use a thin wire for connection.
