LCD LED T.V Panels Modification and Major Repairs

LCD LED Panel Failure and Cure

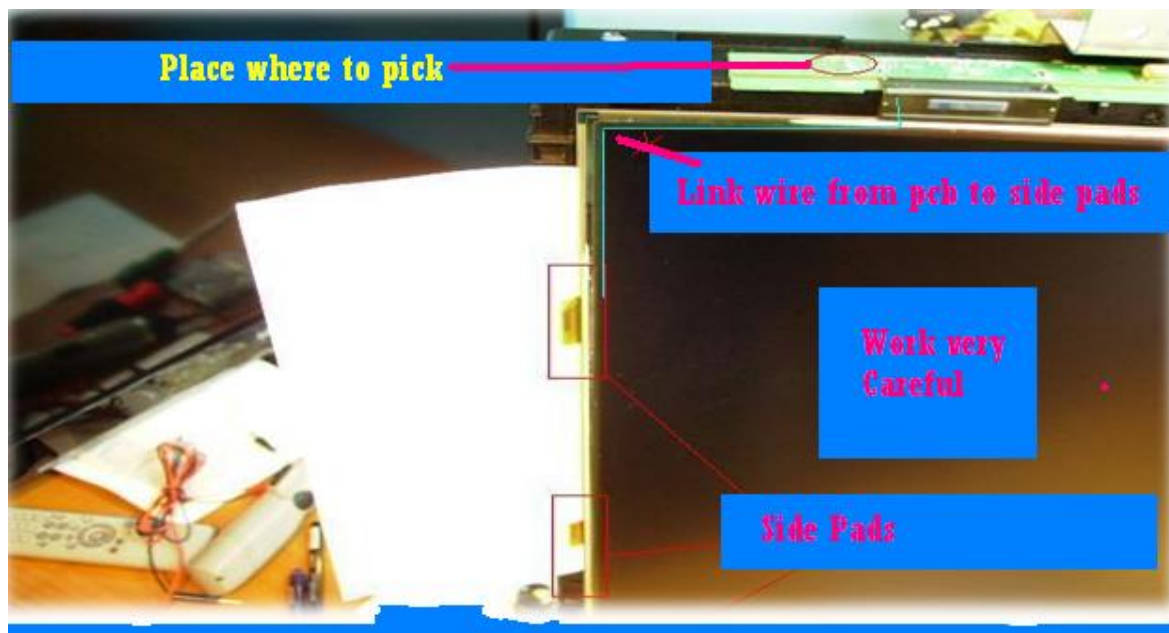
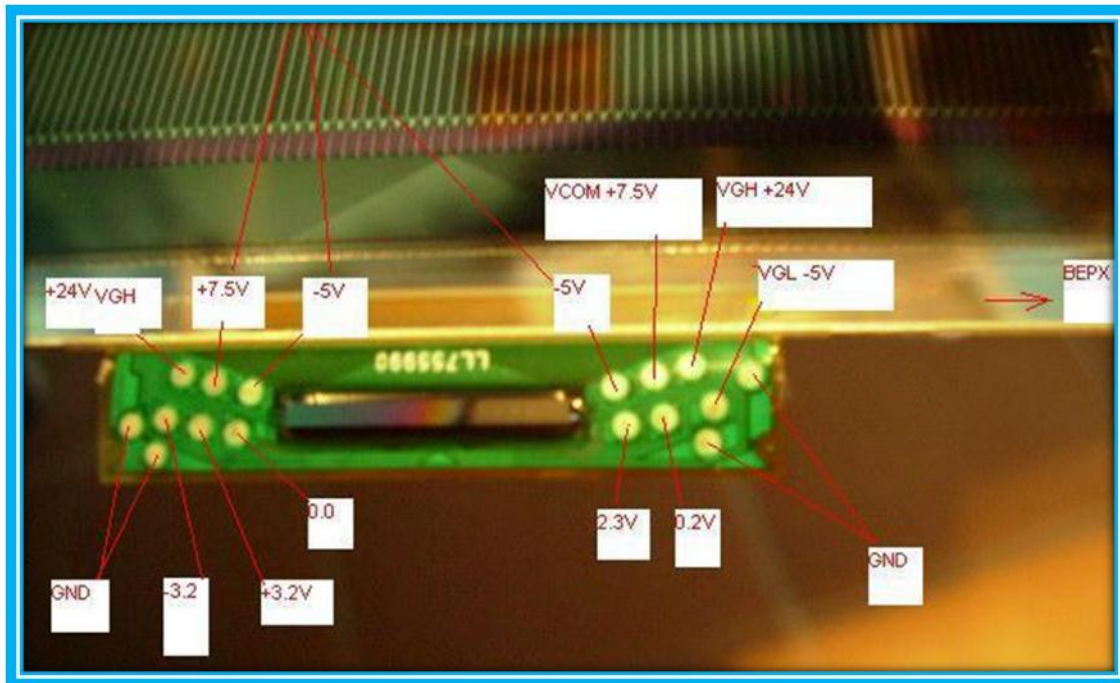
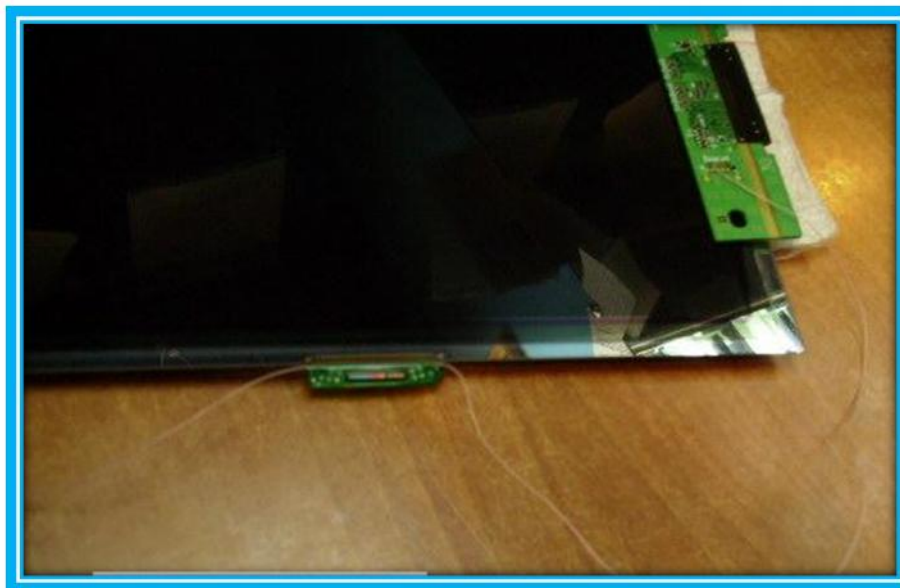
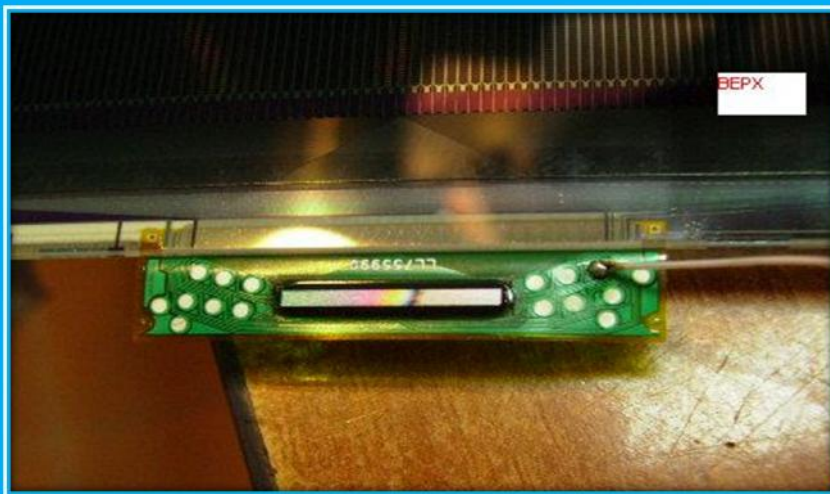
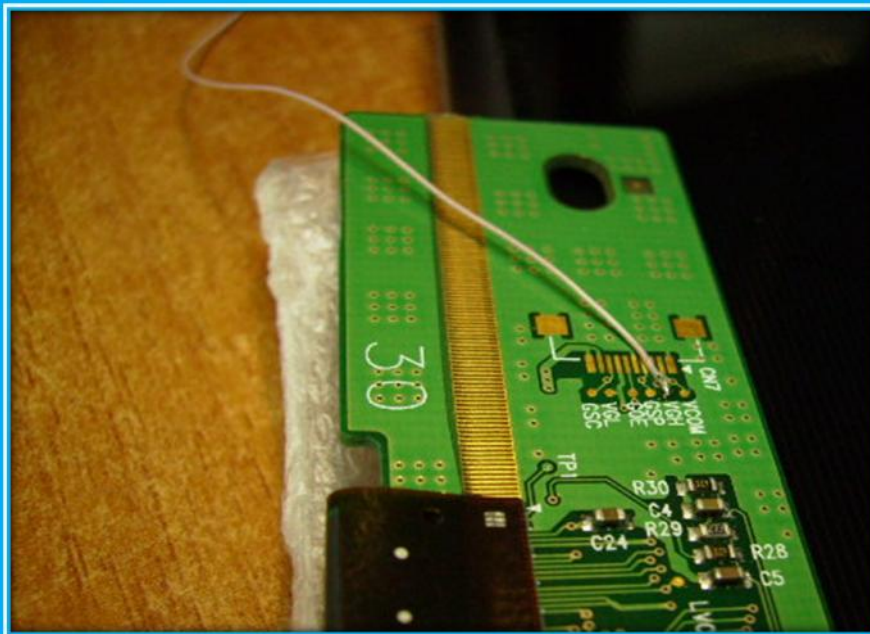
Defect; Dark screen, insulation and OSD interment problem. Picture come and blank him self, some times its come back him self. Inscription on Shield panels LC42WX5 (SL) (D1) on the T-Con LC42WX5-SLC2

VGH VGL,VCOM,5v and other shows in pictures you can soldered from the left tabs to driver upper board ,use a thin wire to reconnect it. (Many Thanks to my Russian Friend)

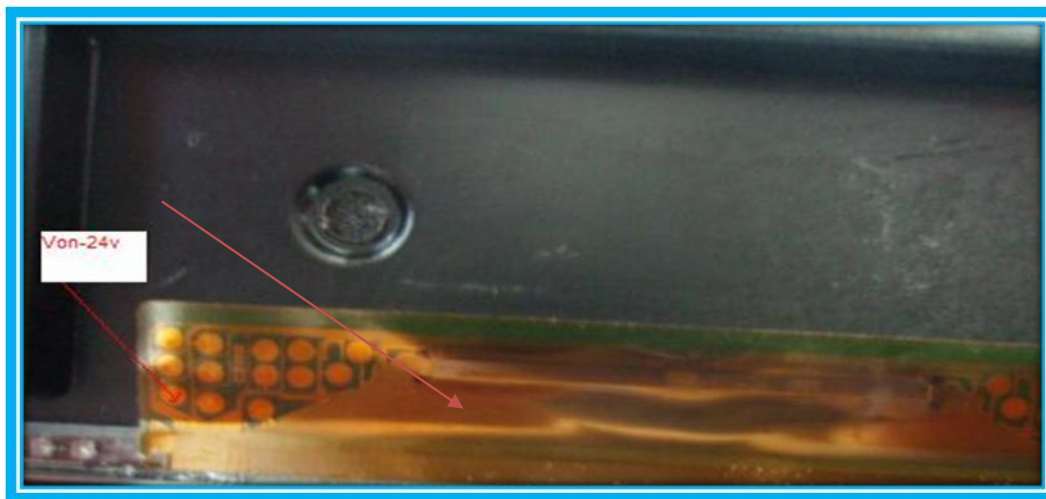
Samsung Panels major problem at No Supply Von-24V to side drive. Its was caused to faint image, some times slow motion picture Von on the panel jumper and the thin wire to circuit board as show in picture

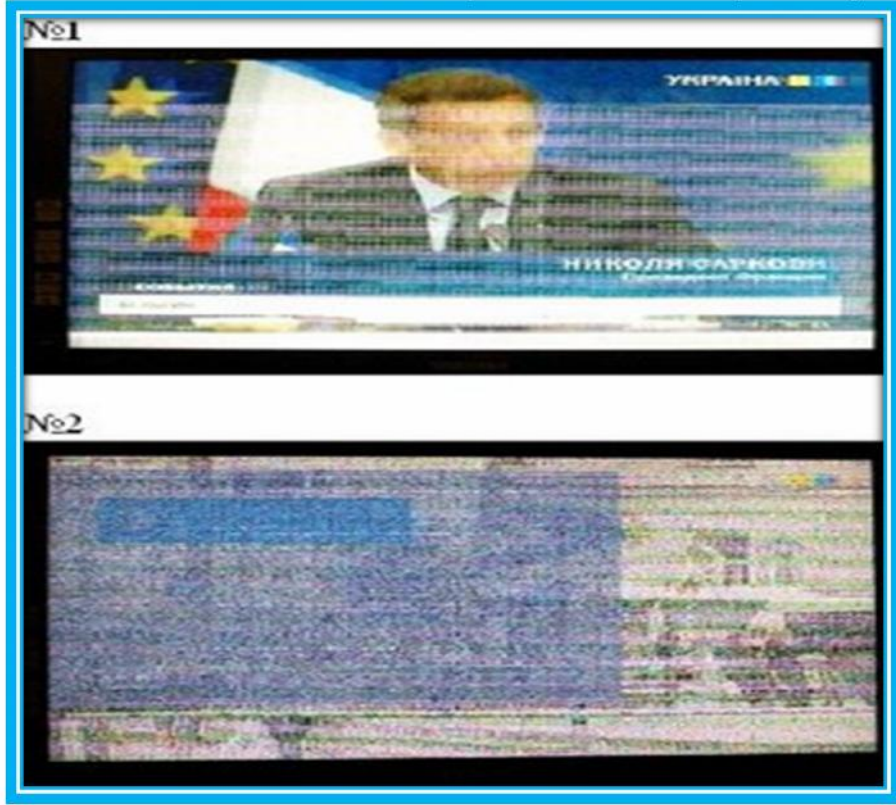
Composition: Scalar SVP-PX56, VIDEO RAM K4D263238, percent S3F866B, and Panel AUO. Photo number 1 and number 2: Taken from Solution: Problem was resolved by replacing the chip scalar IC500 SVP-PX56-7256. A so- same for a given fault is possible manifestation failure of IC222 (RAM K4D263238) X500 (28 MHz) replacement.

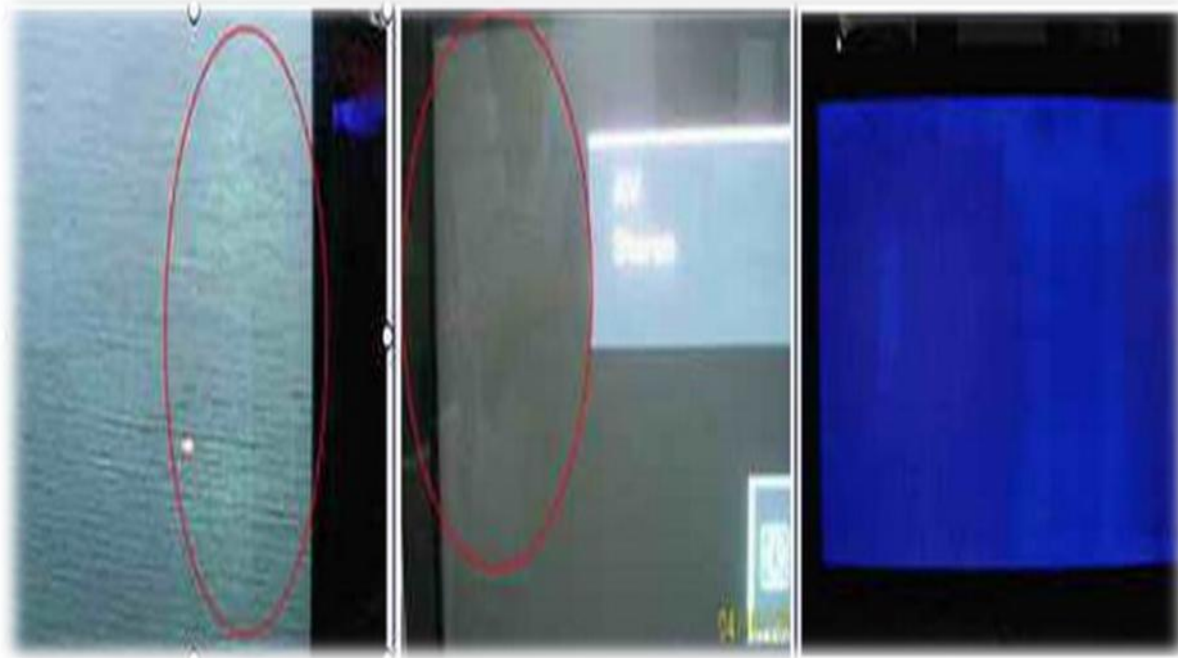
Fault occurs defective discharge. Problem may occur immediately or with heating, in most cases, helps software update fees CTRL. It can also help control reset pulse fronts; knobs are located on the Y-board.

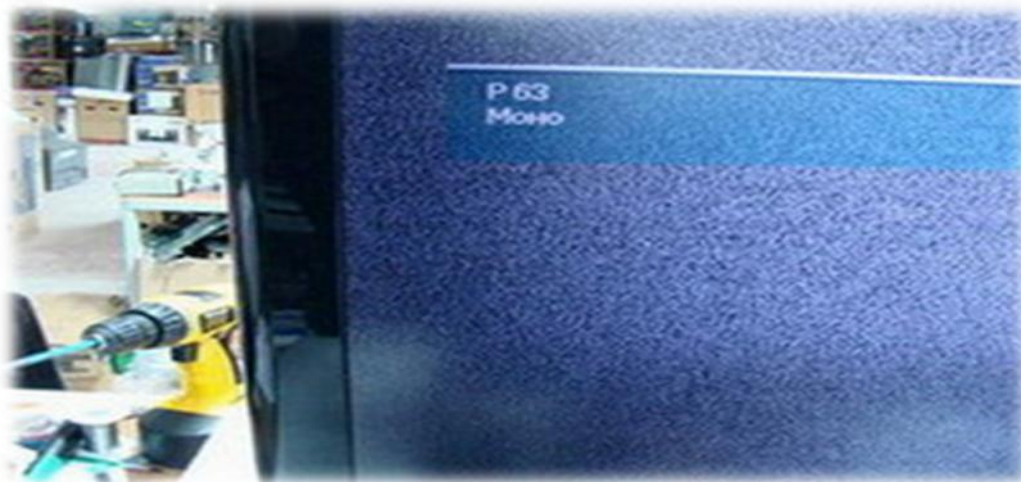
Problem is the failure of the backlight (CCFL).

At the time of inclusion, clearly visible uneven illumination, where light-dead pay attention. First photo spot is seen in the lower right corner. Treatment method is simple- change the lamps.

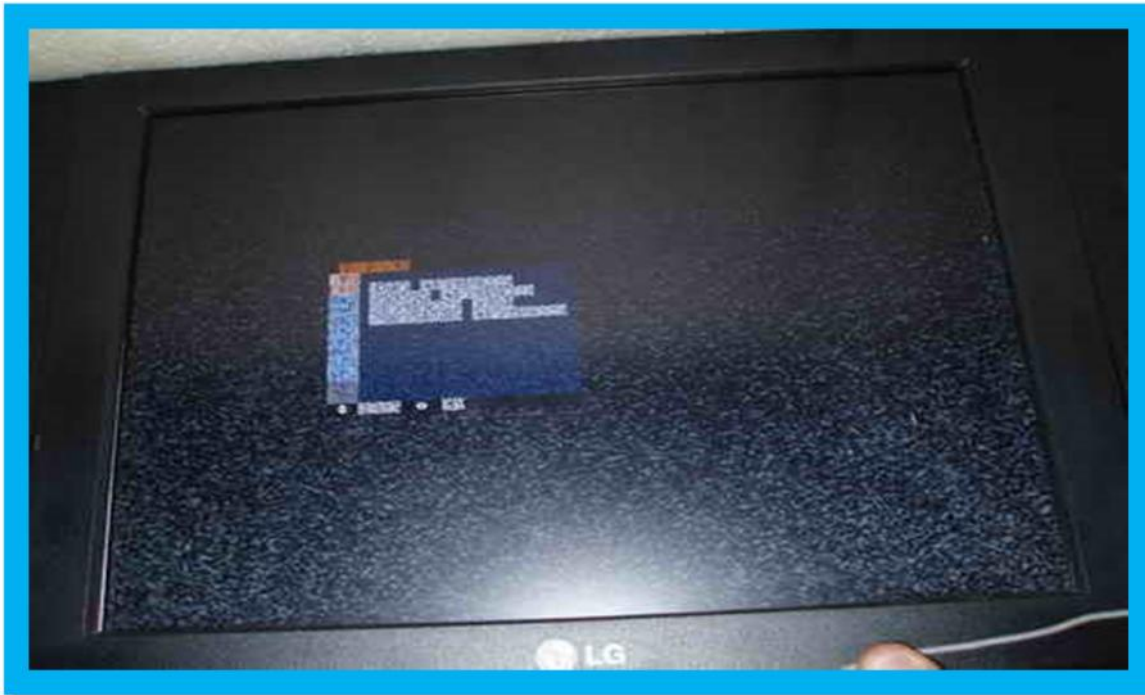
LG model 15LS1R CL-81. Fault Menu does not appear correctly Problem-bus interruption SCL about Eeprom. After Replace the unit turns on normally,

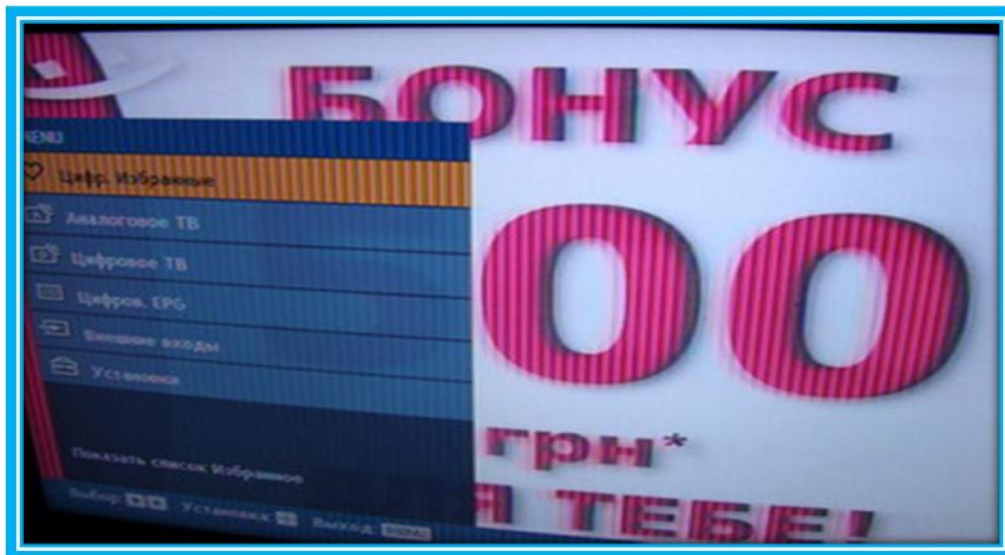
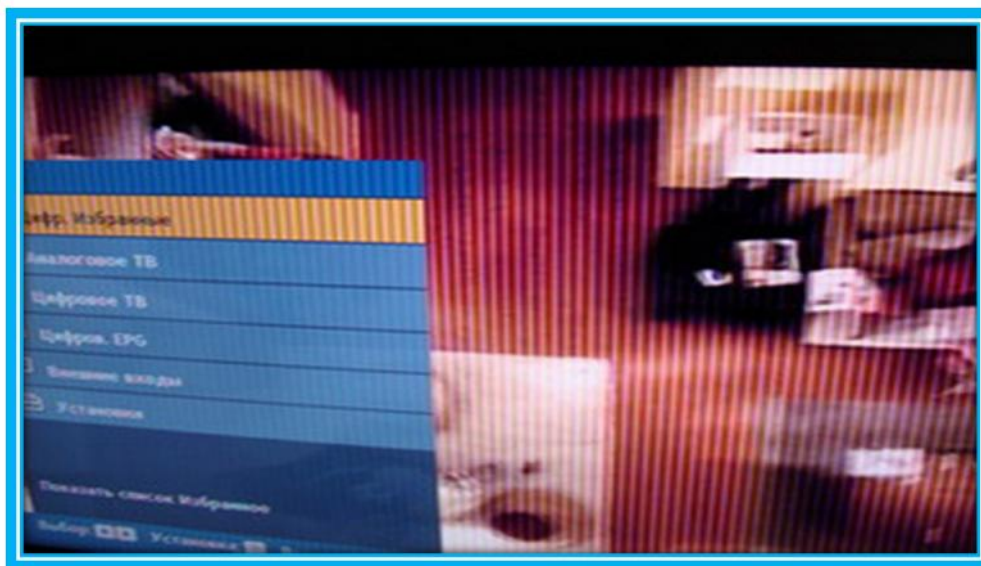
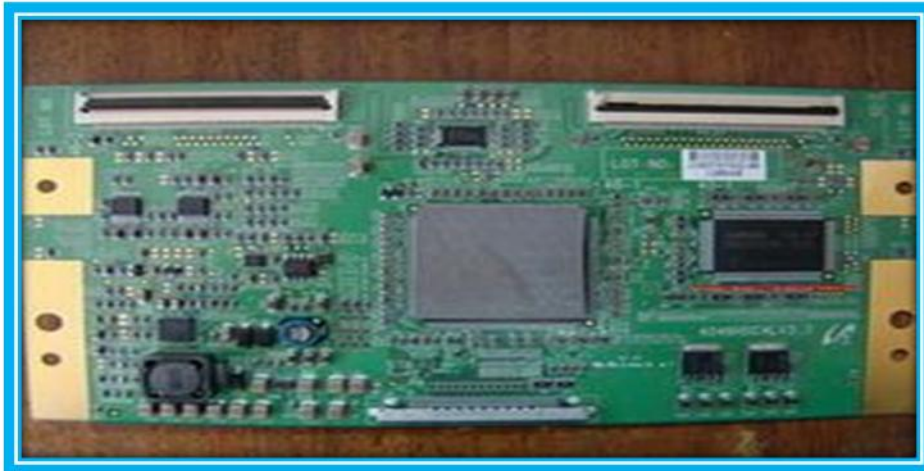
Model: Sony KDL-40W3000

Frequent vertical stripes in the image across the screen Solution Problem T-CON board was in comparison modes and charts with the workers managed to localize the defect came under suspicion SDRAM (IKM1- K4D263238) - dips in packages targeted ,unfortunately Sony does not allow repair T-con boards and provide SDRAM.

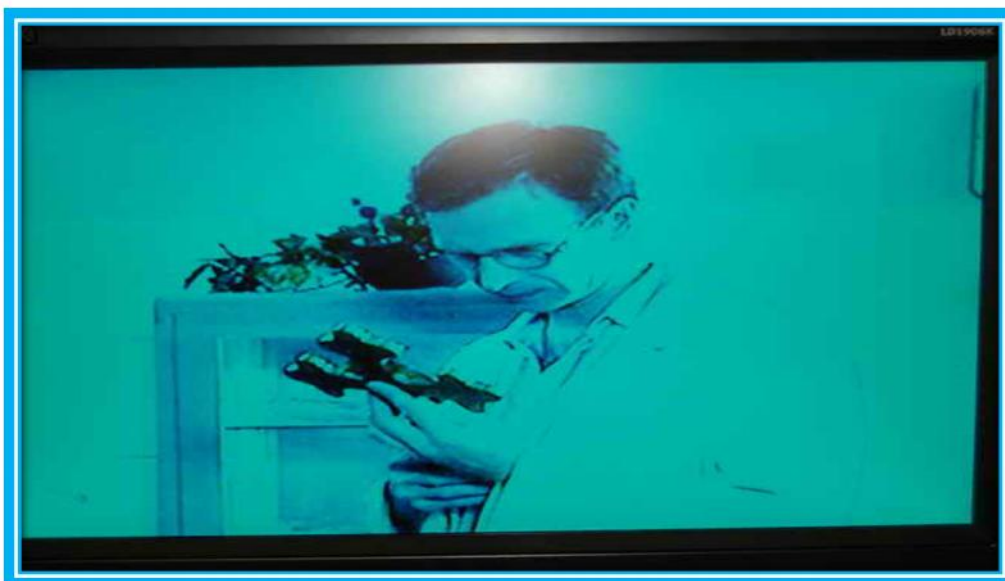
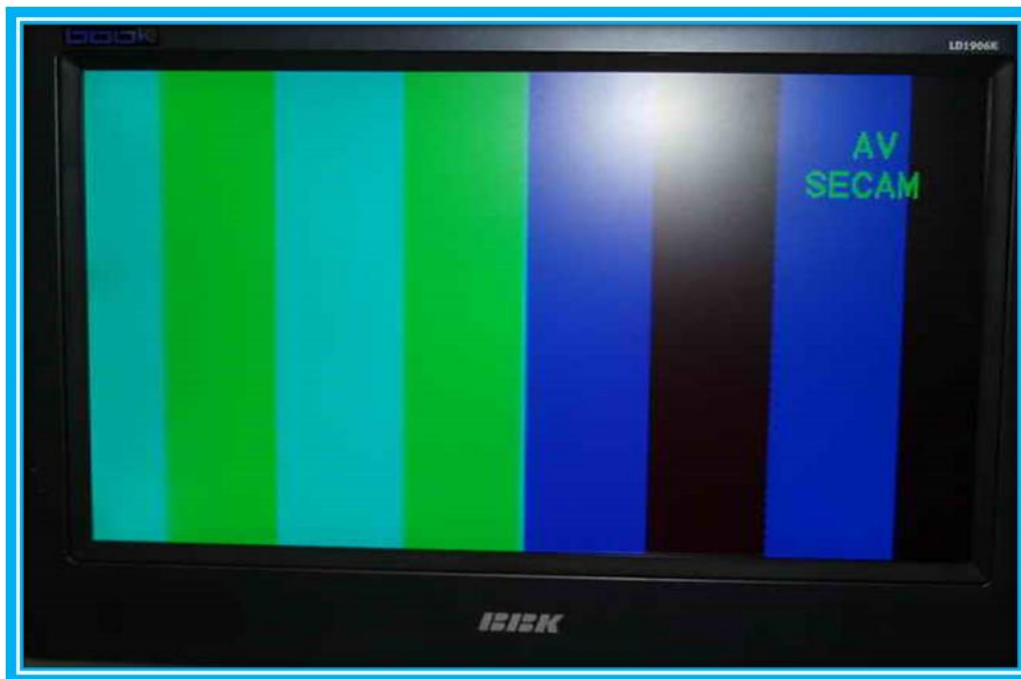
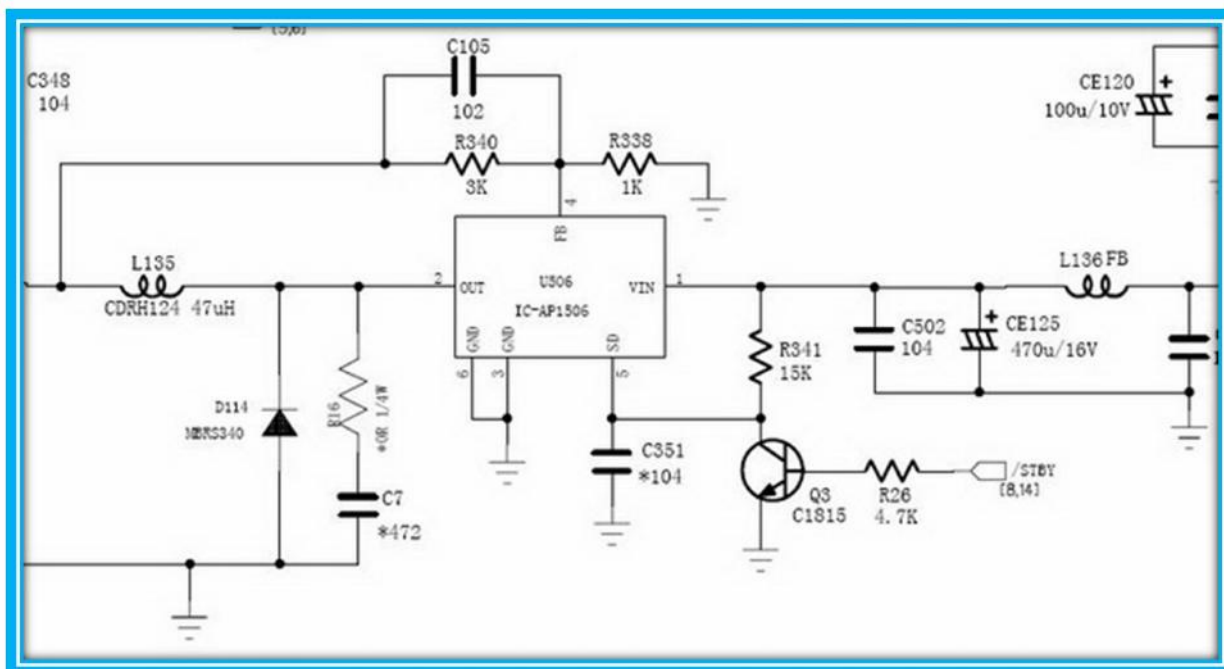
Fault: lay in the fact that when the image appeared in just 30 seconds, the red almost was not there, in service mode, it was clear that the scale of adjustment red 10 units (the other more 100deleny), after adjusting the image became normal, but still turned off in standby incorporating image in just 30 seconds to appear, but the red color is not lost. If you disconnect from the network and a minute later to include all repeated together with the loss of the red color.

CURE: The fault was on-chip DC-DC converter (U506) instead of 5V which he had to give, it output 11,5 V. The most interesting thing that the unit did not suffer after replacing all normal.

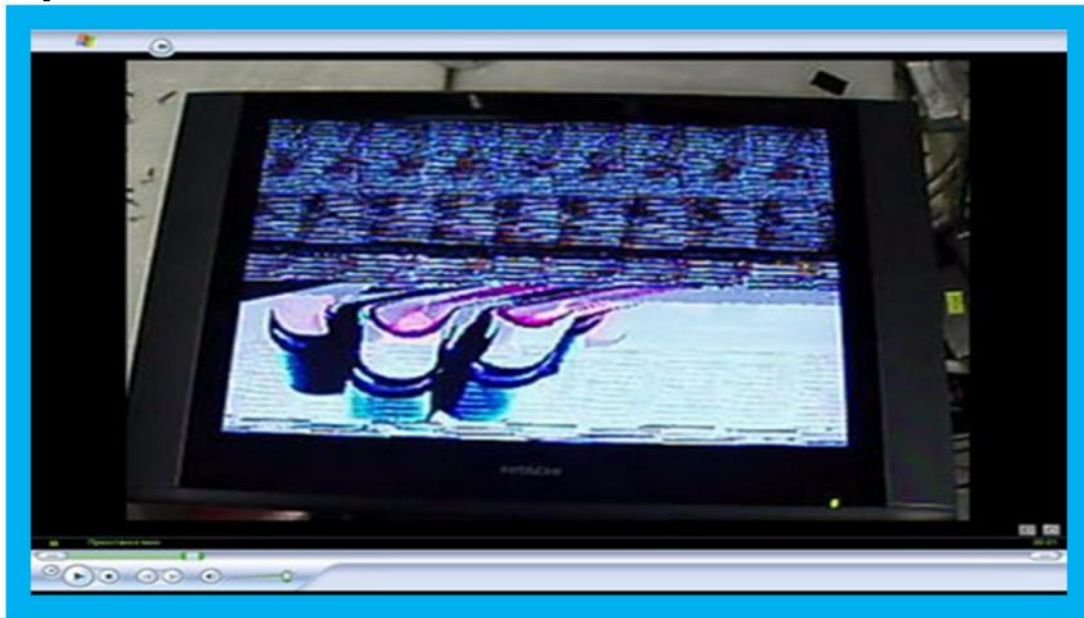
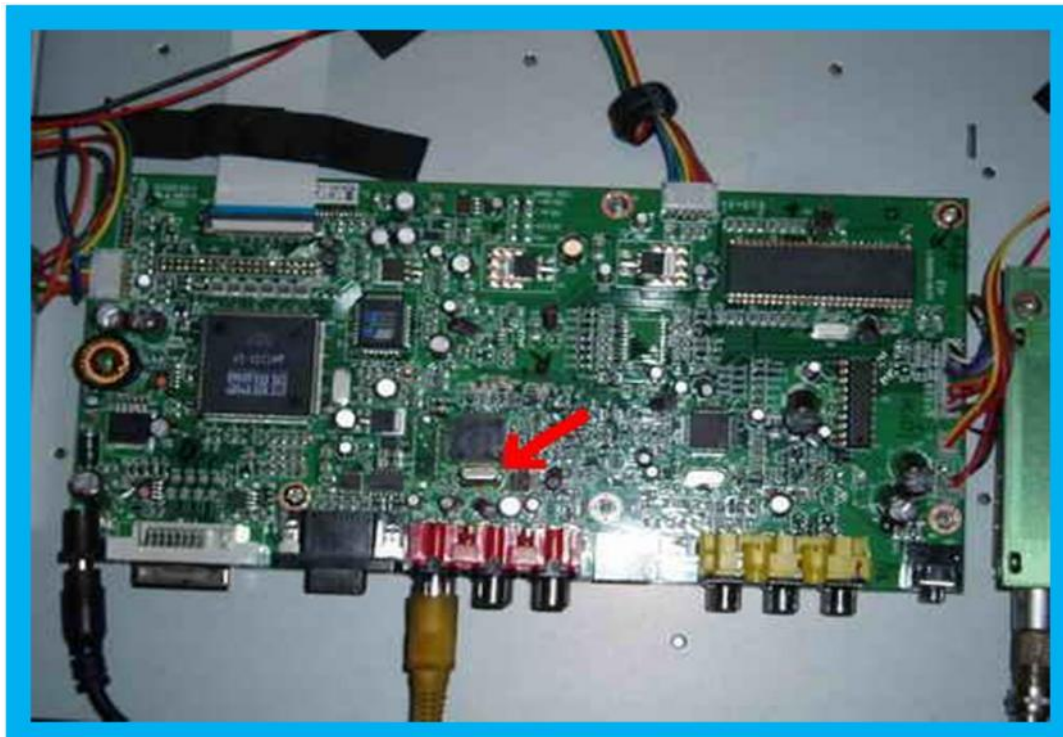
FAULT : Trouble-C warming from 5 to 20 minutes (cold) a horizontal bar moves vertically then another and another, 10 seconds through out completely disappears, the problem occurs only with a tuner, AV on all normal.

Cure: The culprit turned out to be quartz (14.318 MHz) of the commutated chip TVP5146PFP.

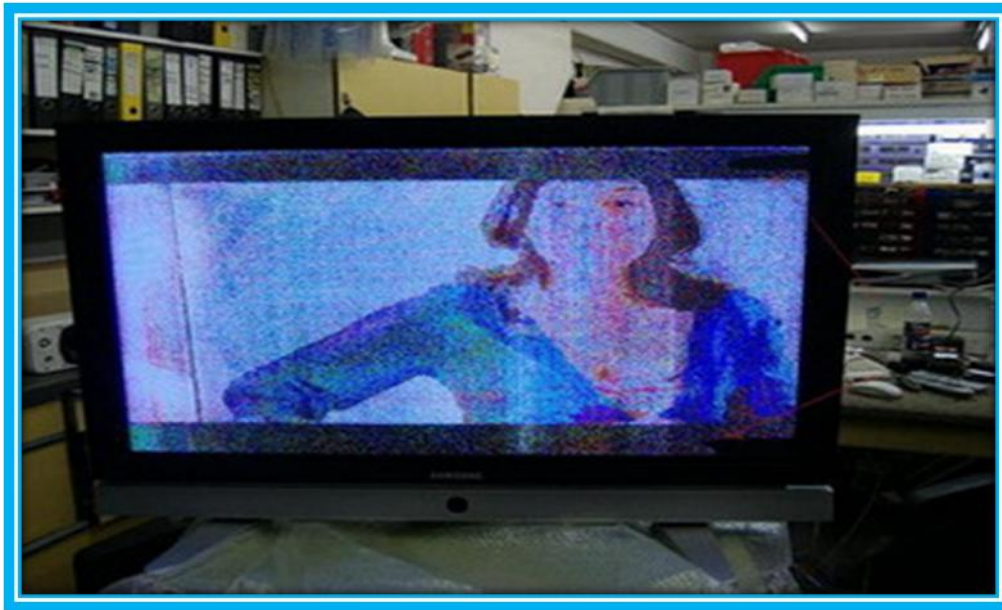
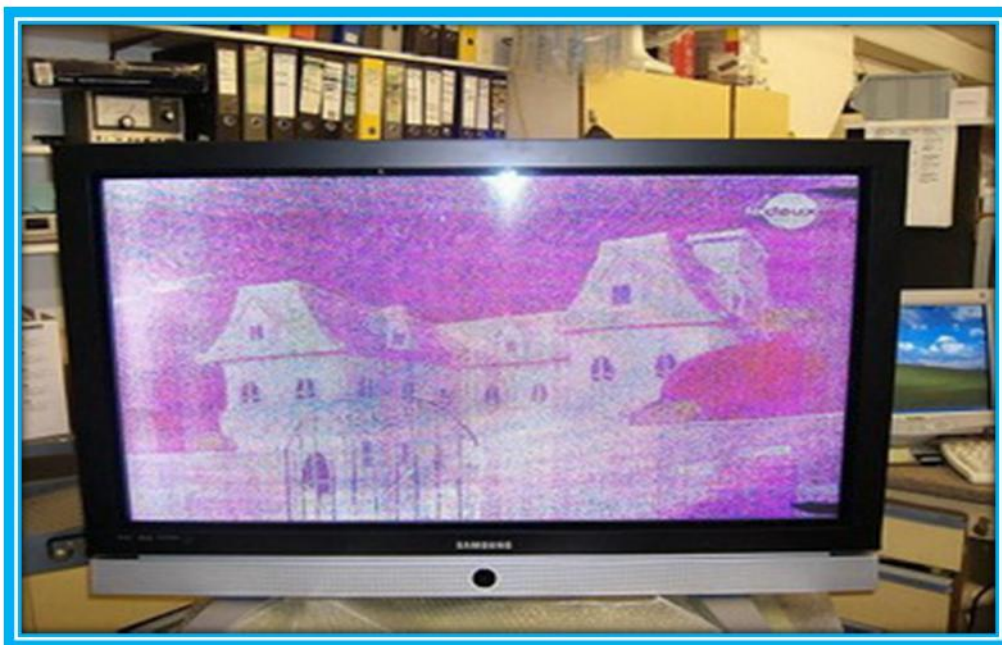
Snow on the screen with spots on providing participants Ghosting color shadow
Problem resolved by replacing Y-MAIN , Y-SCAN Boards.

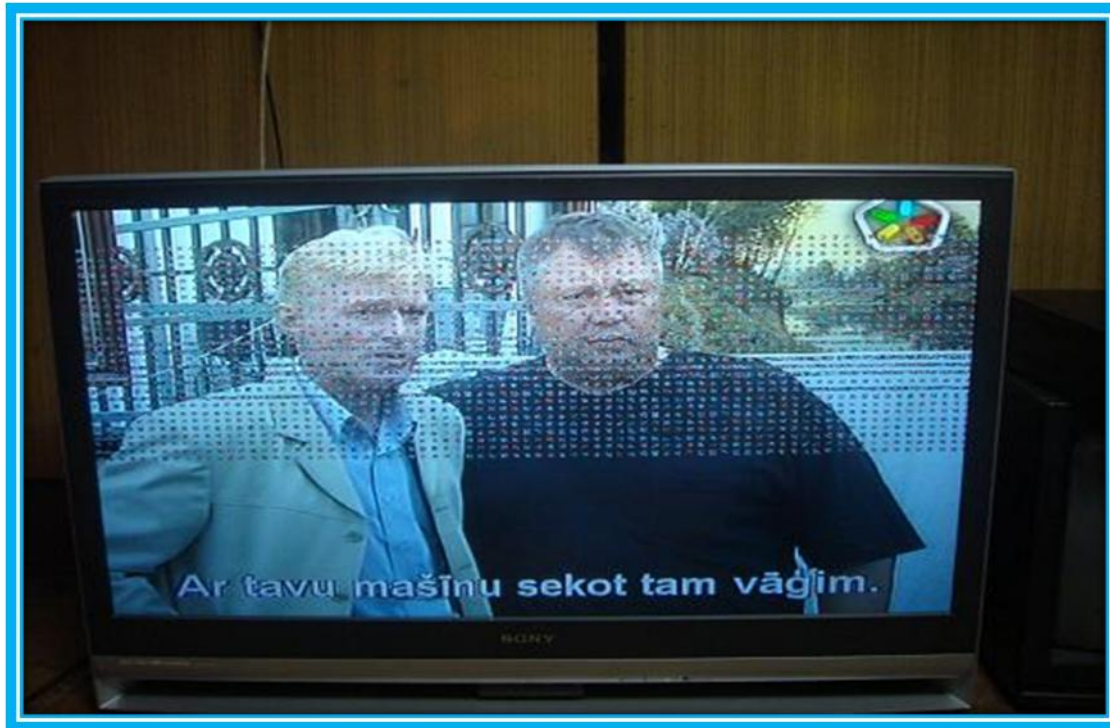
Memory of the video decoder SDA5550 M TTX CXA2069Q S2-Compatible 7-Input 3-Output Audio / Video Switch B11 MSP3411G Multi standard Sound Processor Family With Virtual Dolby Surround NEC UPD61120 CPU TC58DVM72A Flash D1216AATA-6B-E ELPIDA MEMORY CXD1975 largest percent under the radiator and unprinted Plus a bunch of small things **The faulted memory of the video K4D263238G-VC36T**

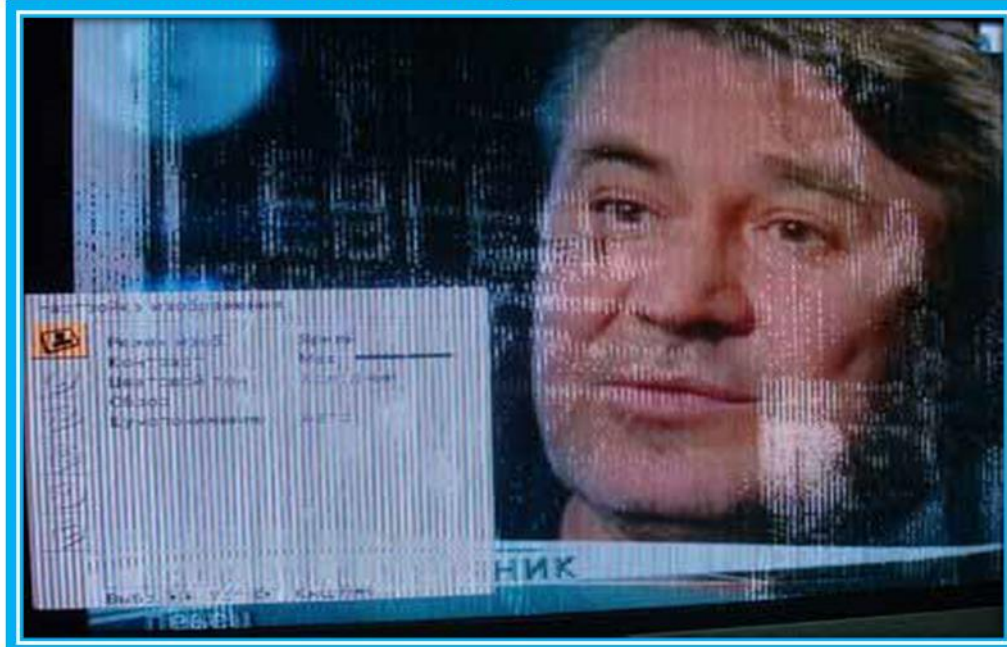
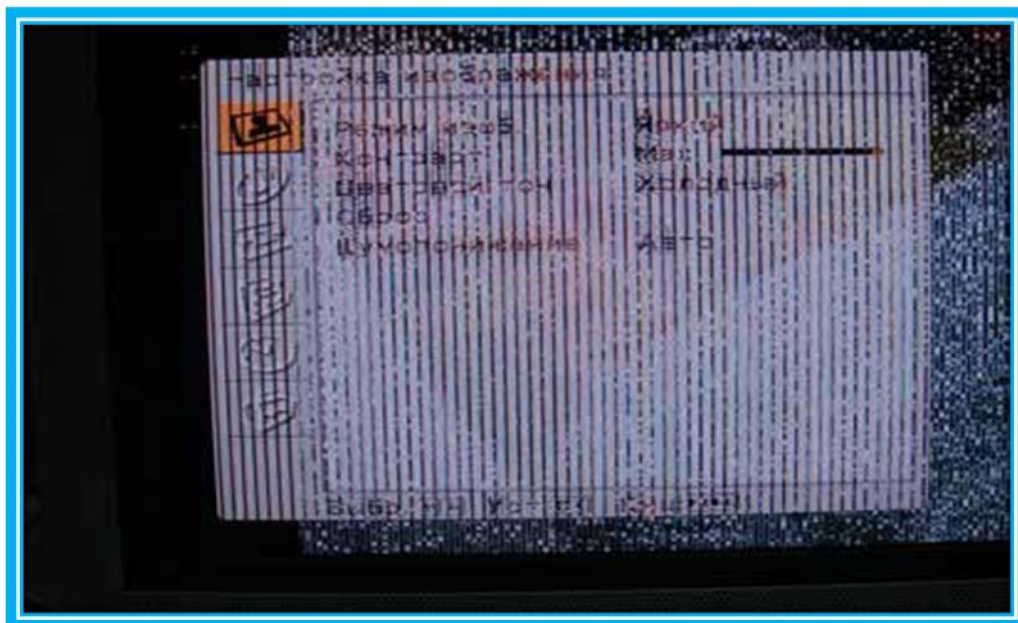
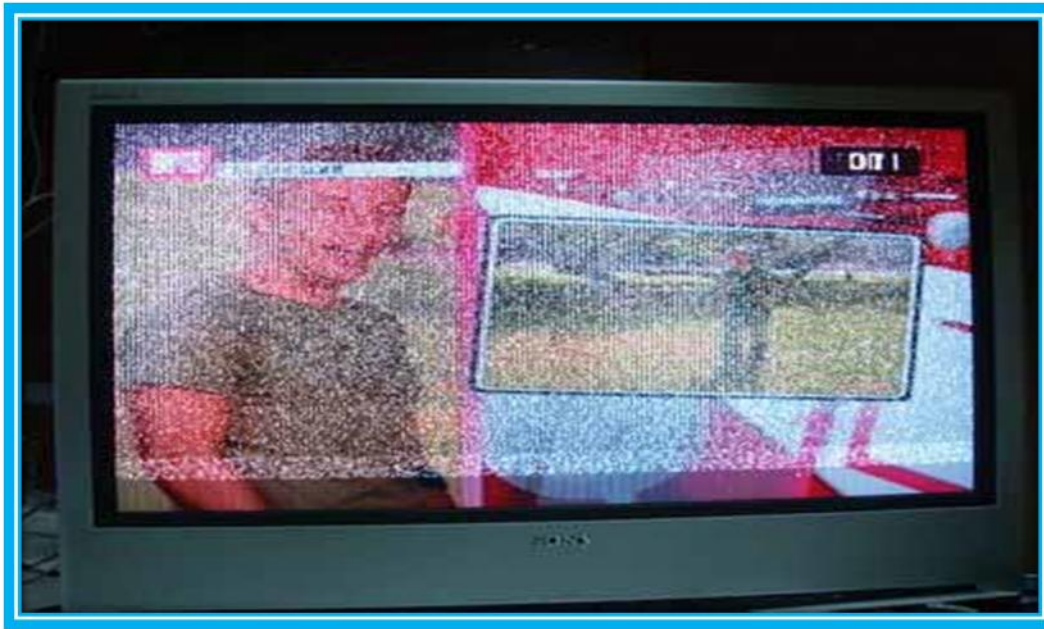
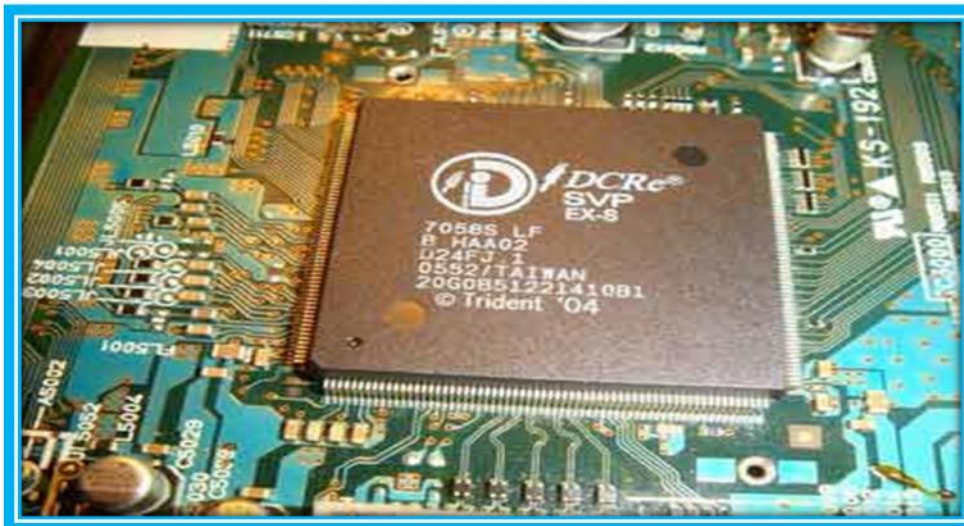
Sony Bravia Resolving scalar

Absolutely identical symptoms manifestations malfunction. The problem was resolved Resoldering scalar (the largest m / BE diagram on the board under the radiator). The truth indefinitely TV to turn on and was seen picture, conjures up thoughts about the problems with the Scalar I.c.

Use pin hole hot air gun with pasting glue, In Urdu I.C ko terka lagaow

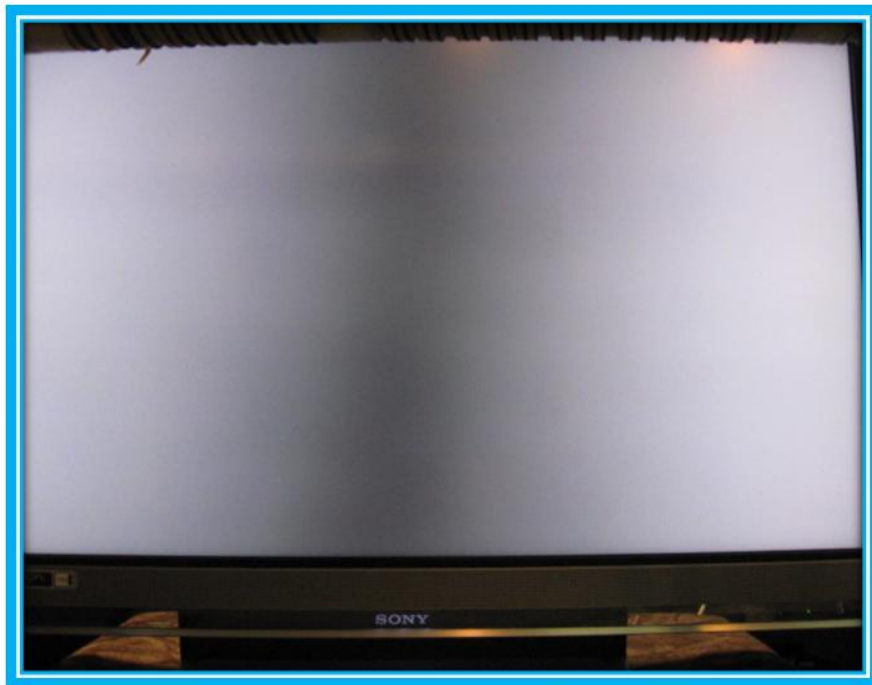
Defect: lights in the center of the raster for defects in **KDL46X3500**.TV have a new type of LCD (from SAMSUNG) with four blocks bulbs 16pcs. In each block, two inverter master slave, 4 powerful high transformer, two in each inverter. BLK and WHT confused with the plant in the second **KDL52H Driver IC IC6701** on both outputs gave common mode.

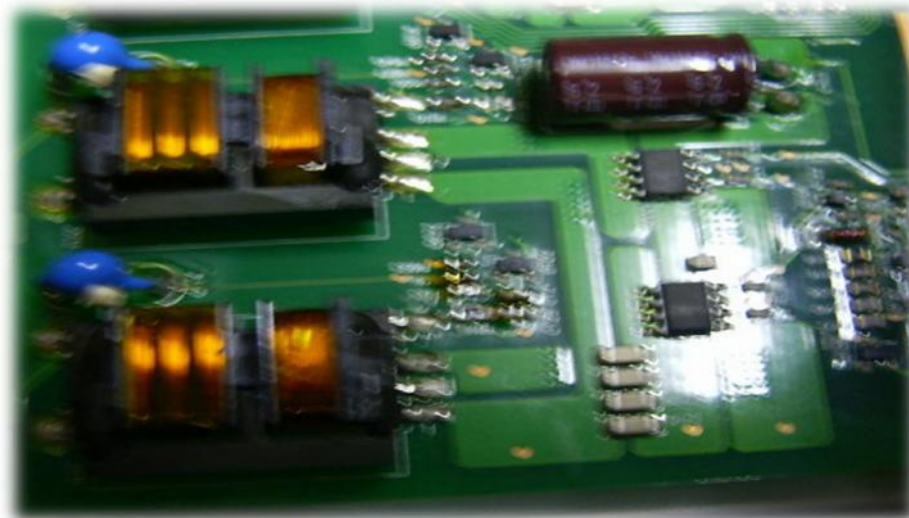
Fault: Dark uneven overexposed image inverter operates on the verge of shut-down. Open SMD resistor 1k in one of the channels in the feedback R111.

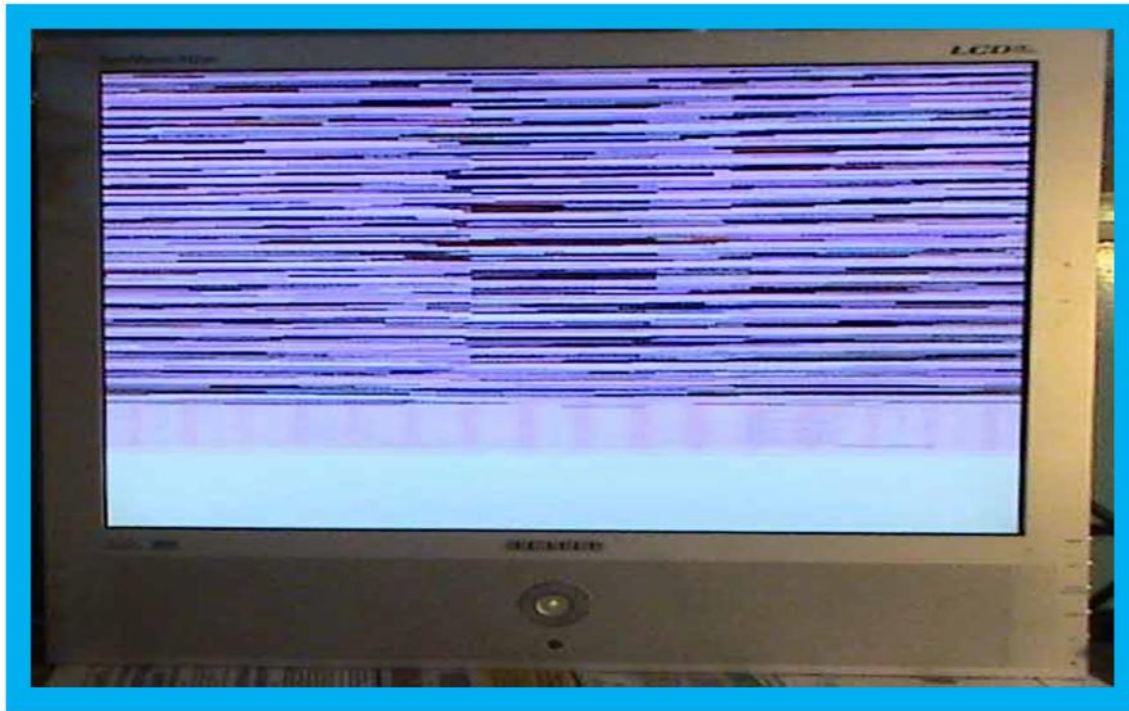
Fault: Planted voltage 2.5 volts, Jumper the S486. LF 25 = 2.5V. In principle, a simple Defect, and calculated quickly, works again fine.

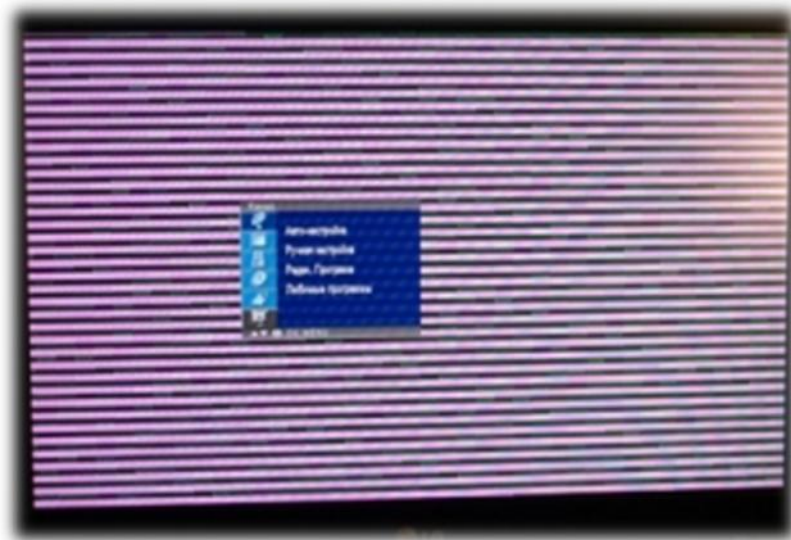
Fault: The screen is horizontally moved on top of the bottom band image is not visible but the graphics is visible clearly, if a signal DVI input on the picture shows. Other AV inputs also strip.

Solution: Replace DRAM M12L64322A-6T solved the problem

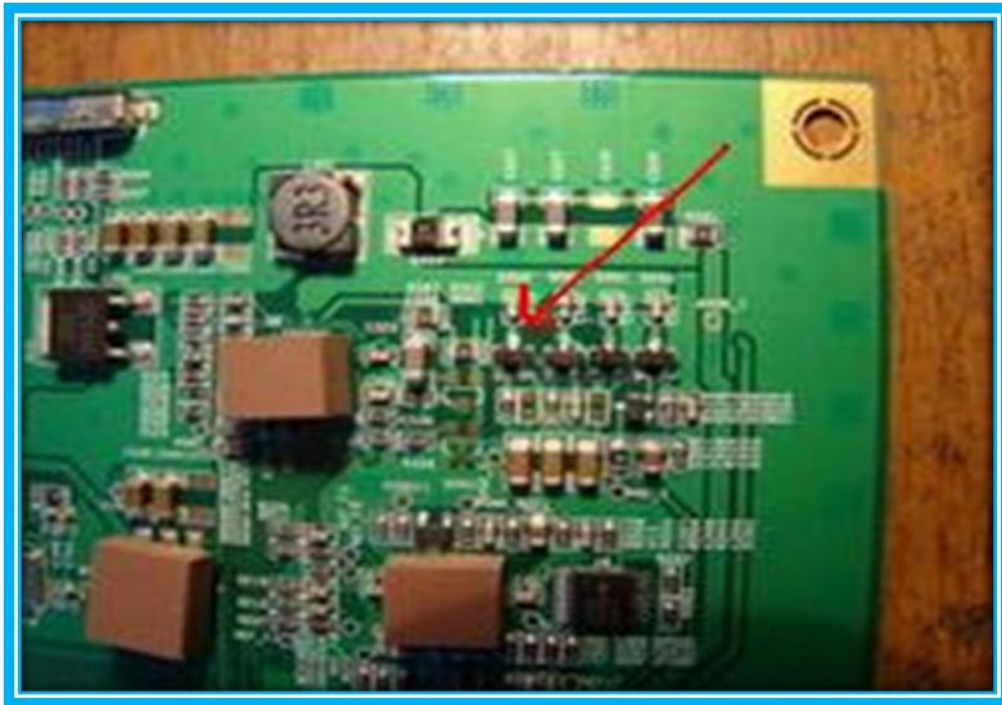
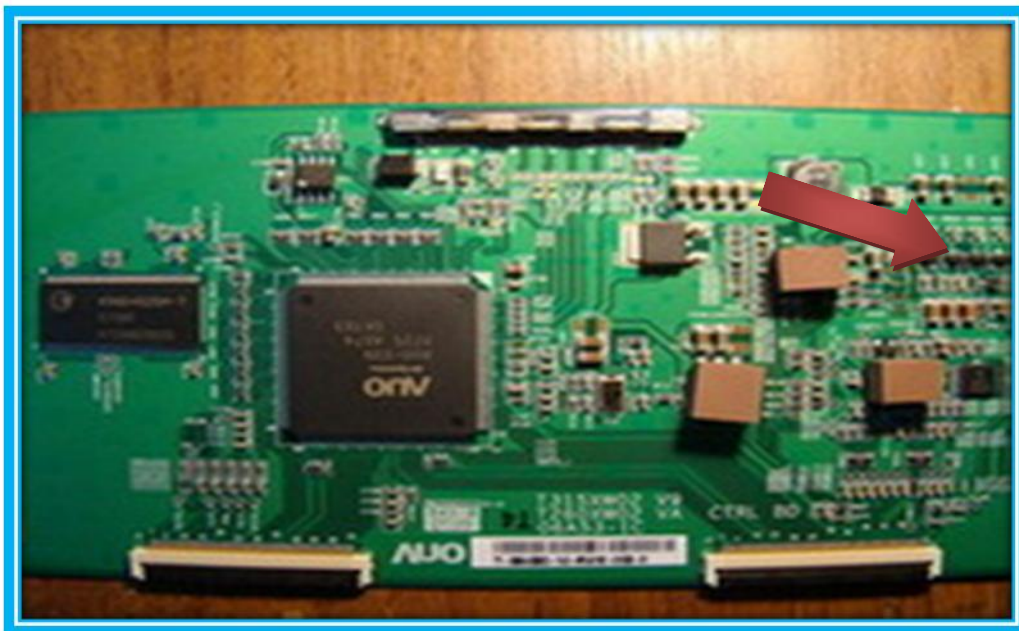
Fault: Slowly illuminates the image, turning into two part .Pre diagnostics detect missing voltage VGH1 (25V) DC / DC converter T-CON.

Solution: Replacement diode assembly D502 in DC / DC converter T-CON

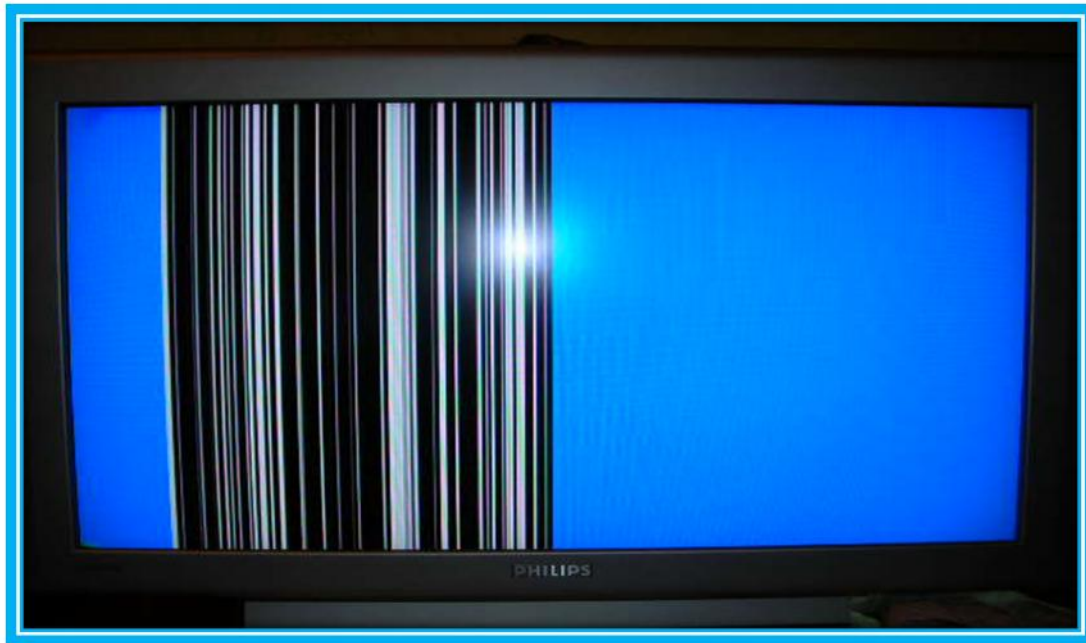
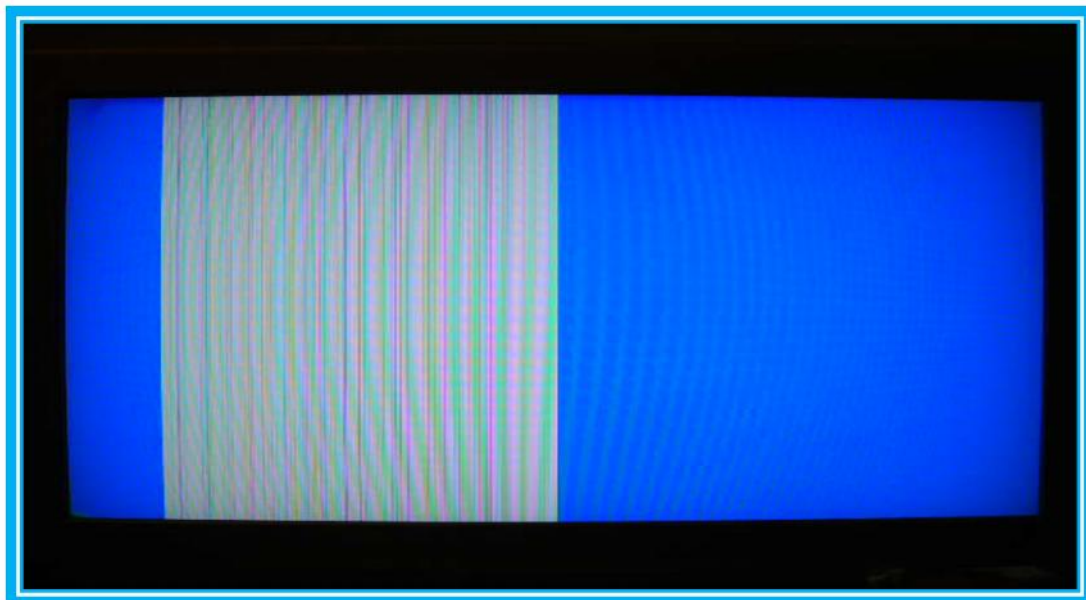
Problem: one of the addresses with a defective hand there is no signal on the control point SSP1 (Source Scanning Right Start Signal)

Cure: On the operating side, from the point of SSP1, wire catches on with the same name to be defective.
