LCD LED T.V Panels Modification and Major Repairs

LCD LED Panel Failure and Cure

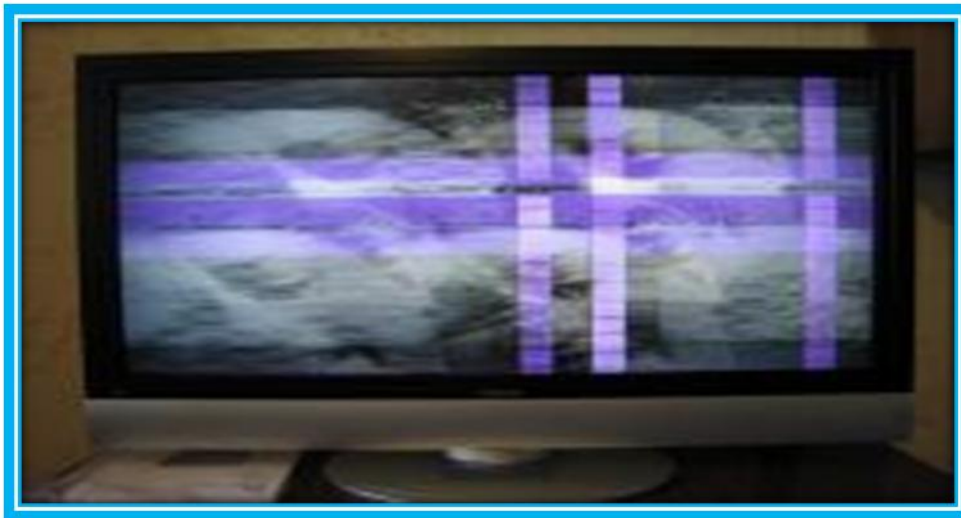
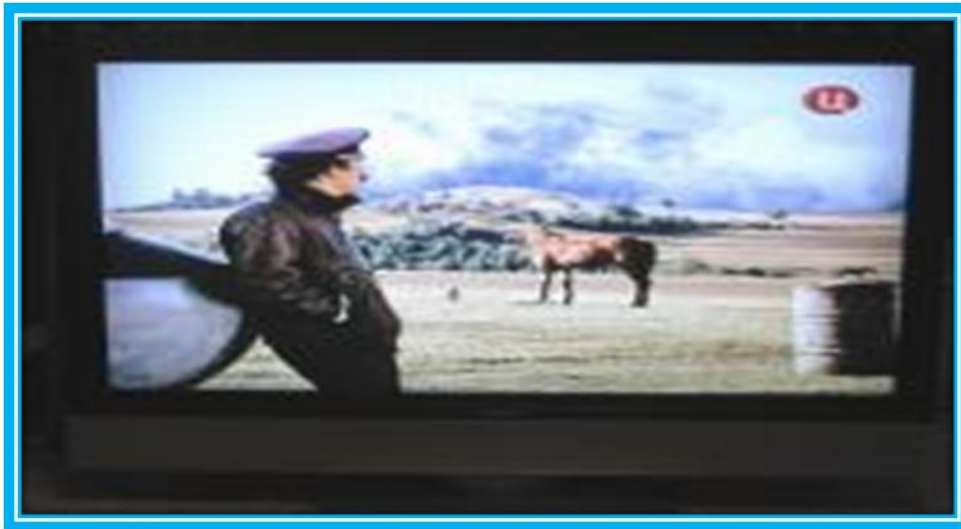
HITACHI 37LD9000TA NA TV scalars on Genesis FLI8532-LF

Problem: Stripes, ghost pictures. Customer says with warming up about an hour to restore the picture. Been with me this was not In this paper, 6 months, the defect became apparent at 4 months. Capacitors tested voltage signed on board (5v, 12v, 24v, 3.3v, 1.8v) are also normal, normal pulsation. Flex on the matrix tested. **Composition-Genesis FLI8532-LF Scalar MSP4458 Multi standard Sound Processor Compatible CXA2069Q S2-7-Input 3-Output Audio / Video Switch HDMI SIL9011CLU bit (50 degrees basked scalar).** When focus forum chain VS warmed scalar using alcohol-rosin flux. Warming because: 1min and 2min 280grad 360grad soldering station without nozzle top. From a distance of 25-30mm After warming image back to normal Operation.

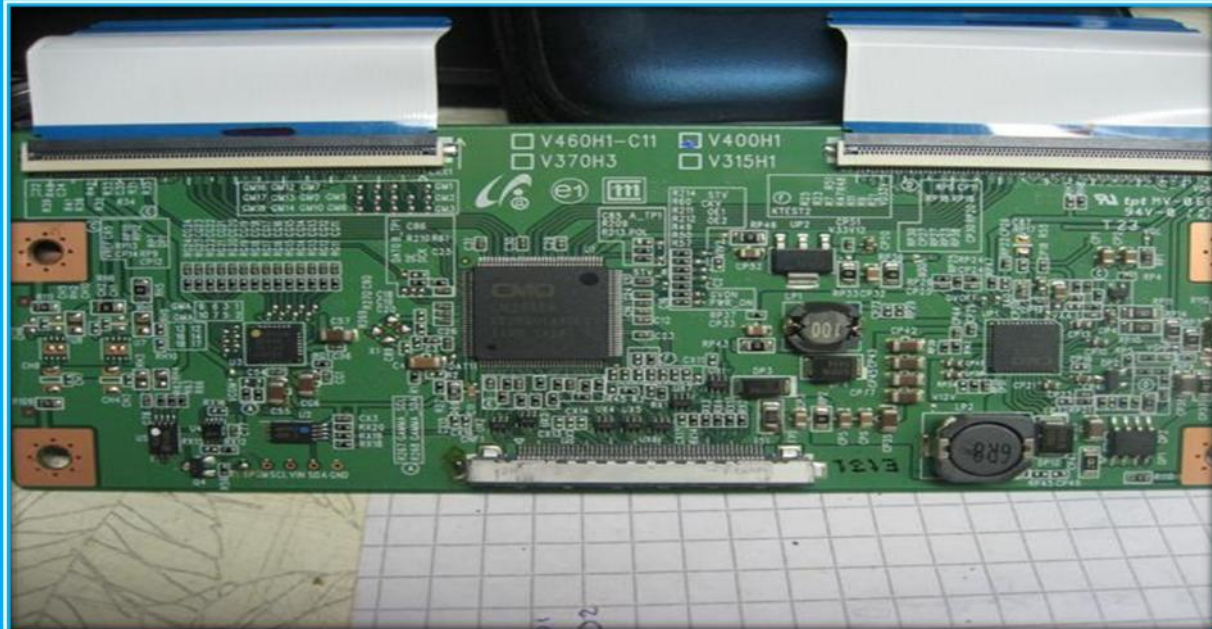
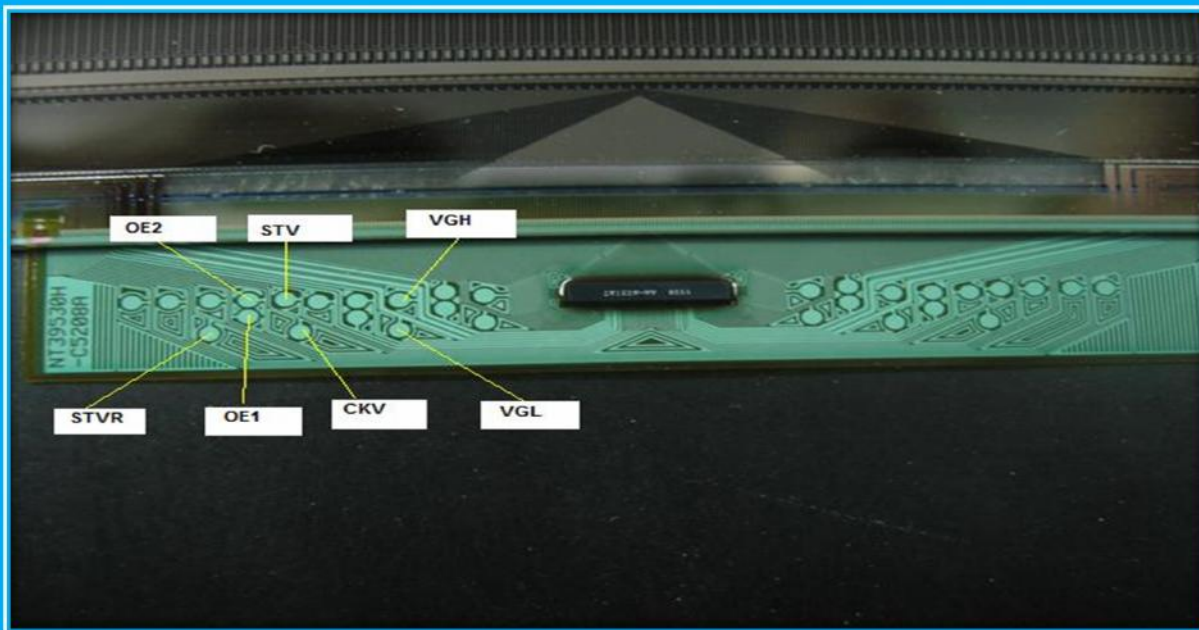
PANEL V400H1-L12 REV1 TCON V400H1 PETAL NT39530H-C5208A Driver 1138 AA-A521AT

Common Problem of this types of panel you should Test and jump these connection as we shows.

This is a Pin data of above Panel main connection shows in picture, Connection sold with thin wires to Pads to T-con board STVR – 142 pin; OE1 – 141pin; CKV – 150pin; VGL – 5pin; OE2 – 142pin; STV – 150pin; and VGH – 8pin.

See this circuit board of T-Con board for these connection.

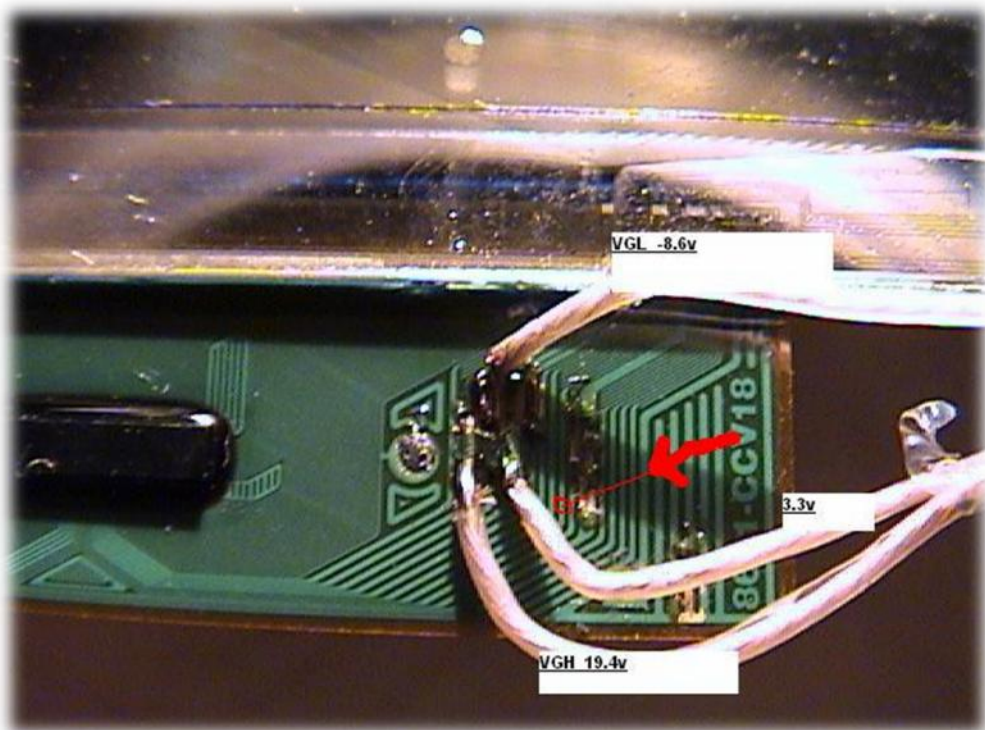
Panel M260TWR1

Open fields STV signal change on the side of the driver, if the finger could move on the side, the picture may appear on leads, use jumper wire for connection VGL, VGH, 3.3v

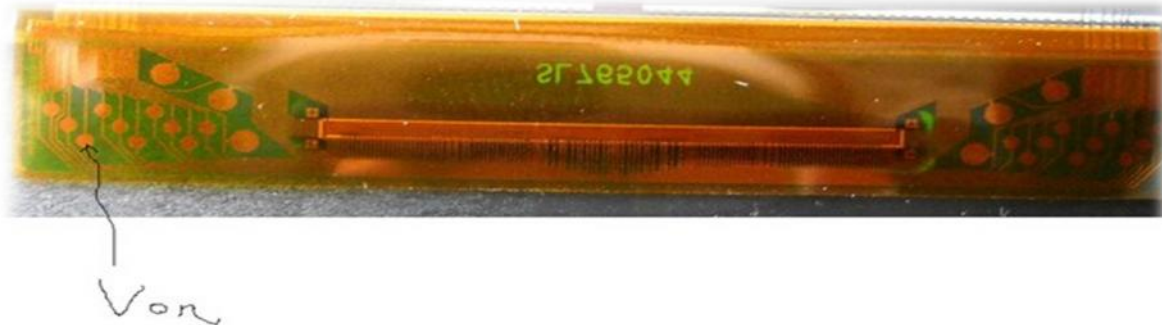
PANEL: LTA320WT-L05

T-CON: 320WTC2LV3.7 17MV22-2 CHASSIS. Slow Motion, Picture, Blur Image.

Use Jumper Wire for Von connection

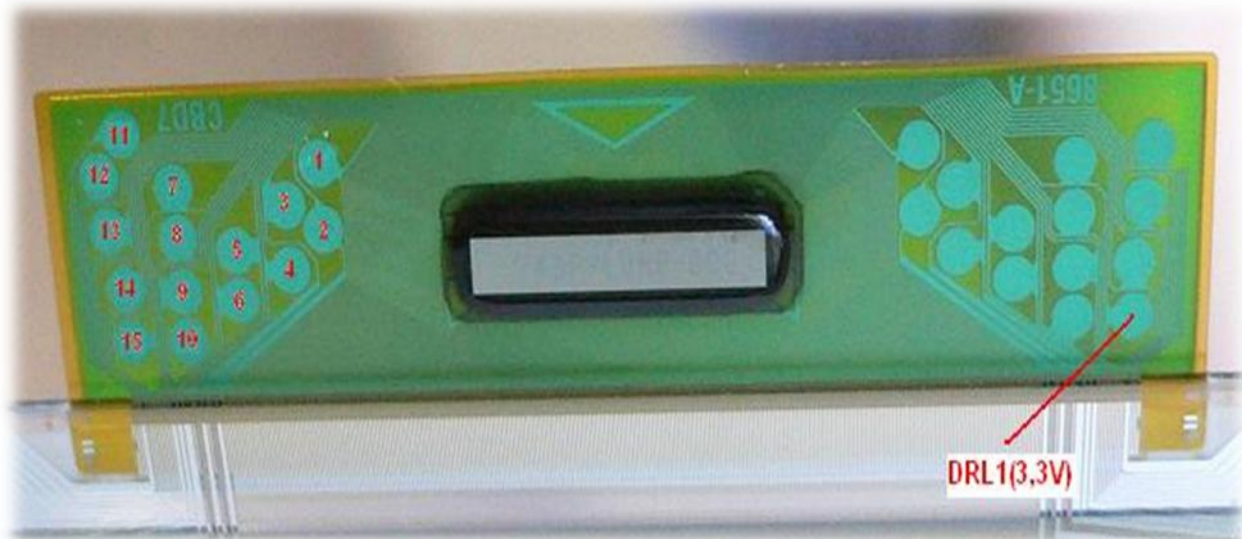
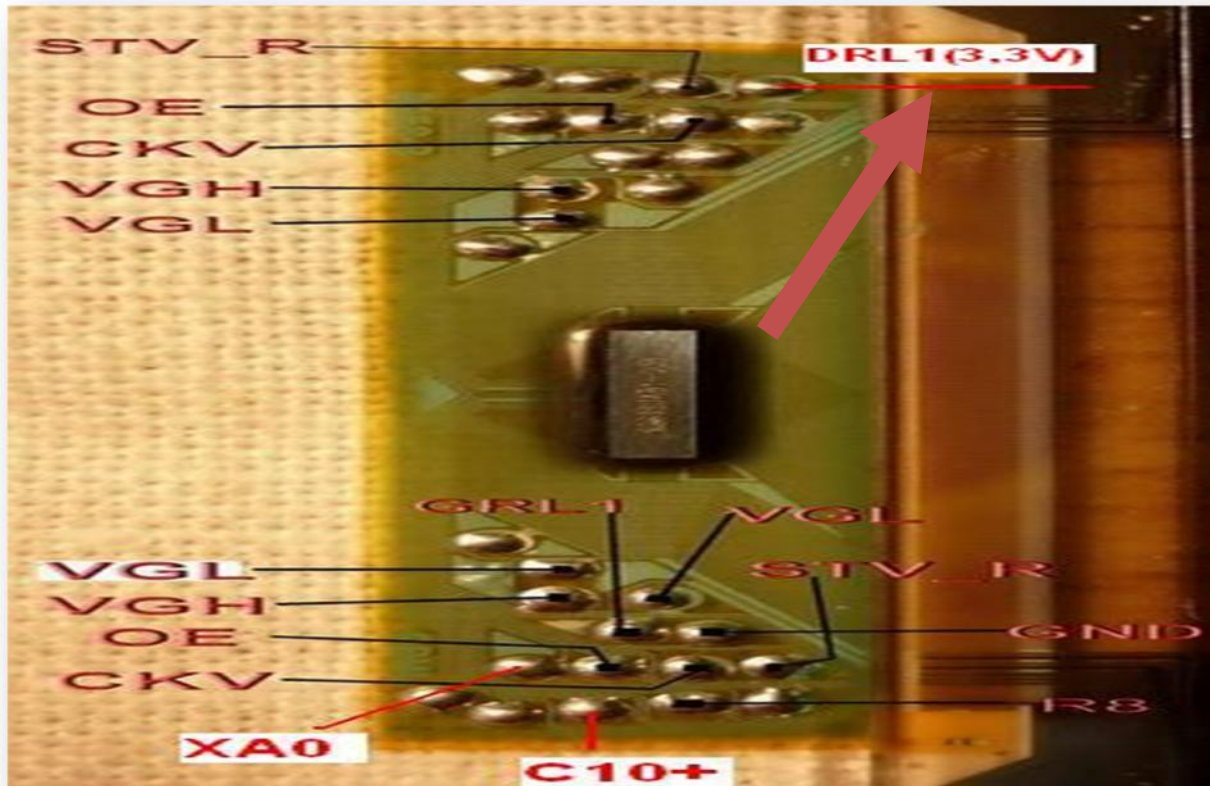
Panel V260B1 Major Problem of this panel you should use jumper wire.

Should Have DRL1, 3.3V and side pad should have GRL2 3.3V. D-drain, G-gate, respectively, DRL is the power of column drivers and GRL lowercase .

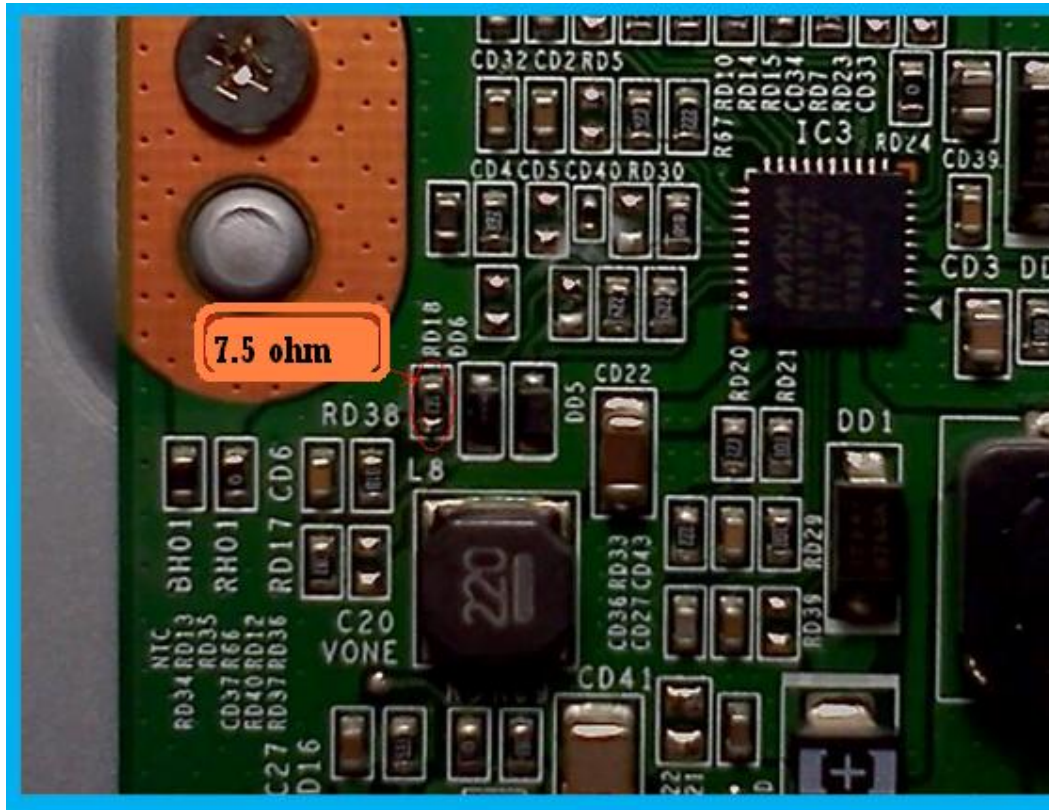
Came to malfunction doubles the image vertically and "banding" in the upper part of the image.

Fault panel. Solution - Reduce stress VOFFE from -12V to -19V. In the T-con installed DC-DC **MAX1722**, change resistor RD18 leg FB3 12kOm with nominal 7.5 ohms. VOFFE voltage drops to -19V, double vision disappears, only the top of the image there are hardly identify blackout strips. But the client is satisfying with the result.

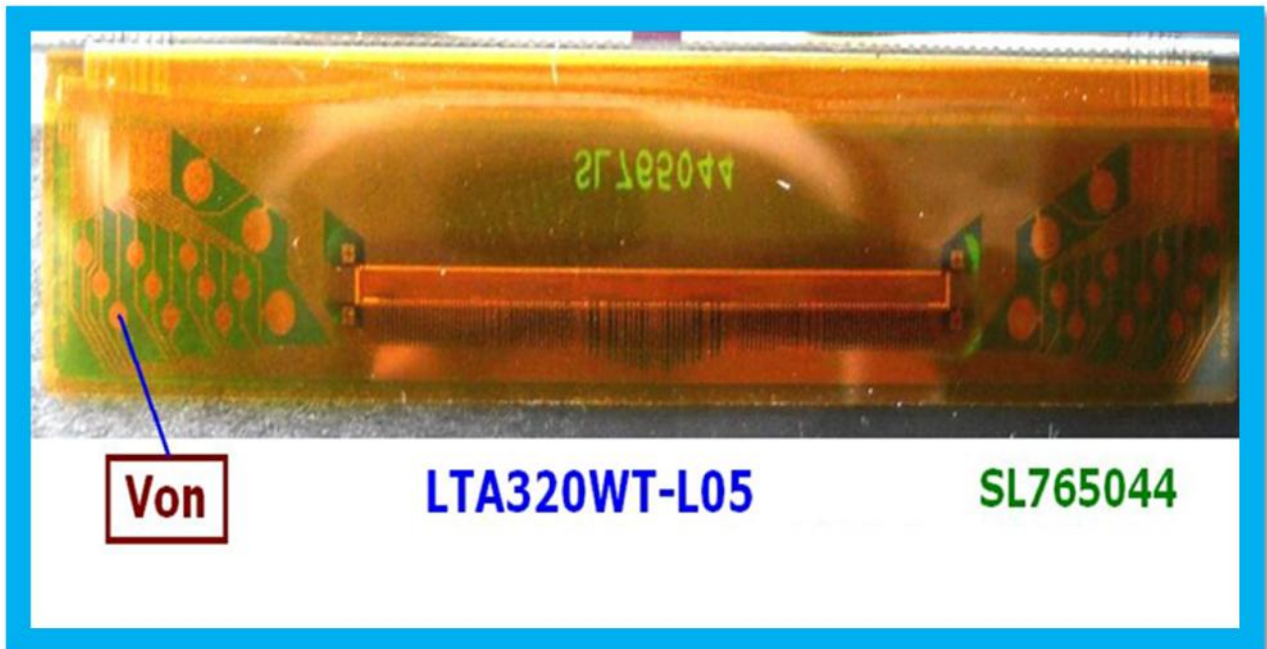
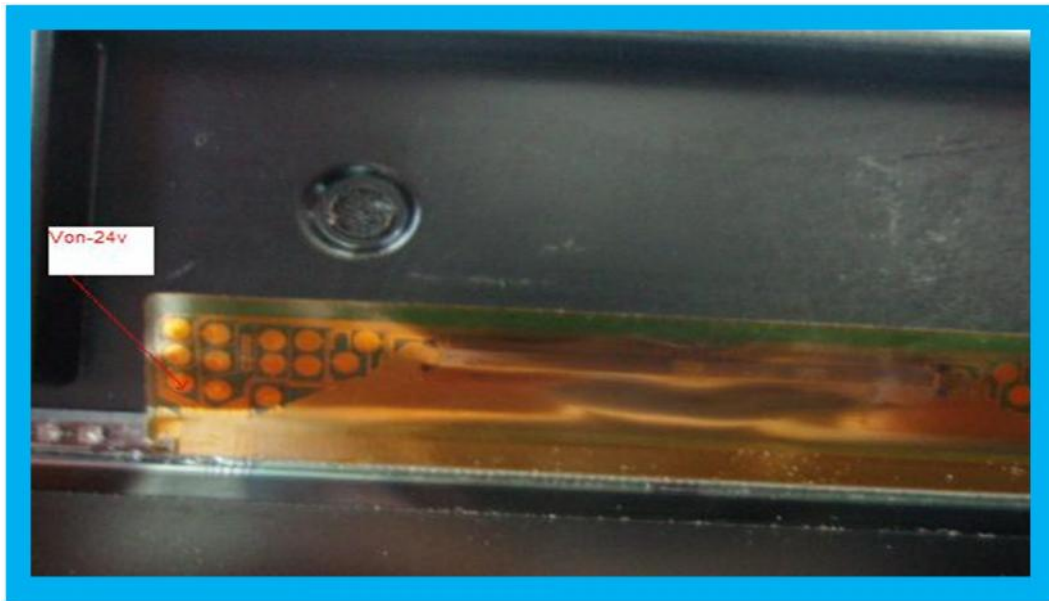
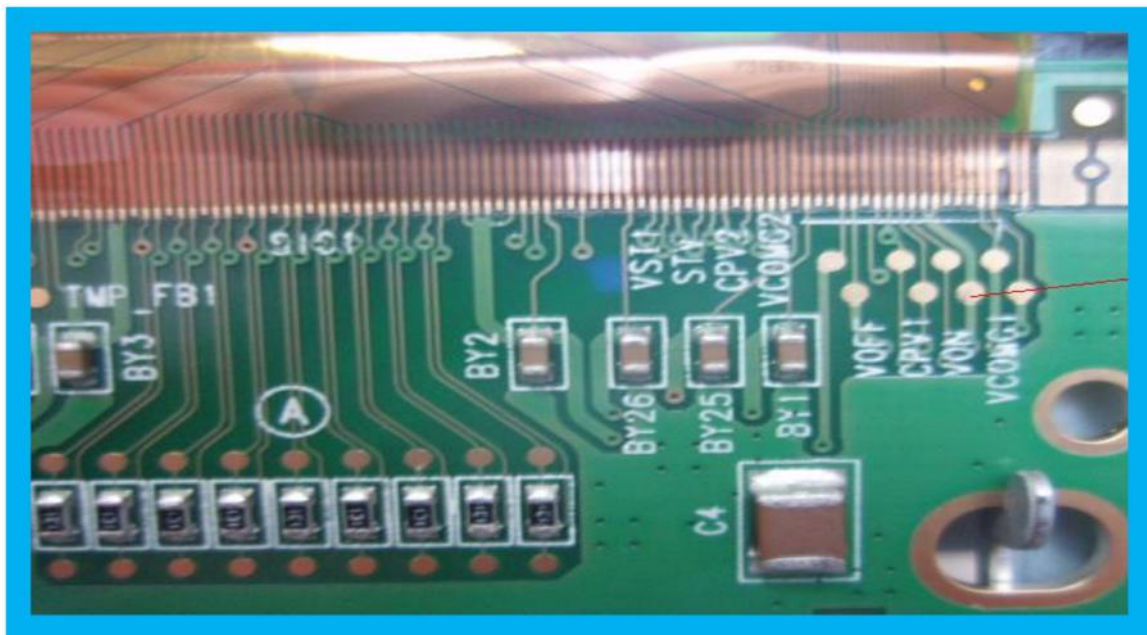
SAMSUNG they USE PANEL LTA320WT-L05. Lack of supply Von-24v on the side loop Pad, Von panel use jumper and planted gum on trail disappears. Photos are attached.

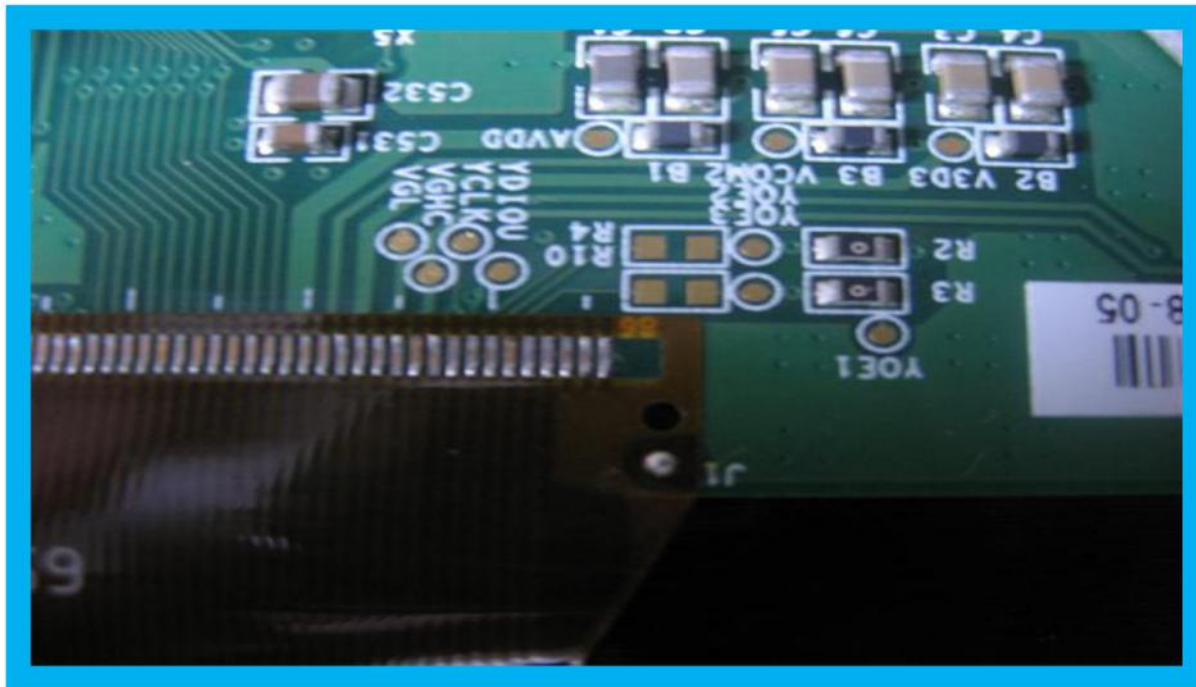
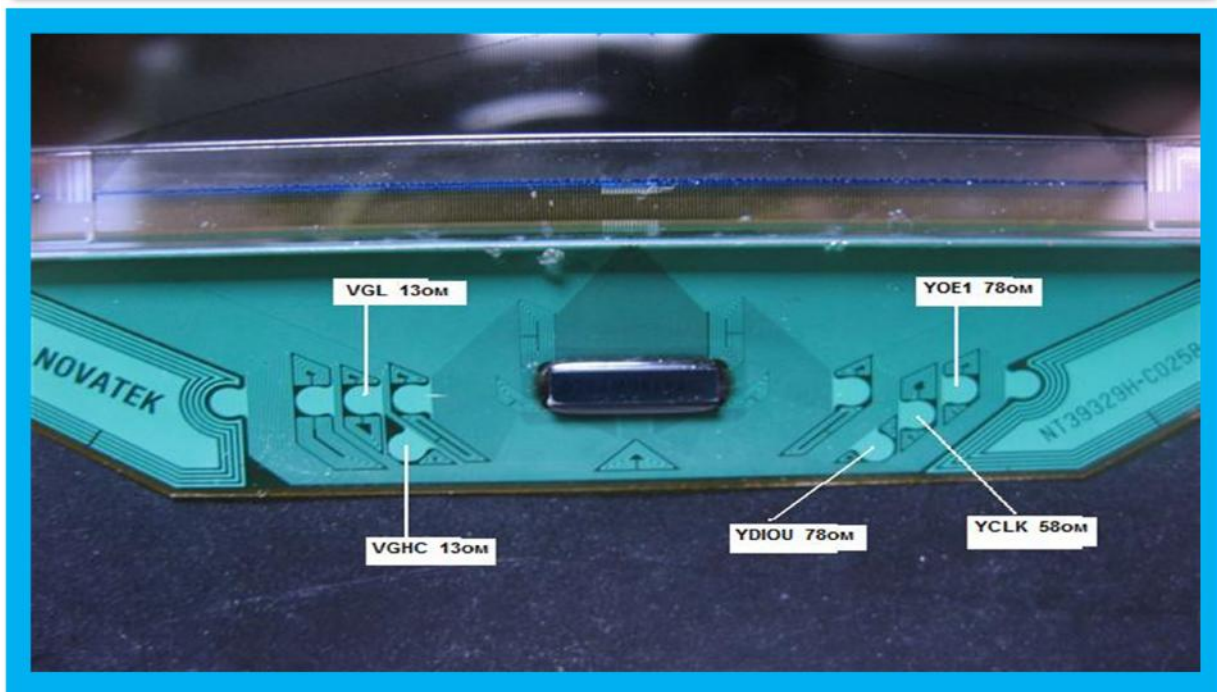
PANEL T370XW02 V.5 TCON T370XW02 V.5 CB

PROBLEM: SOME TIMES PICTURE COMES VERY GOOD AND SOME TIME WENT WHITE.

RESISTANCE FOUND ON THESE CONNECTION,VGL VGHK YCLK YOE1 YDIO ...USE JUMPER WIRES FROM MAIN PCB TO PAD FIX THE PROBLEM.

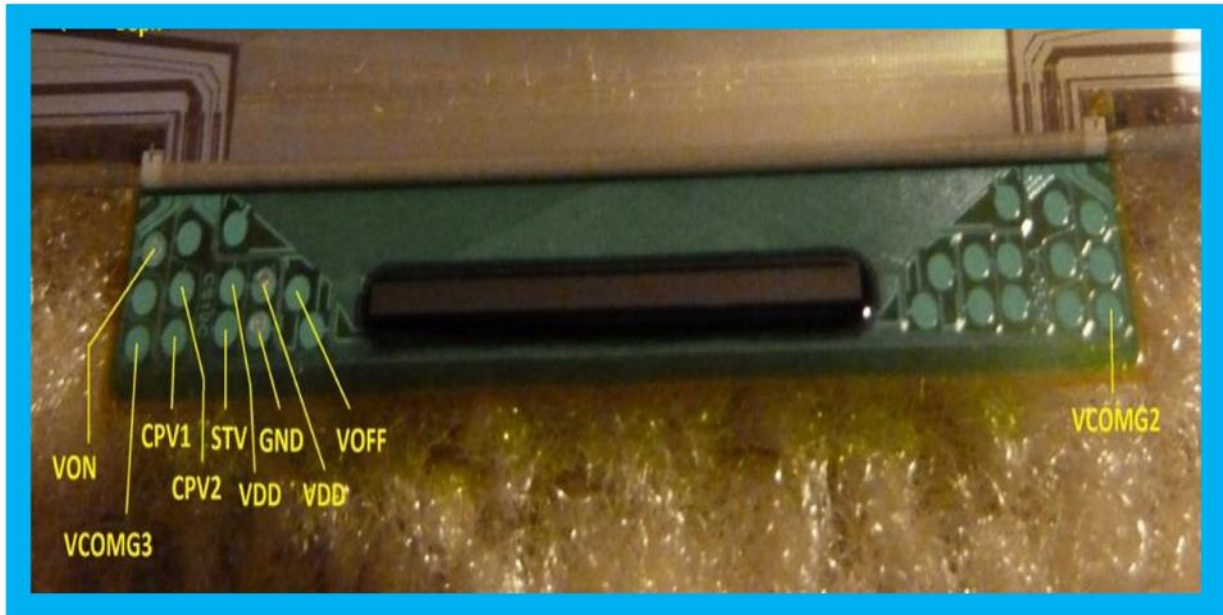
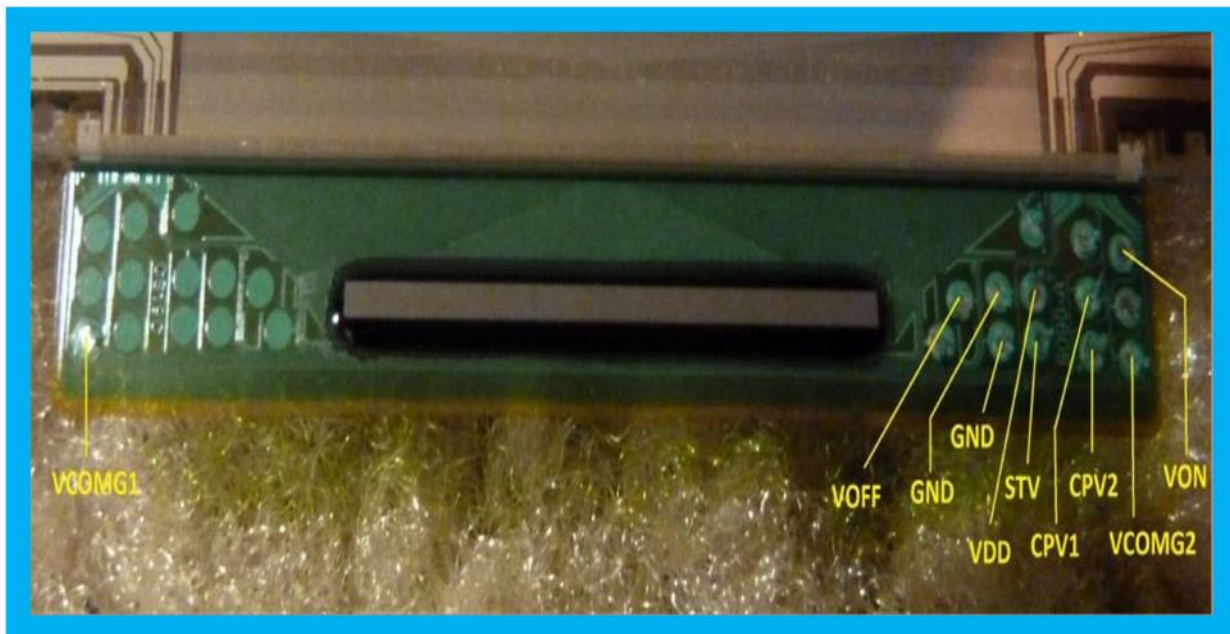
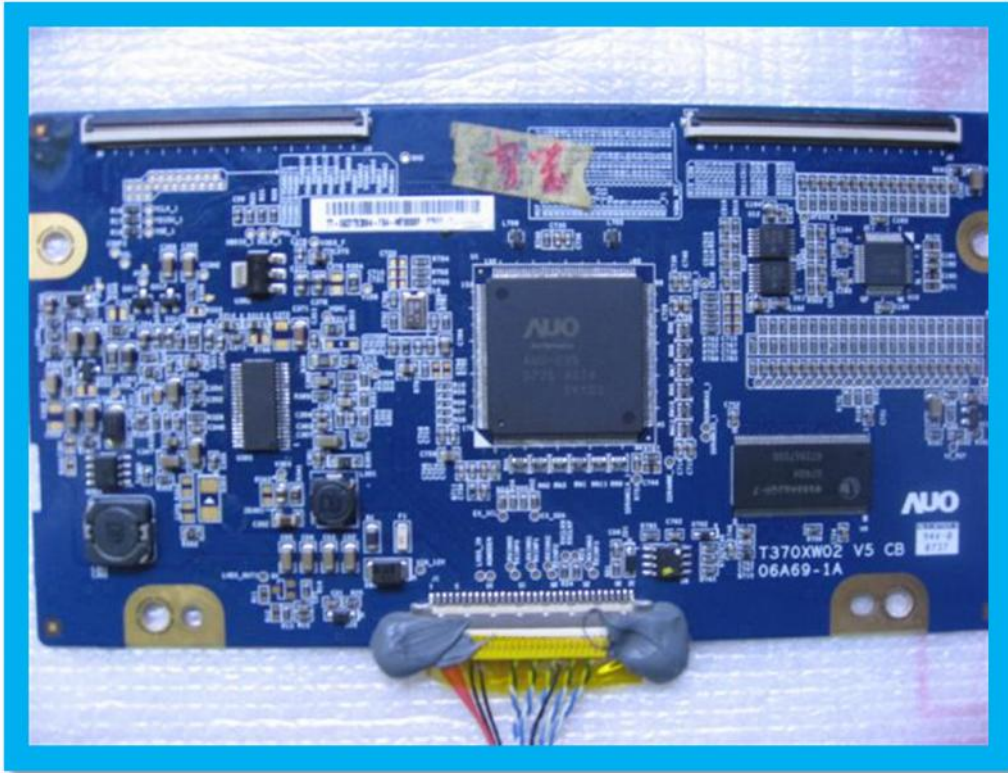
PANEL LTY460HB08 460HBSR2LV1.1 -RIGHT, 460HBSL2LV1.1 -LEFT

Pads on one side **CS19C** , with other **5090-A** .

Problem occurs immediately after the blackout and retardation with tails on the right side. After 10 minutes of normal picture. Identified chaotic changes resistance from 150 ohms to nothing **STV, CPV1, CPV2, VCOMG2 VCOMG3** and between the right and the upper plate side driver. Stir loop right fielder vertical driver helps restore . Reconnects helped restore the picture.

See all of these connection and use thin wire and connect at PCB points.

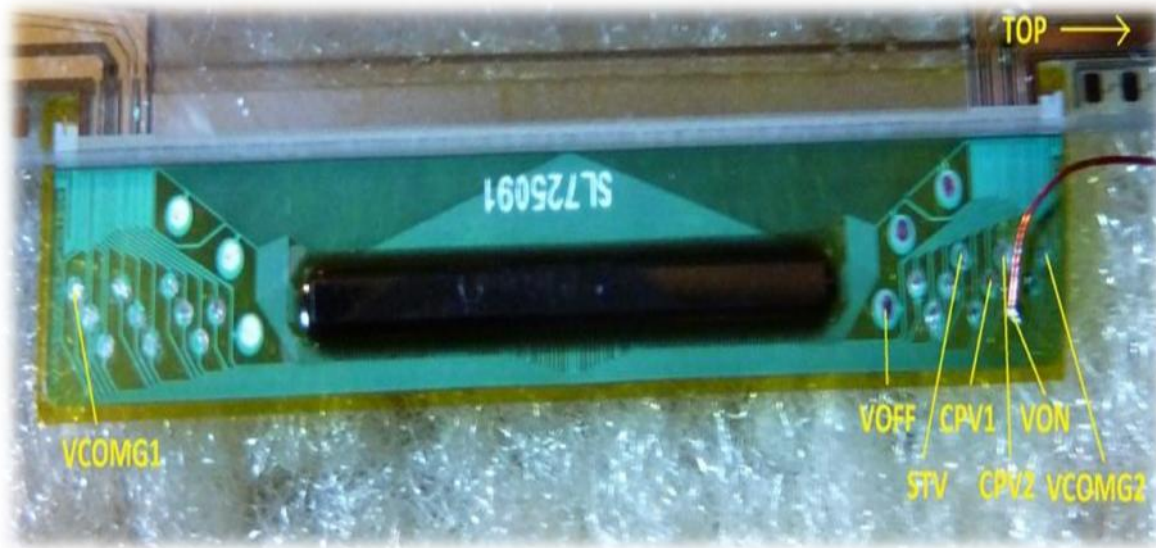
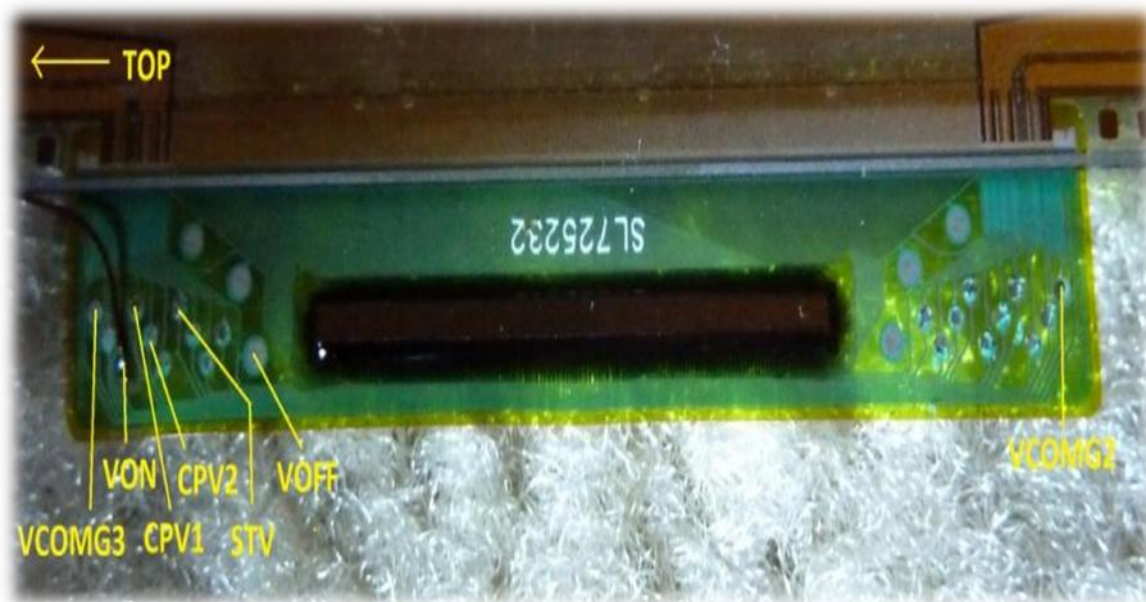
Panel LTY460HT-LH1

SL725091 left Pad **SL725232** right Pad Trims: **460HTSL2LV0.3** - left and **460HTSR2LV0.3** - right. Petal **SL765085** - left, **SL755496** -right

Television were defective floating with tails pictures. Dropouts **VON** strips from the upper side driver on both sides. Reconnects normalized image. Here is pictures **SL725091** and **SL725232** ,**SL765085** and **SL755496** - identical. Just noticed that different

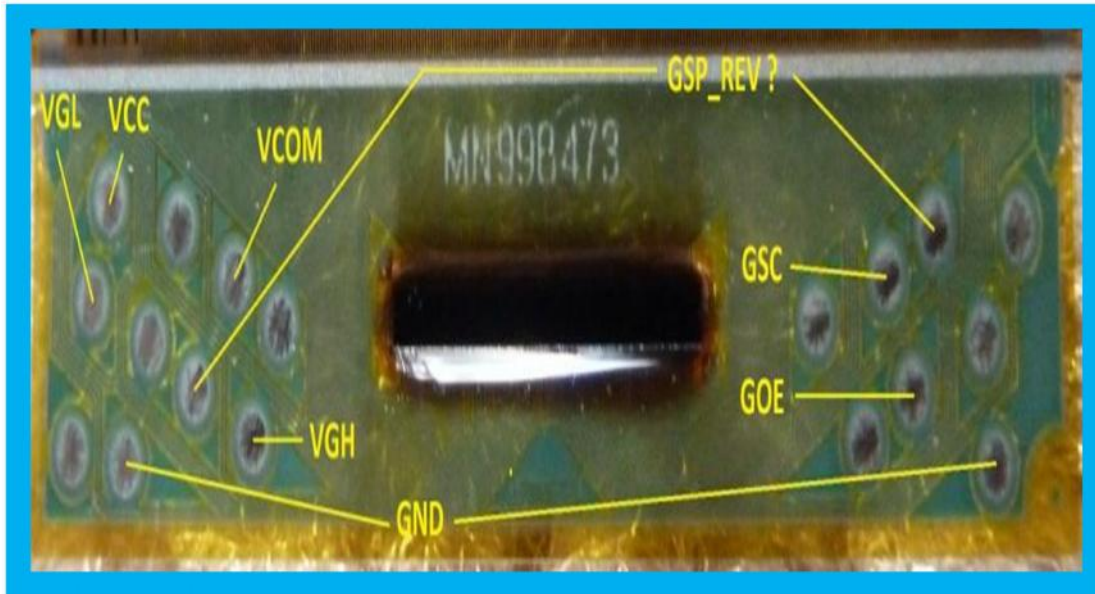
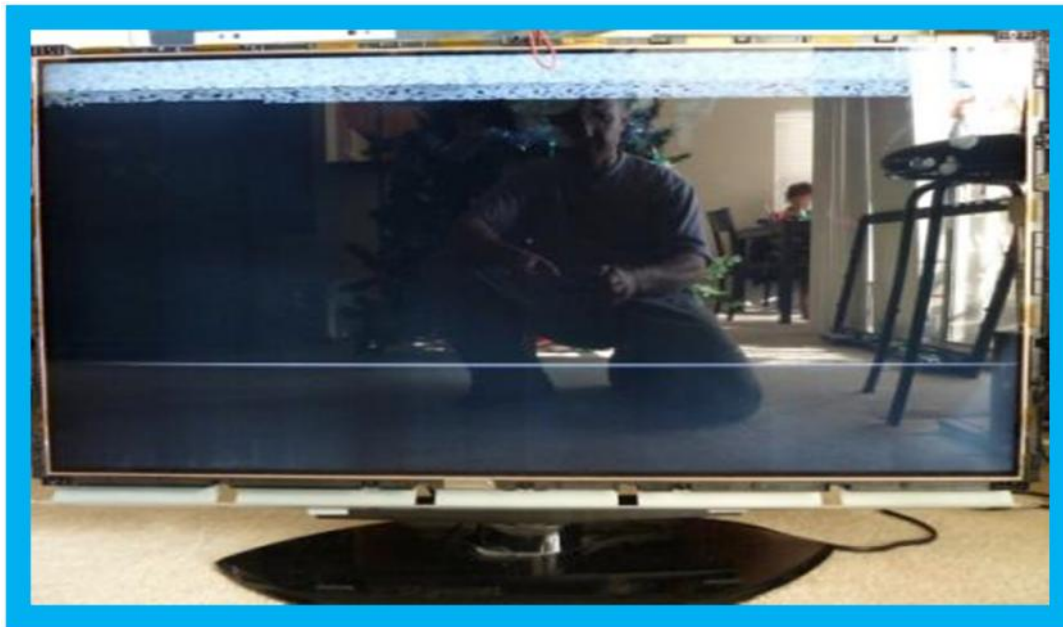
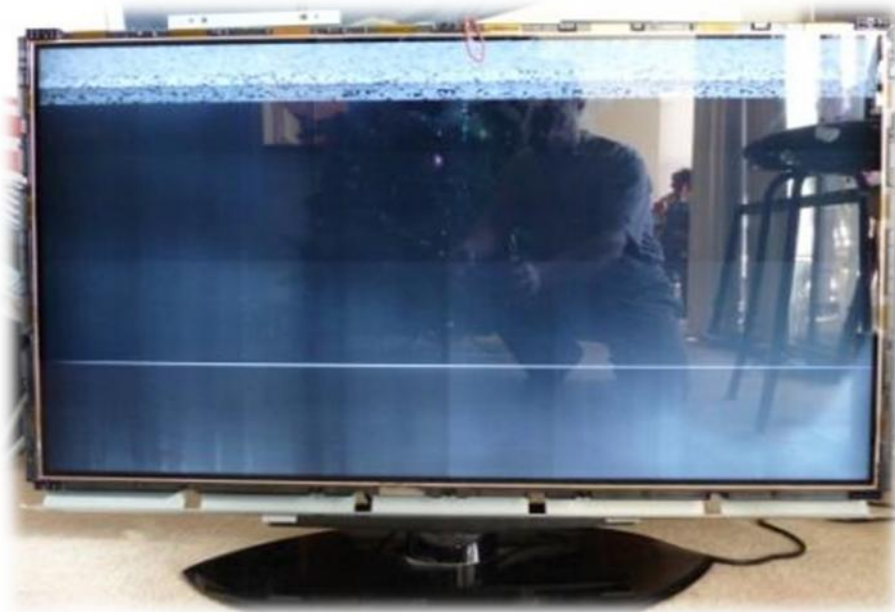
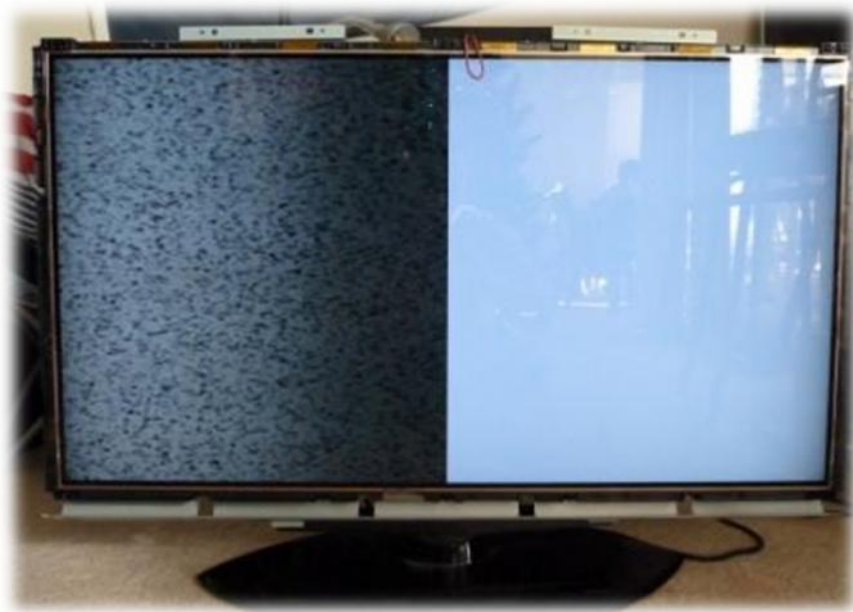
[TOSHIBA, SHARP, PANEL LC420WUD \(SB\) \(M2\) .LC420WUN SBA1-731-LEFT, P / N 6870S-0642D - LEFT STRAP.LC420WUN SBA1-731-RIGHT, P / N 6870S-0643D](#)

LC420WUD-SBM2 T-con. Television with 10cm band image at the top of the screen. Also there's the band a few pixels on the right side between the 3rd and 4th from the top side pads . Gradually fills white with clearly visible transitions between drivers. It was found on the sagging VGH_M T-con 10.7v to 24.7v with VGH. Strongly heated third top right side strap when tilting right from T-con VGH_M = 23.5v, VGH = 27.1v and the picture appears on the left, but with greenish artifacts and without contrast. All connections between the slats and ears in order conditionally, because some go up to 200 ohms but not jump but presumably GSP_REV - 3.2kOm or wrongly location. Honestly decision yet, but since have information on the panel decided to immediately post in this section. Burn not see any sense, because it is not clear between what, and make a hole in the tail easily. While I tend to remove the side lobes. Finally got around to the panel. It was revealed VGH in the right half. When disconnecting appeared full picture but with shading and tails on the right side. VGH was clipped on the driver who basked (third right top). Appeared normal in the upper half of the picture and brake in right. Were then removed the right driver. The left side does not pull the whole screen, which

can be seen on a white field on color and dynamic picture all perfect.

[Connect these points with thin wires.](#)

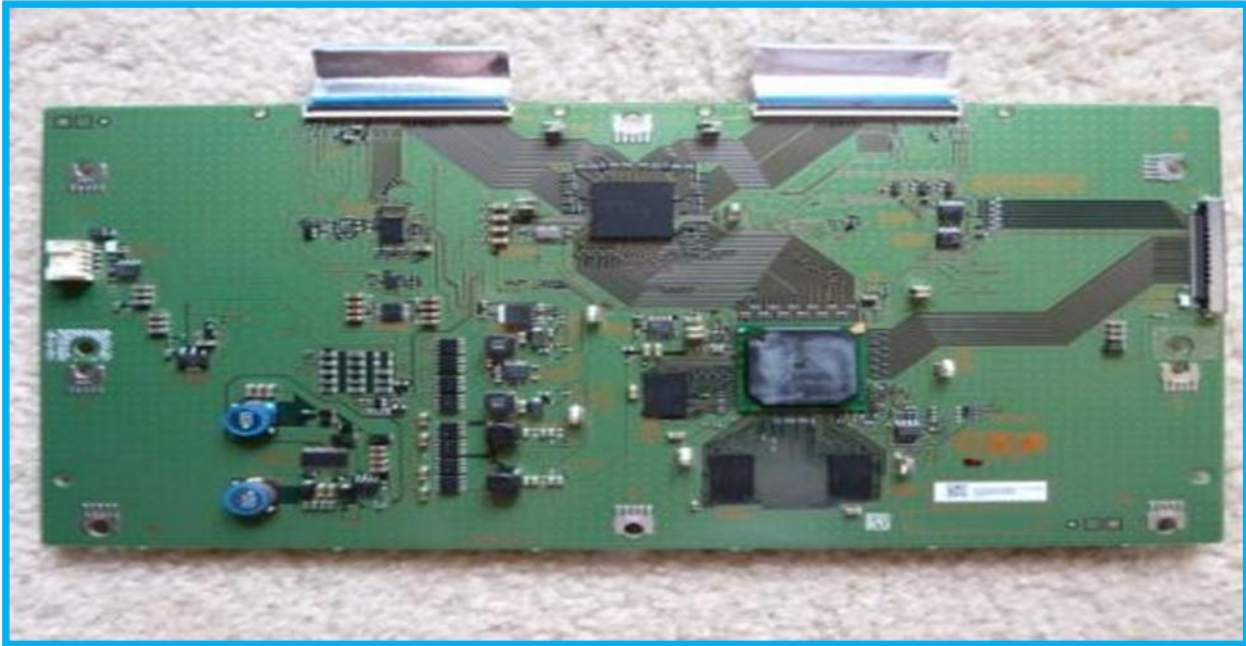
HT215F01-100

HT215F01 100X0.0 -Tcon110CCUKR4-00D - driver FCY0C 8656- petal-

Turns with a white spot, which gradually increased and transformed into a blue screen or a weak, horizontal, solid, thin strips, then partially in vertical, sometimes, Open MLG, there were a few such cases have been on the petal of the penny is no, we have to carefully soldered to the track. When induced VOFF1/VOFF2/VOFF3 lines recommended by T-CON temporarily remove R238 and R237, to avoid confusion.

loop Contacts points: \ 1 and 2 - SV \ 6 -OE1 \ 7 -SPV \ 8 -STV \ 11 -VOFF3 \ 12 -VOFF2 \ 13 -VOFF1 \ 14 -MLG \ 15 -VCOM \

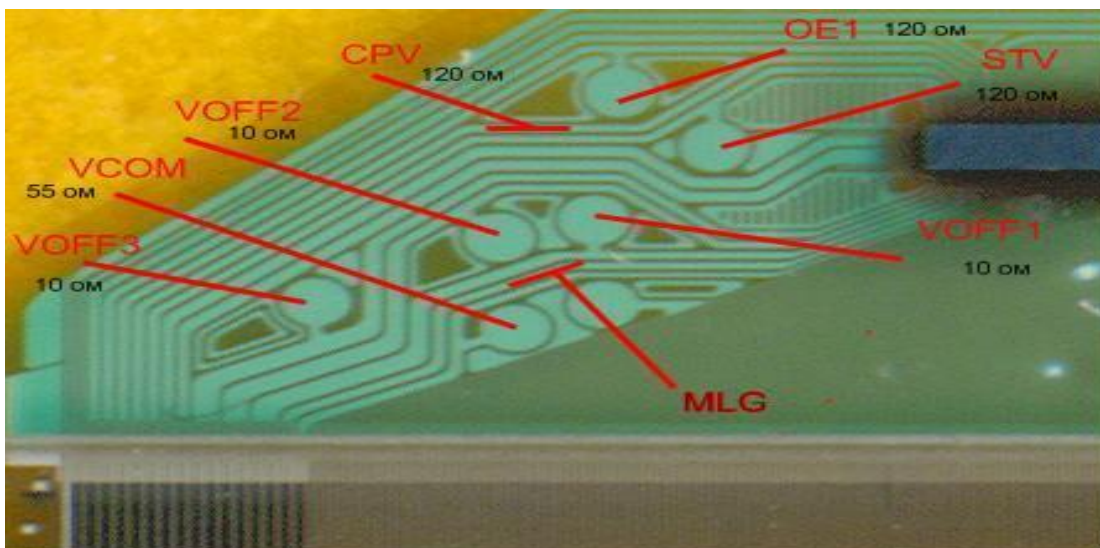
Philips 32PF3320/10 main LC4.5E AA QD32HL02 REV: 01

Panel CLAA216WA01

Take measurements on a dead panel, if anyone has a working well be compared to the driver side. Understated VGH - 13V must - 20.7 V with understatement VGH no picture, screen dark. PWM dead - AAT1177, the chain of VGH AAT1177 Up zero jumper from the circuit energized VGH VDDG - 24V brought together a chain of series-connected 1N4148 + R (3000m) resting on the zener diode 20V.

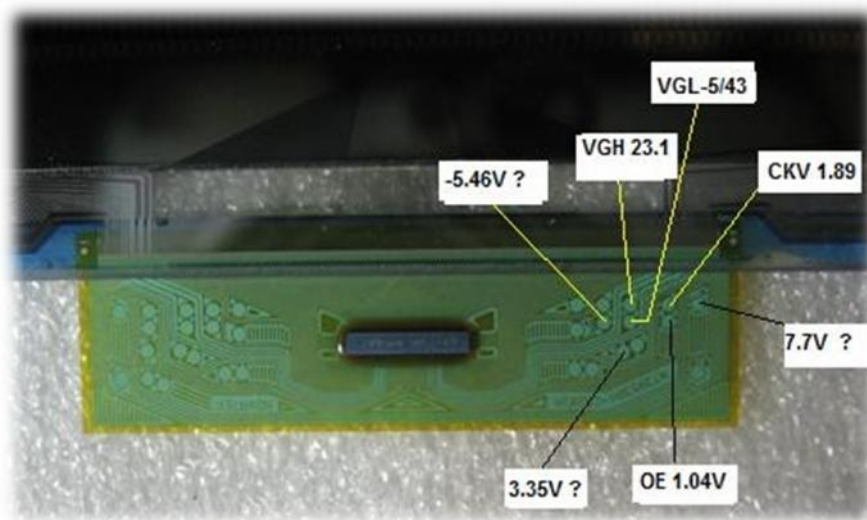
Panel LC320WUE-SAA1 stands in 32PFL5604, Missing the lower half of the image, with the heating pours milk. Underestimated VGH to 1V on the two side address driver, threw jumper panel board. More detailed measurements of stay was not possible, resting visiting relatives, suitcase accidentally left in the trunk before you go to them second such panel this month with similar defects.

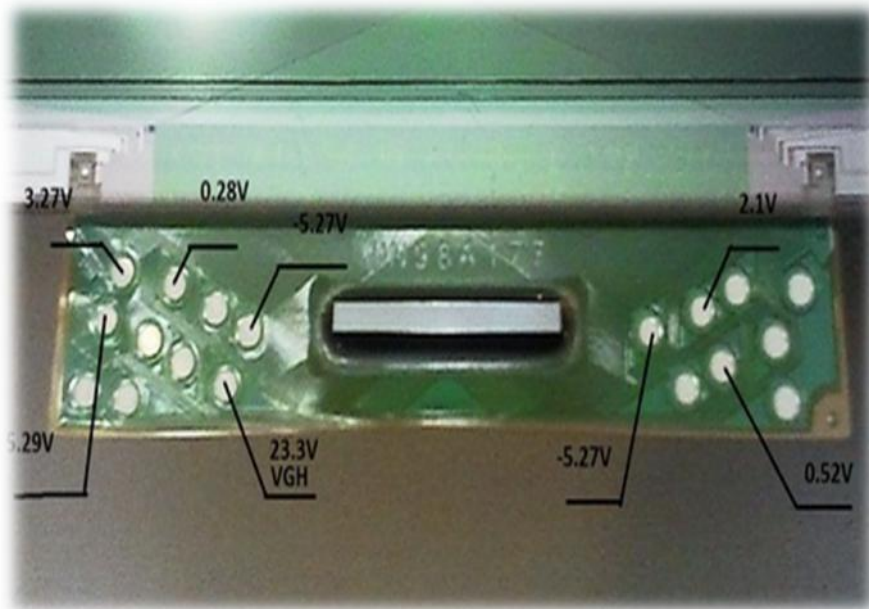
Matrix (panel) - LTA320AB02 T-CON - 320AB02CP2LV0.3

very popular defect "Running Picture"

There are two drivers in positions ICS1 ICS2 and from which signals STVP1, CKVB1, CKV1 and STVP2, CKVB2, CKV2 go to the row driver say so drayverov1 group and group 2 drivers (as it is there precisely arranged known only to developers but let's just say that one group of duplicates another group) and so one group of drivers has a broken case that spoils us a picture, in my case it group1 controlled corresponding signals with index 1 through driver ICS1. Evaluate to what group accidents Register disconnecting power turns with Von ICS1 And ICS2, and landing legs 1 chips to the body where no longer run after shots off Von, then that driver controls the group with broken register. might seem that removing power from Von (+28 v) with the desired driver problem is solved, but it is not so, but to become a great picture but eventually 5 minutes if the picture has static objects such as a channel logo (pictured logo and Rossiya24 NTV), the artifacts appear as intermittent bands cm photos. But it is also solved simply be removed from the board and apply for a driver signals STVP, CKVB, CKV power Voff (-12v) 8 foot driver chip. And in general, is all almost perfect picture! , Only fifteen minutes on NTV was seen faintly artifact, almost discernible unless you know where to look not possible, it is possible to win by increasing negative voltage Voff to -16 --- 17volt. Voff I installed 16., 3v, adjustment Voff I realized zener 9,1 v included as shown in the picture (between the emitter and collector of Q2, to the emitter cathode, anode collector). This method to combat "running shots" can be applied to other matri-
