LCD LED T.V Panels Modification and Major Repairs

LCD LED Panel Failure and Cure

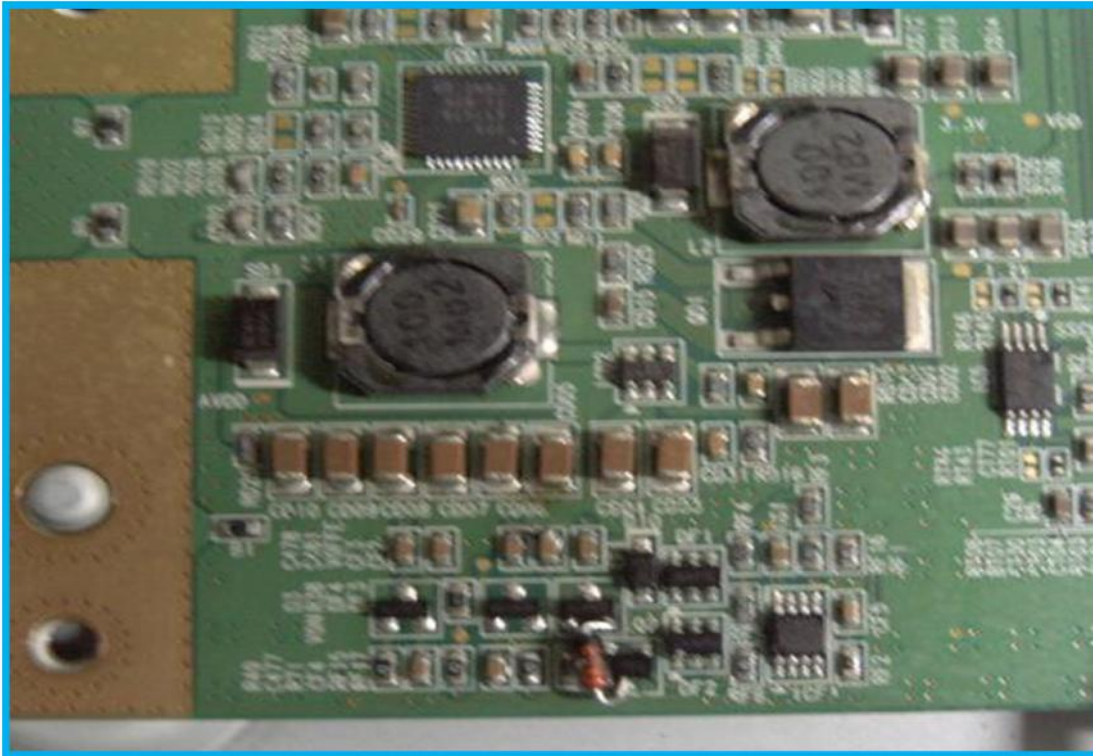
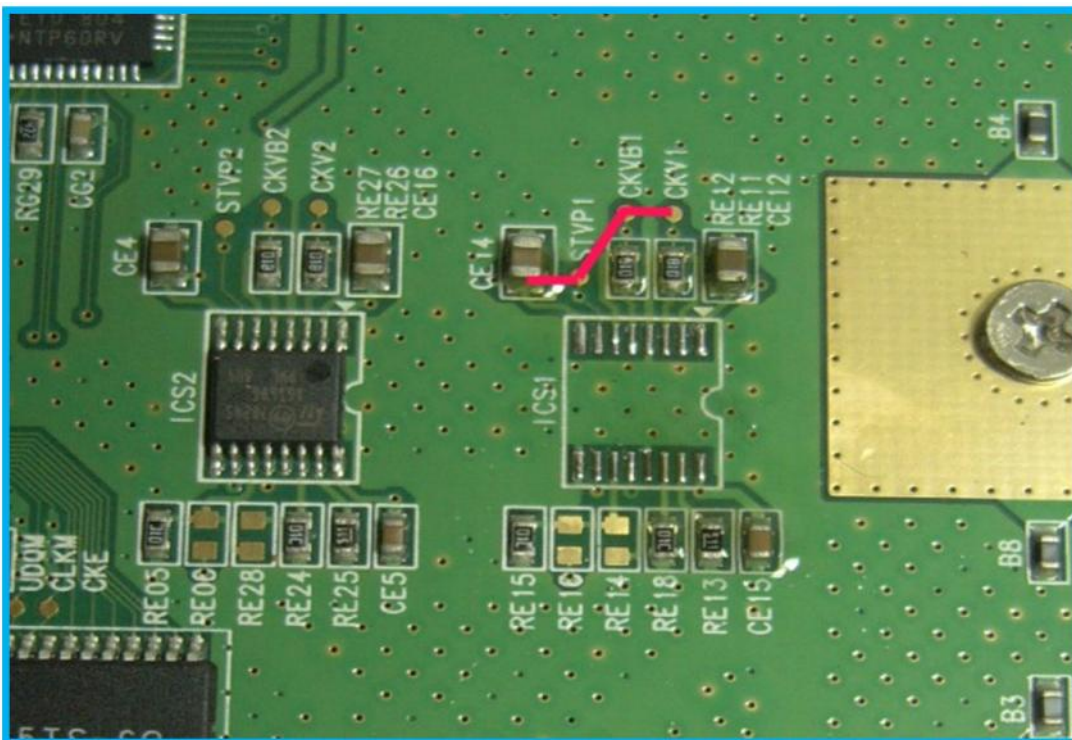
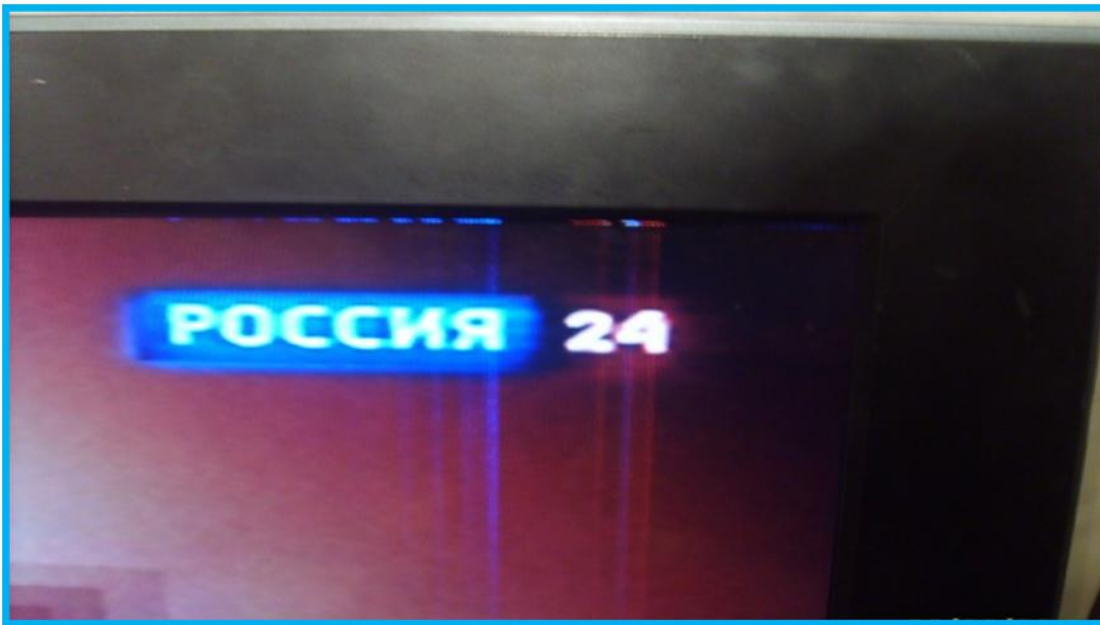
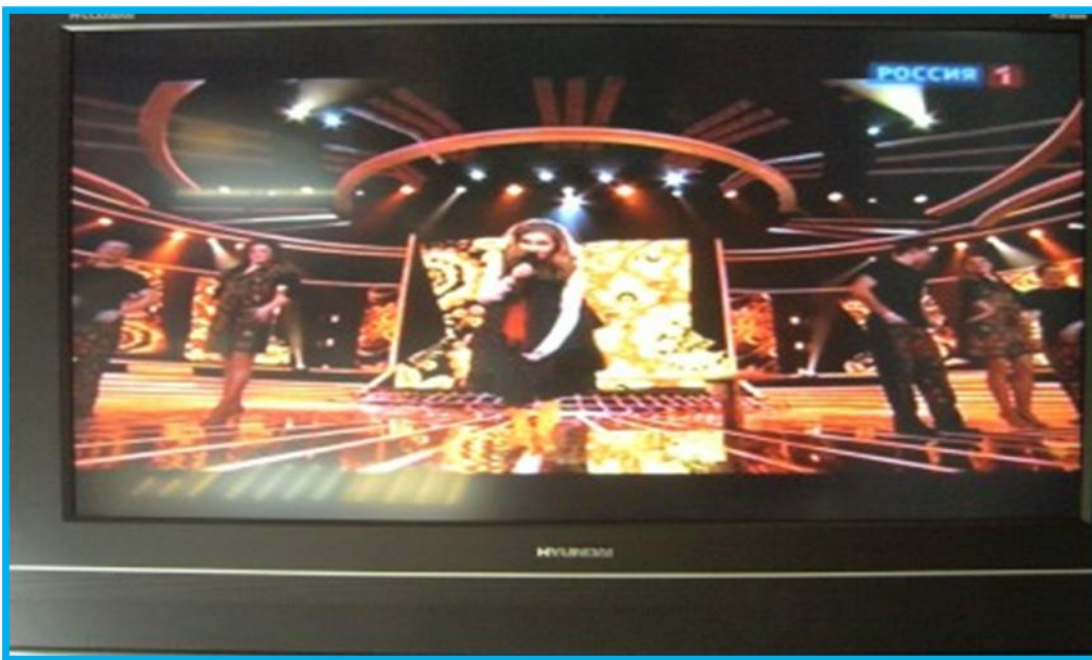
very popular defect "Running Picture"

There are two drivers in positions ICS1 ICS2 and from which signals STVP1, CKVB1, CKV1 and STVP2, CKVB2, CKV2 go to the row driver say so drayverov1 group and group 2 drivers (as it is there precisely arranged known only to developers but let's just say that one group of duplicates another group) and so one group of drivers has a broken case that spoils us a picture, in my case it group1 controlled corresponding signals with index 1 through driver ICS1. Evaluate to what group accidents Register disconnecting power turns with Von ICS1 And ICS2, and landing legs 1 chips to the body where no longer run after shots off Von, then that driver controls the group with broken register. might seem that removing power from Von (+28 v) with the desired driver problem is solved, but it is not so, but to become a great picture but eventually 5 minutes if the picture has static objects such as a channel logo (pictured logo and Rossiya24 NTV), the artifacts appear as intermittent bands cm photos. But it is also solved simply be removed from the board and apply for a driver signals STVP, CKVB, CKV power Voff (-12v) 8 foot driver chip. And in general, is all almost perfect picture! , Only fifteen minutes on NTV was seen faintly artifact, almost discernible unless you know where to look not possible, it is possible to win by increasing negative voltage Voff to -16 --- 17volt. Voff I installed 16., 3v, adjustment Voff I realized zener 9,1 v included as shown in the picture (between the emitter and collector of Q2, to the emitter cathode, anode collector). This method to combat "running shots" can be applied to other matri-

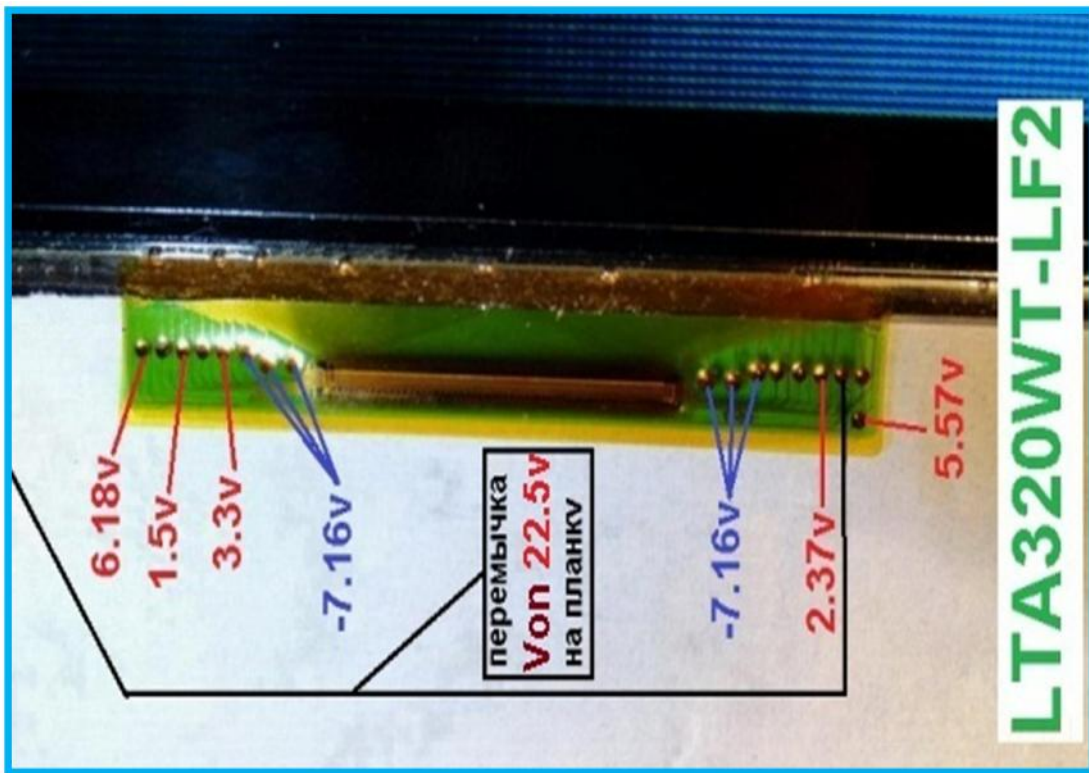
LTA320WT-LF2 DAEWOO DLP-32C1

DAEWOO DLP-32C1 LCD 32 "TV. LTA320WT-LF2, fee T-CON: 320WSC4L V5.8.

When the LED blinks red 4 times. Image on a static picture is normal, only slightly dimmed on dynamic - residual plumes from moving objects. C OSD same thing happens. Supply voltage OK: 5V, 12V, 24V, 30V. bit gives a lift Supply matrix (4,8 V), I think the problem in it. Stresses on board T-CON has: VON - 22,5 V; VIN - 4,8 V; COM - 15V; VOFF - minus 7V, VDD - 2,5 V; STV - impulses too. top two trims - almost symmetrical: the right and left 320WTSR4L V0.0 320WTSL4L V.0. Stresses on pines reach everywhere .

Similar problem was solved with VON wire strip on the upper driver **third bottom pin** reset on the advice (wire MGTF).

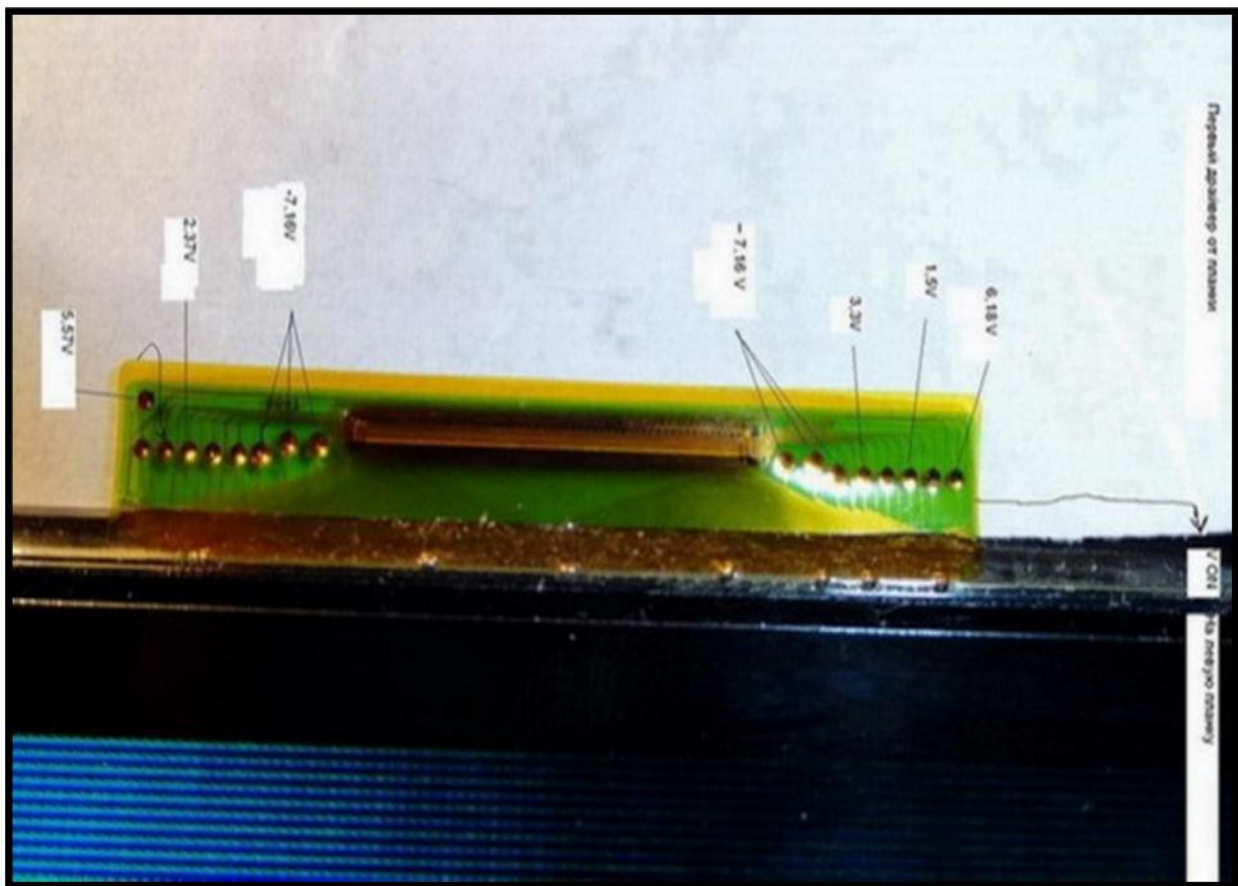
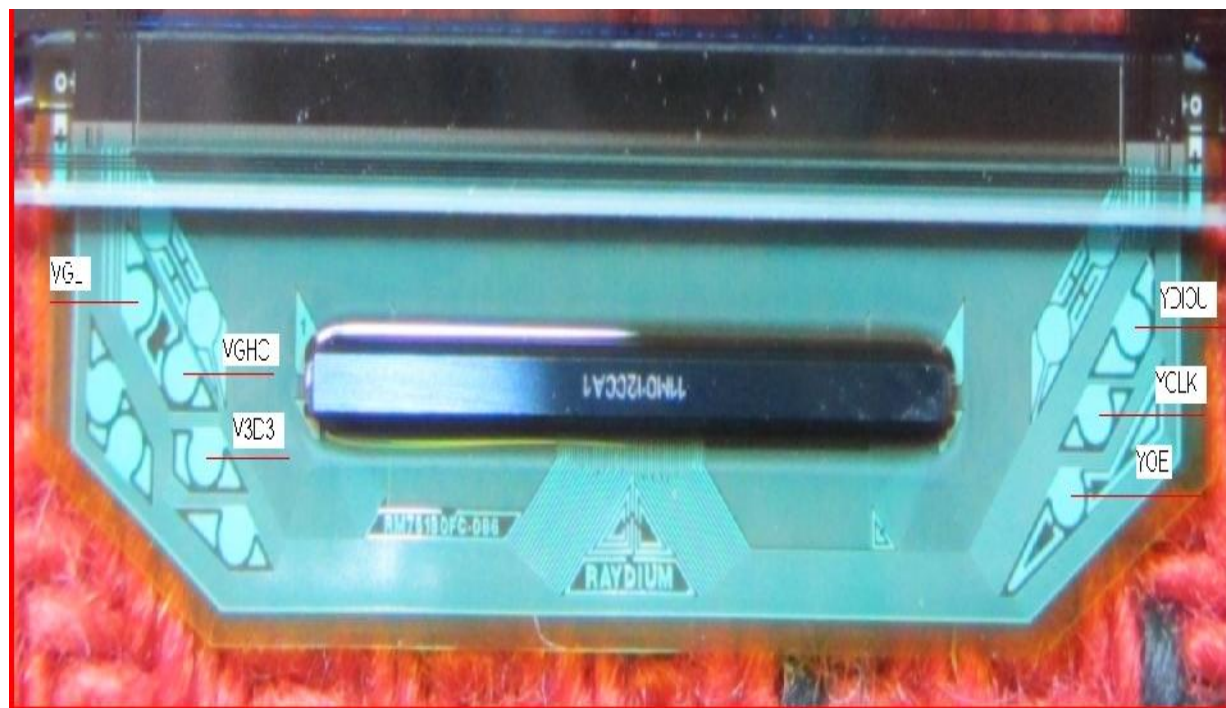
Panel Samsung LTA320W2-L13, fee T-CON: 320W2C4LV6.4

Composition board T-CON: Comptroller LRX4222T3, RAM-K4D263238F, EEPROM-24S64WP, gamma correction-EL5420CRZ. Stresses in points Destroy T-CON board all have: Von _24v; Vcom_-7v, AVDD_15 v, Voff - minus 7v, TD_3.3v, VIN _5v; VDD_2, 5v.

There are similar themes where glass breakage Von- treated wire MGTf type. T-CON board is two loops on the left and on the right scarves glass panels. glass on two boards 320W2SL4LV2.1 (LEFT-RIGHT-left right).

Flex - glass call only the left scarf, no break. Checkpoint Von (24 volts) on the left tab.

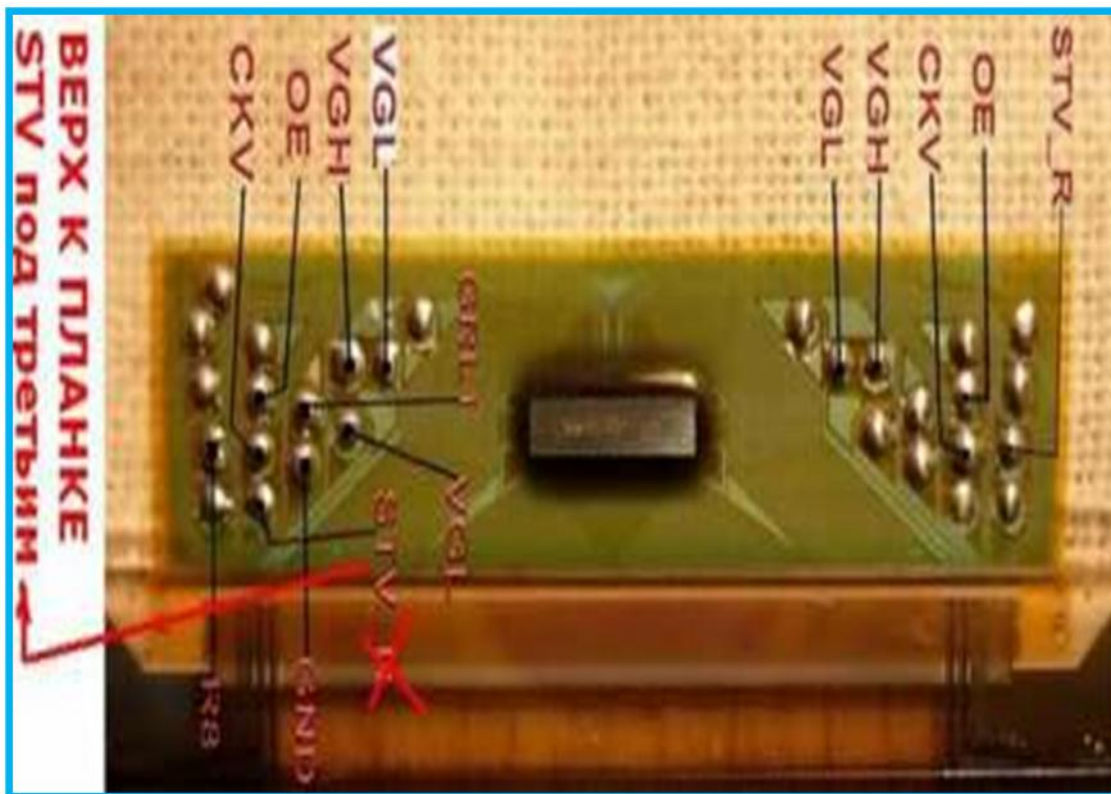
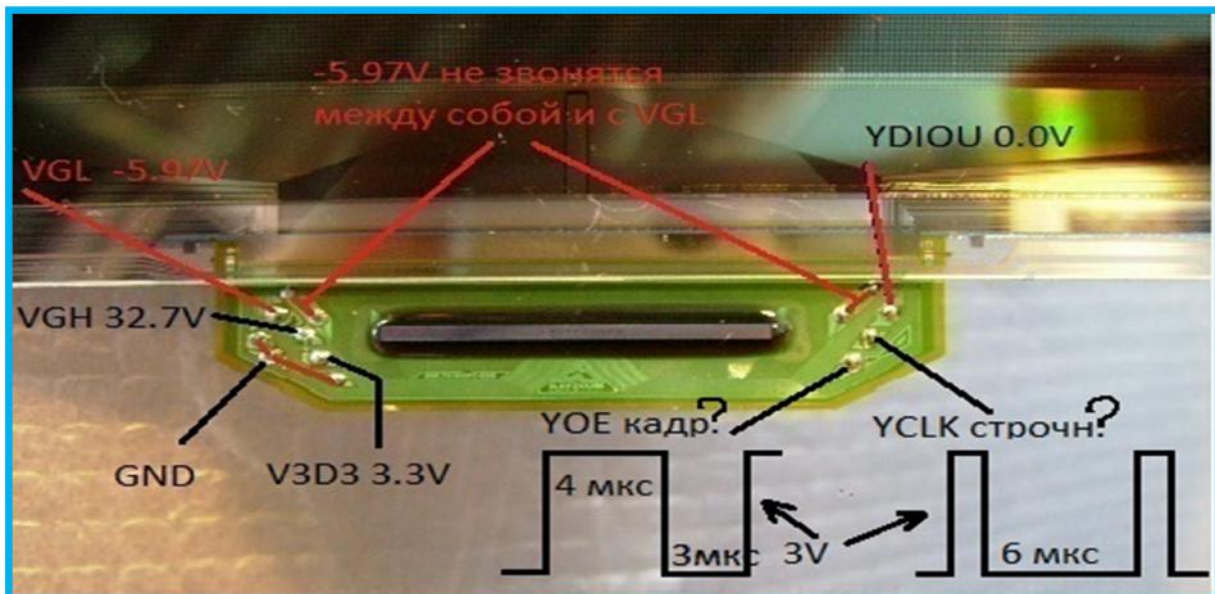
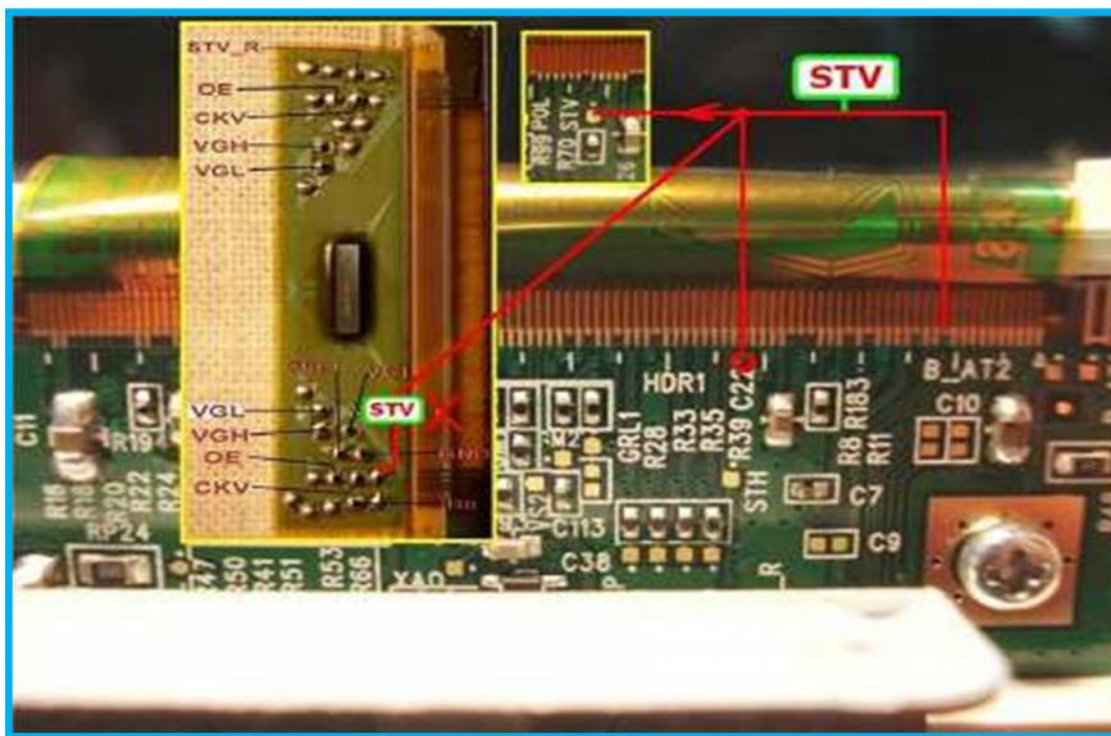
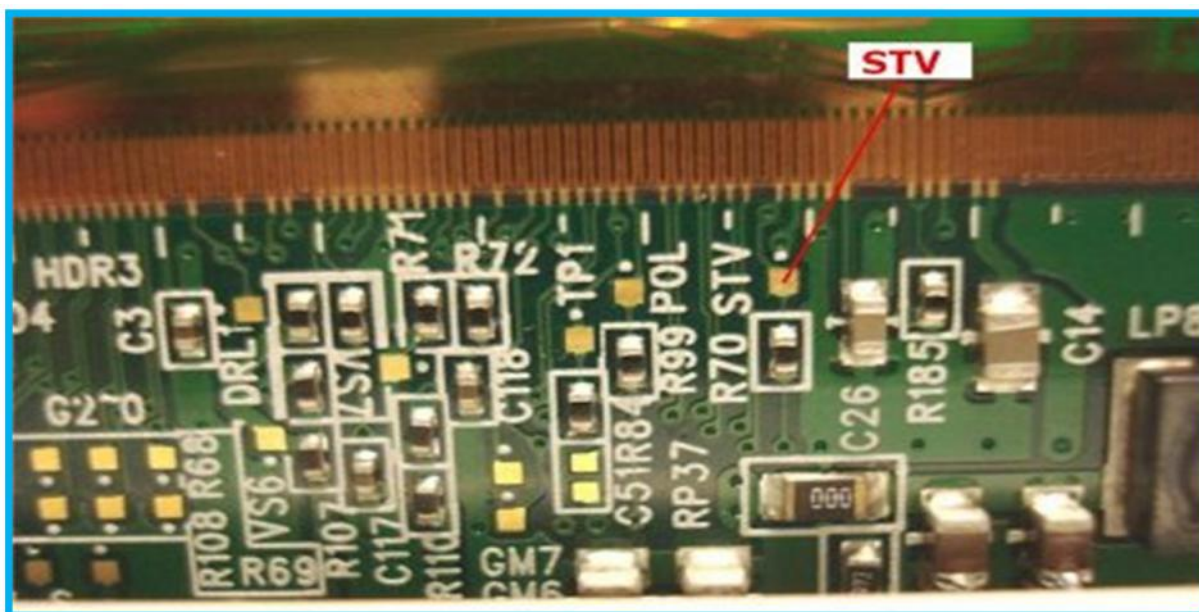
For objectivity give their information for consideration on this issue. producing reconstituted panel V260B1-L11 Rev.C1 T-CON Bracket V260B1-XC11 (Philips 26PFL5403S/60 TCM2.0E LA) discovered in part difference signal STV and STV_R . Data breakpoints on the petal is not identical . . waveform are identical but are out of phase . In my case was open signal STV . When duplicating conductor STV_R , as has been suggested (two equivalent top and bottom lobe) in the photo (quote already corrected version on STV) - - from the upper lobe of the control point (near to the bar) to the signal STV_R Bracket - operation panel is restored, but only for a while , until you have a primary conductor breakage in glass (or contact on cable). With his spontaneous recovery in the operation after the closure of duplication between the signals obtained STV and STV_R panel and again becomes defective. In my case (almost immediately revealed when running) observed the effect of "running footage." A colleague came repeated two weeks later - "the cold is no ISO first 15 minutes." I believe that the manifestation of the defect can be varied depending on the degree of resistance to breakage and recombination it ... I enclose a photo correct location signal STV on the petal panel V260B1-L11 Rev.C1 and planks overhead T-CON V260B1-XC11 Petal - CBH1 / 8658-B (the inscriptions top / bottom respectively lobe location relative to the panel) Driver - 821SSU371-00B (Philips 26PFL5403S/60 TCM2.0E LA) signal STV_R and its location (top photo) on the petal driver remains unchanged and the same name, including and on the bar. Changes and corrections to apply only to the lower (erroneously called STV_R) on STV and added point (s) of its origin with straps. Displaying two points signal STV , which comes with a signal to the loop in the panel, but soldered to them is problematic. Therefore, you can traverse the backup conductor further to the checkpoint, as in the photo - is under the third vertical train drivers from the side of line drivers. At the bottom (or right) photo reference point is located in the third vertical driver to the center panel from the side of line. Have an opinion on personal experience that these messages occur in direct relation to the above error -

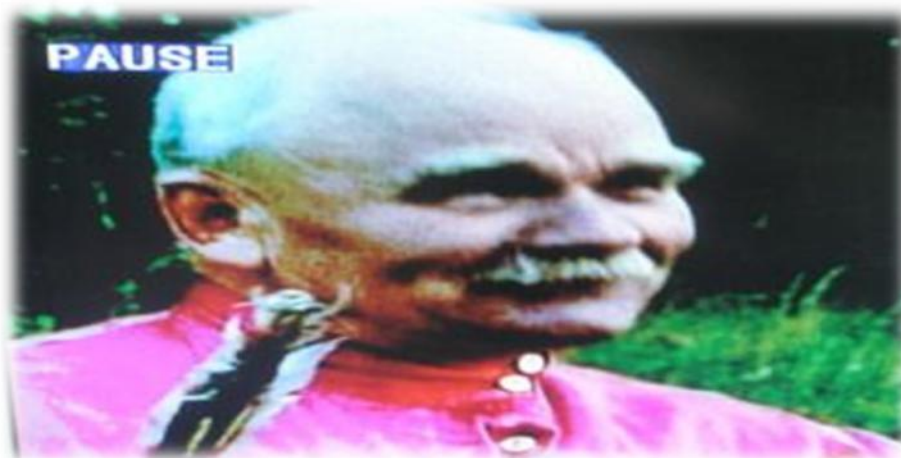
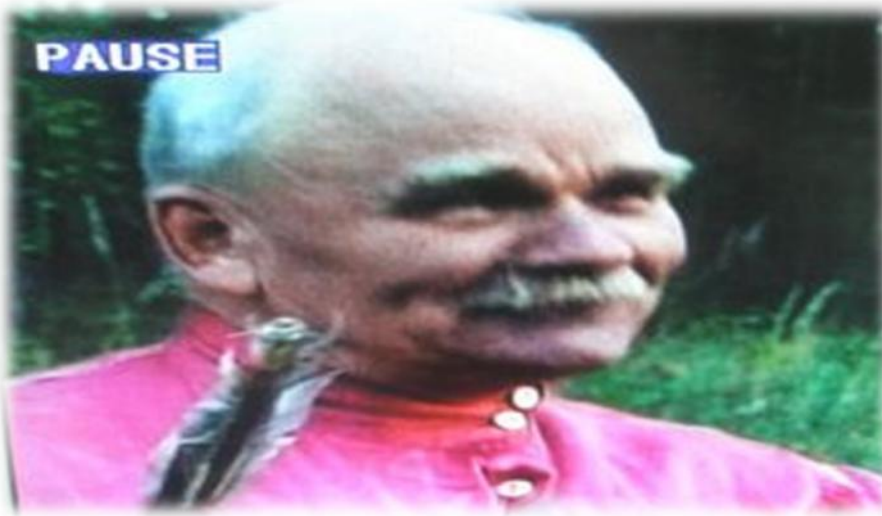
Philips 32PF3320/10

Main LC4.5E AA QD32HL02 REV: 01 and T-con V32BC3

Color distortion in the form of dirty greenish-brown shades (visible on the face of his grandfather) and lack of semitones (seen on the shirt of his grandfather.)

The module T-con voltage VCOM3 instead it was 6,5 V 12V - broken output circuits AS34-G. The second picture after troubleshooting. AS34-G gamma corrector and defect quite often worth and Samsung.

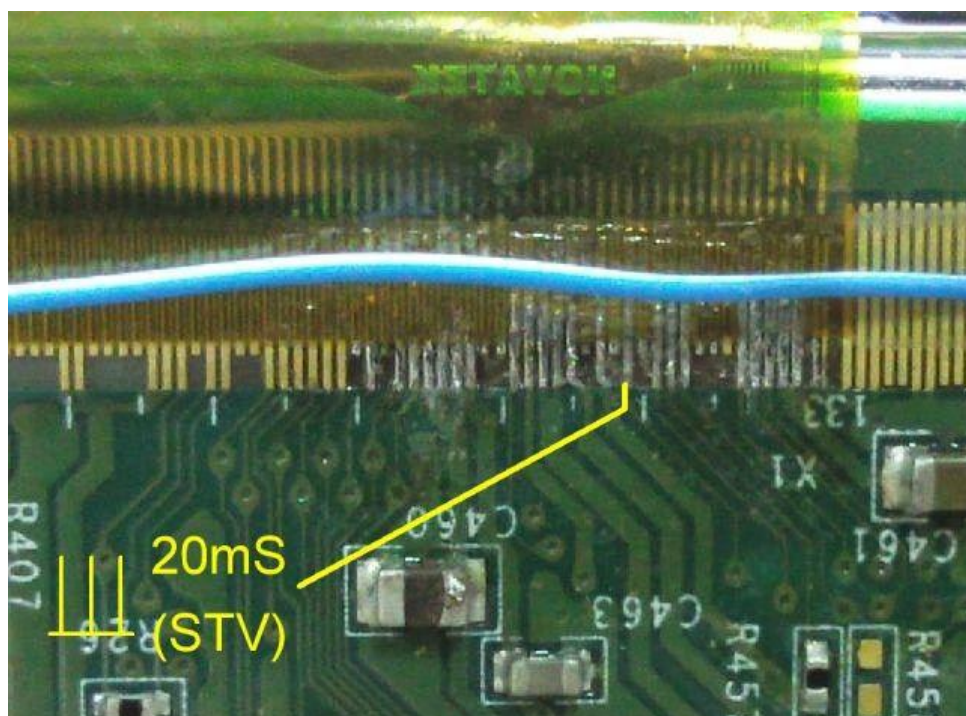
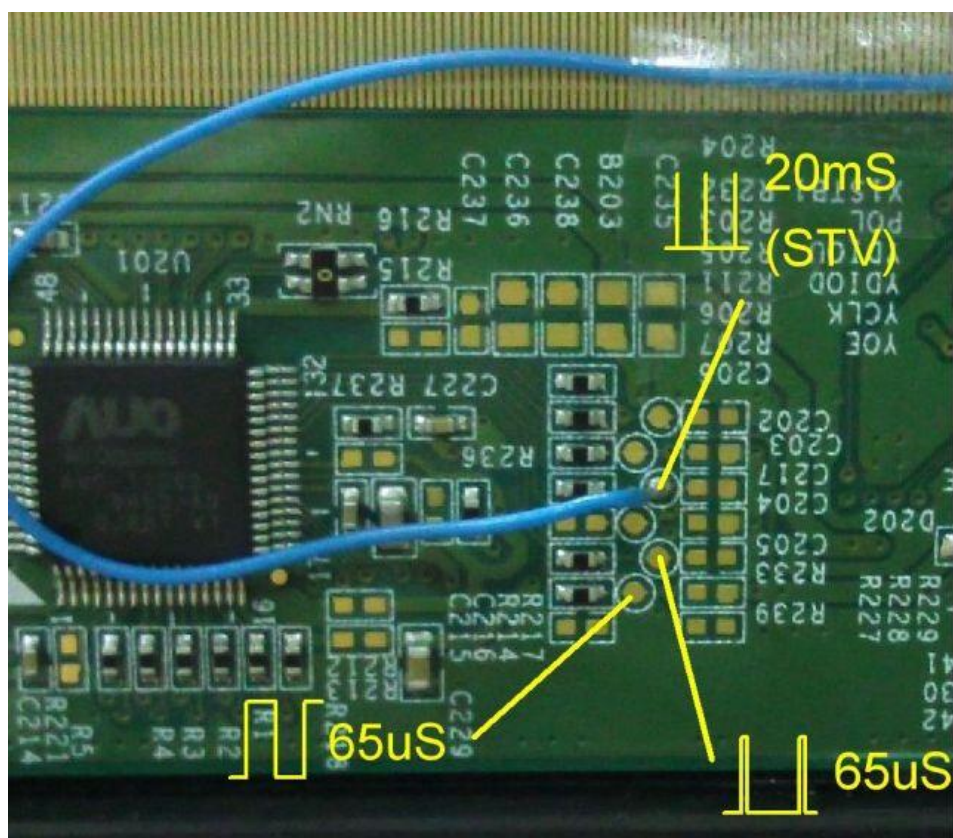
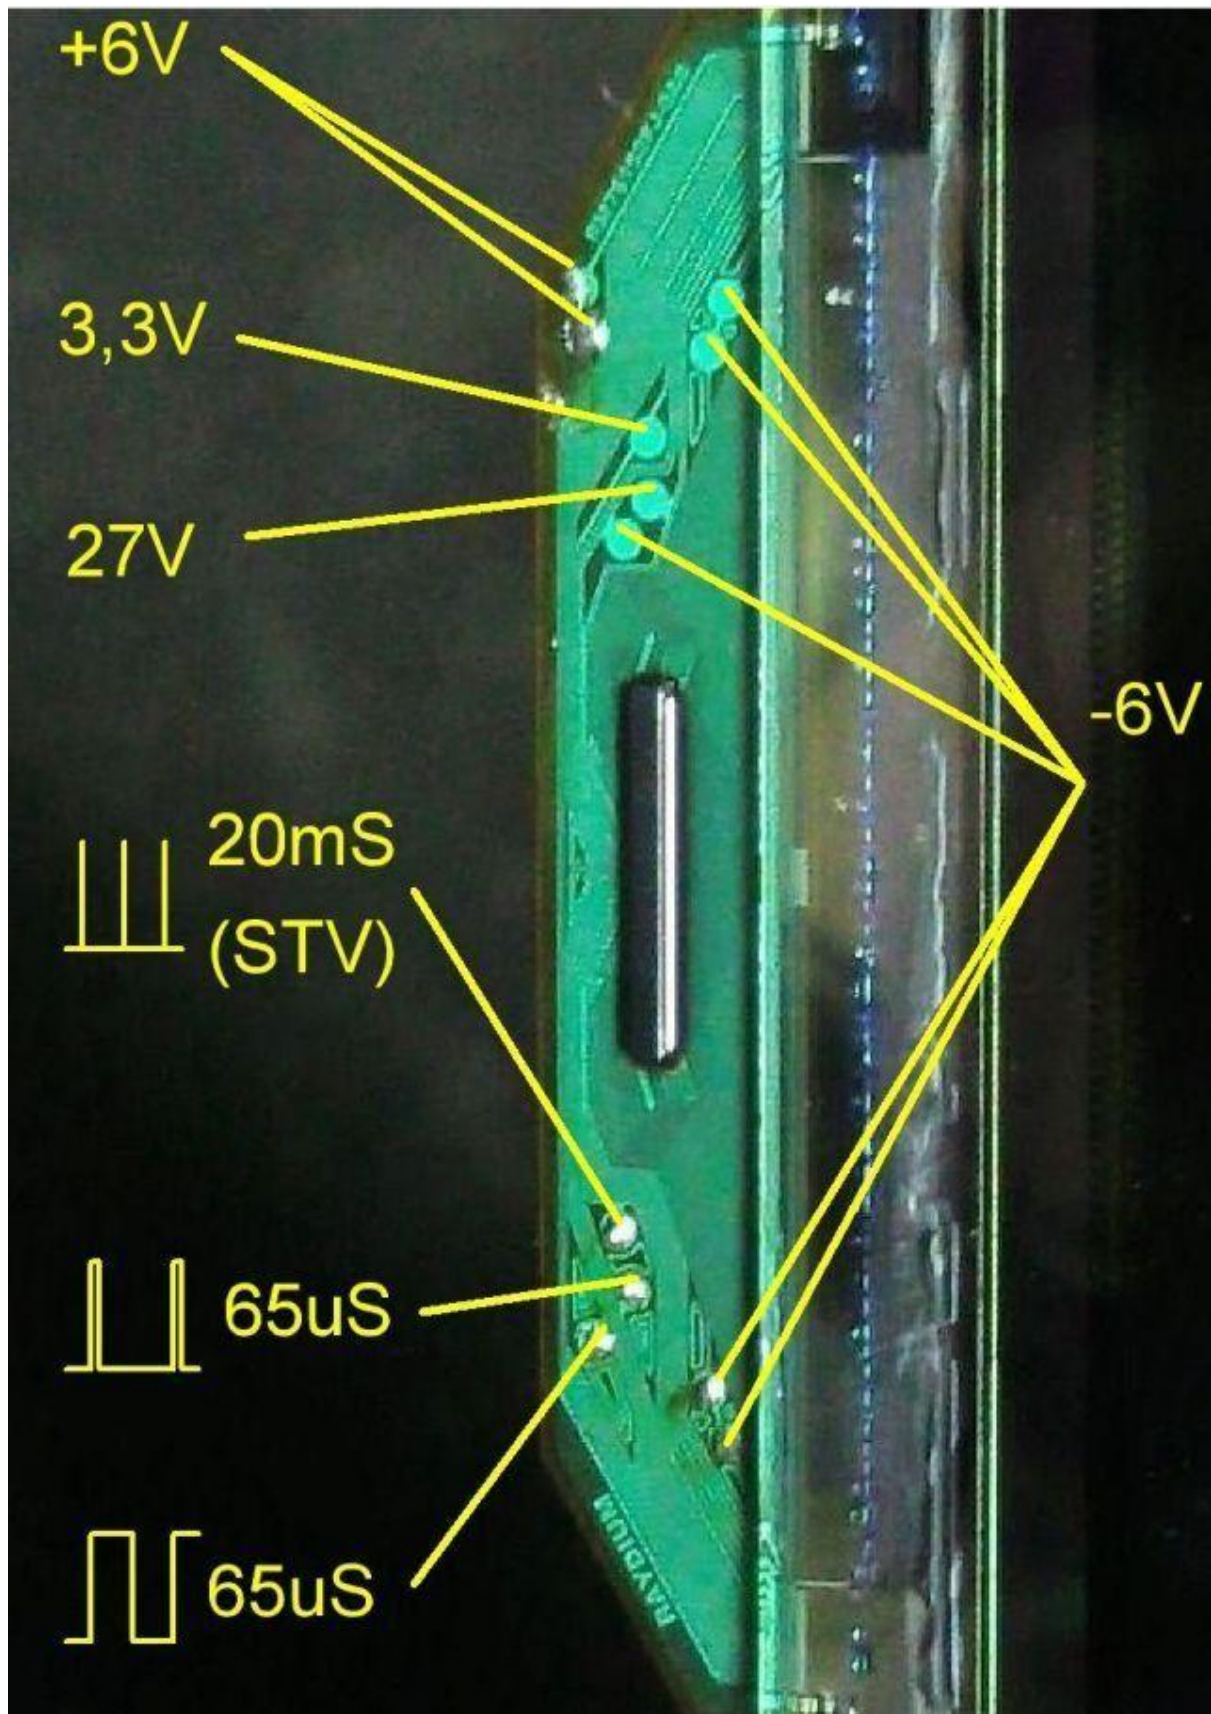
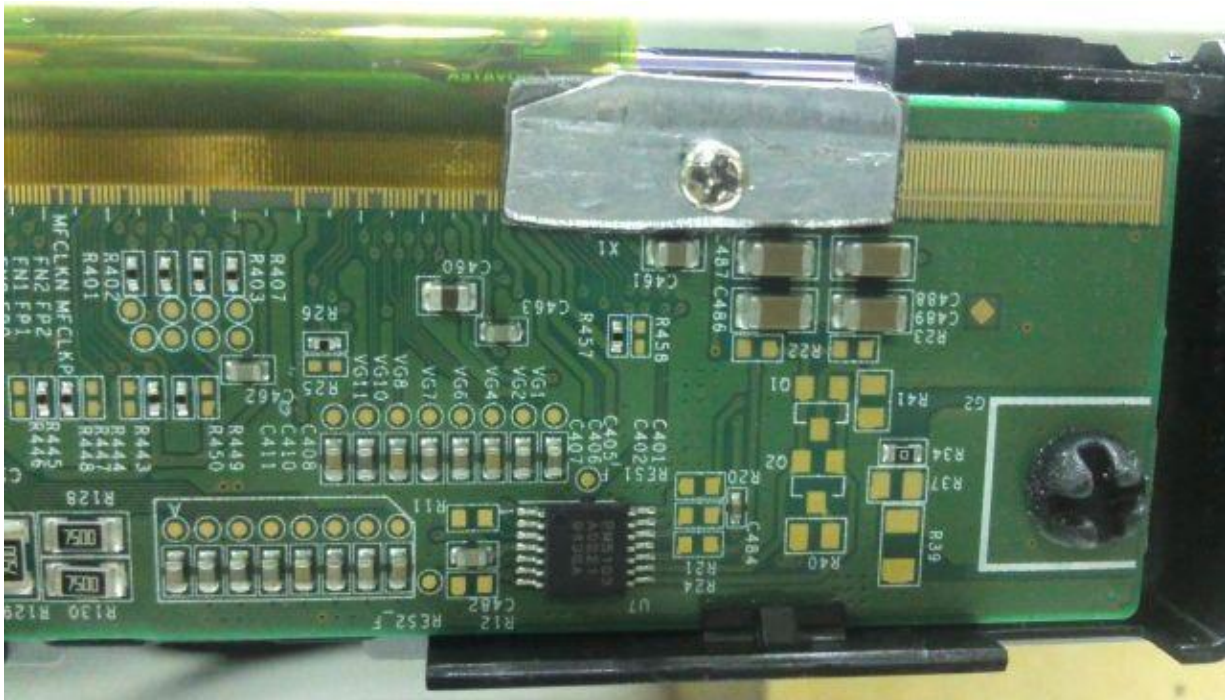
T260XW05 V0. T-con built on the top plate.

Classic problem - periodically lost control signals driver - side screen is dark , then slowly appear colored vertical stripes . Reach the ear proved difficult - the glass is glued to the plastic frame. Turn down seemed dangerous - some coppers very close to the glass. Risk did not turned out that bad contact - at the extreme conclusions , where loop is attached to the plate. Screw length pressed iron plate with gasket . Three days normal flight . Thought for the future: if you still have to climb into the ear , then it is best to remove the glass together with the frame , and then break out the relevant section of wire cutters Worked all night. Solder - did not help. Hence, in the glass. Tore off the glass from the frame it turned out all the same STV. Throw wire.

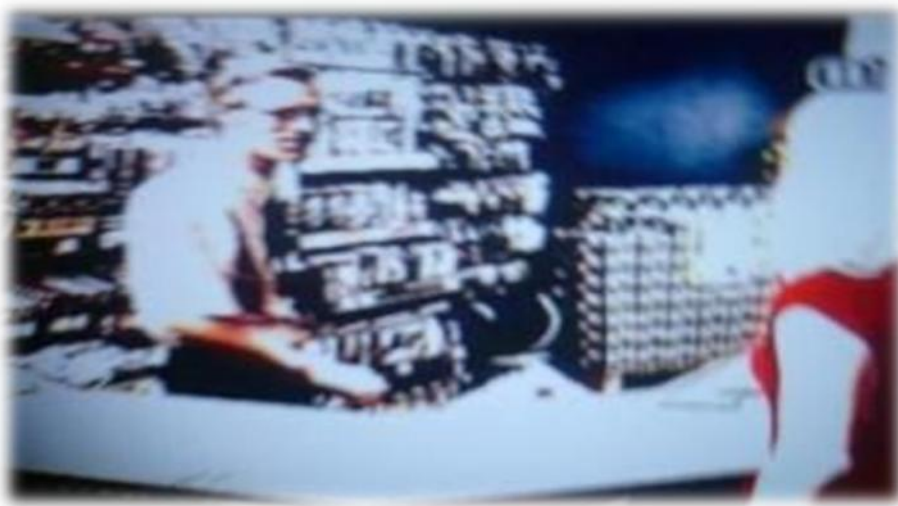
Panasonic TX-R32LE8.

Negative. The problem is T-con, namely the ill-fated gamma corrector. Although it was much more prosaic. When measuring out voltages the control points: VREFU_L - 8,8 V, VREFL_L - 0,15 V, VREFL_H - 6,1 V (all voltages removed after repair, so relative). When continuity strapping Shorty MAX9590 circuit to ground - 25 pin (C360). Banality - solder wicking ..

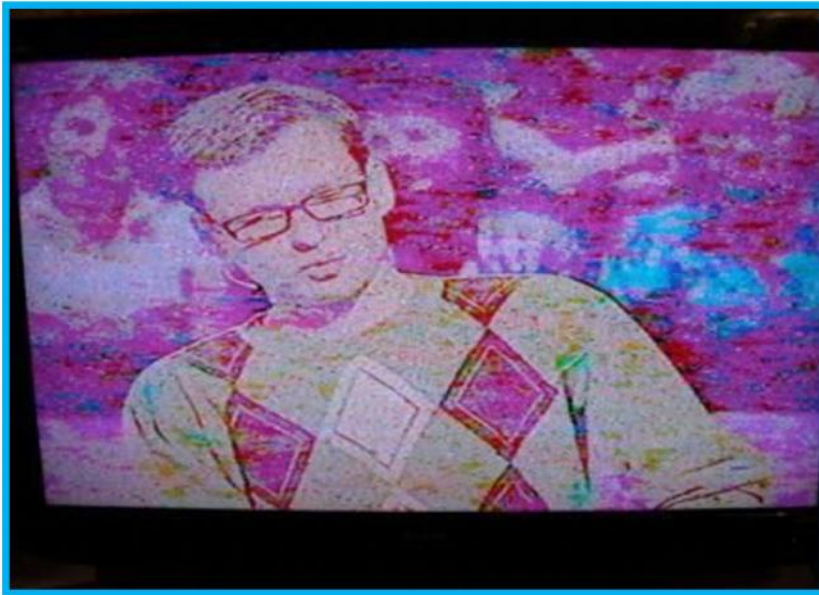
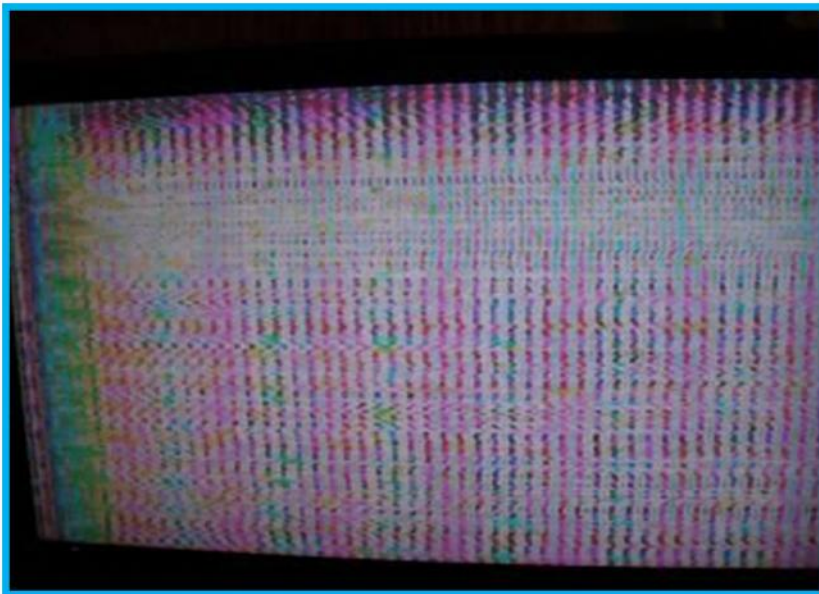
Chinese fault" ALUG model: two characters H4280

Composition: CPU aka Scalar MSD106CL-LF-Z1 flesh 25H32VS1G, 3 pcs EEPROM 24S02, TDA9886TS, TPA3124D2, HCF4052, and some even X50V330 reason was damaged firmware external Flash 25H32VS1G, after flashing with the donor operation was restored.

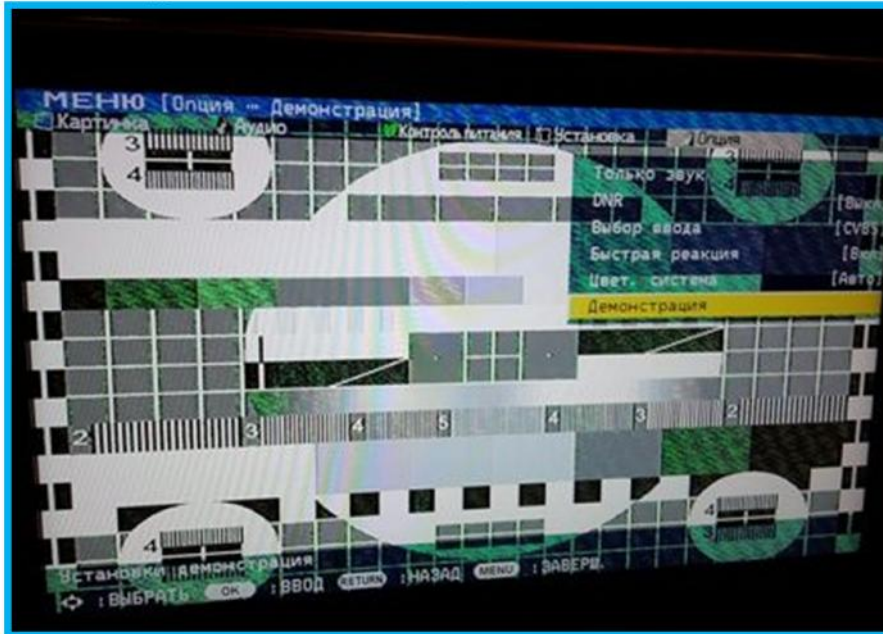
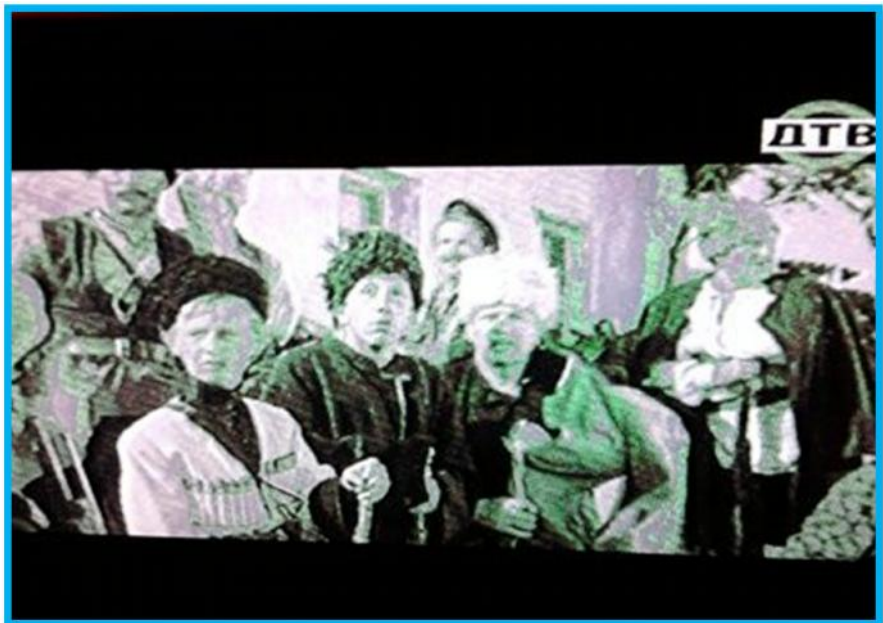
SAMSUNG LA46M81B. Panel LTA460HB05. T-con 404652FHDSC4L 0.0

Left part of the frame is repeated vertically, right-norm. Left out slightly blurry. That broke off to find out there was no time. Hurried customers. So just cleared out the loop on the main board and soldered properly. Every restored. That he managed to trace-spread. By the way, was not in place on the board 24S64 Tcon. Set and poured firmware from Tcon panel LTY320HA03-01.

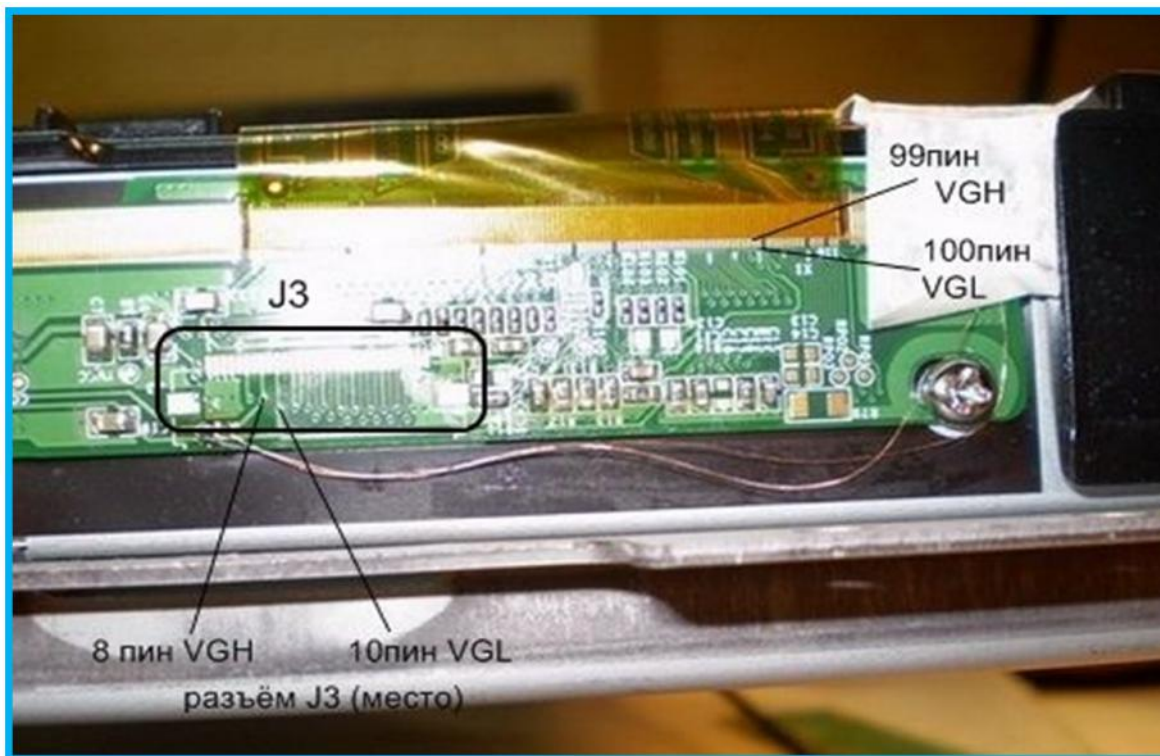
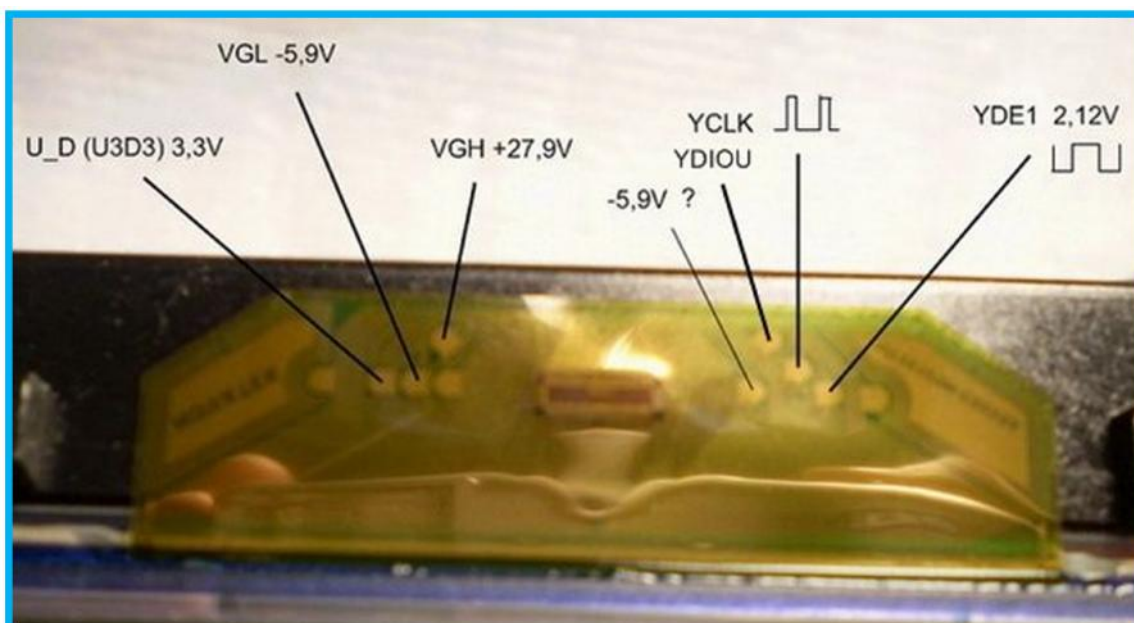
Matrix AUO T420XW01 VC stands 42JG10R-TA T-con T370XW02 VC Ctrl BD

Problem As in the photo, sometimes pause with the transition to the white state, or appear out "influx". Duplicated VGHC and VGL. Normal flight

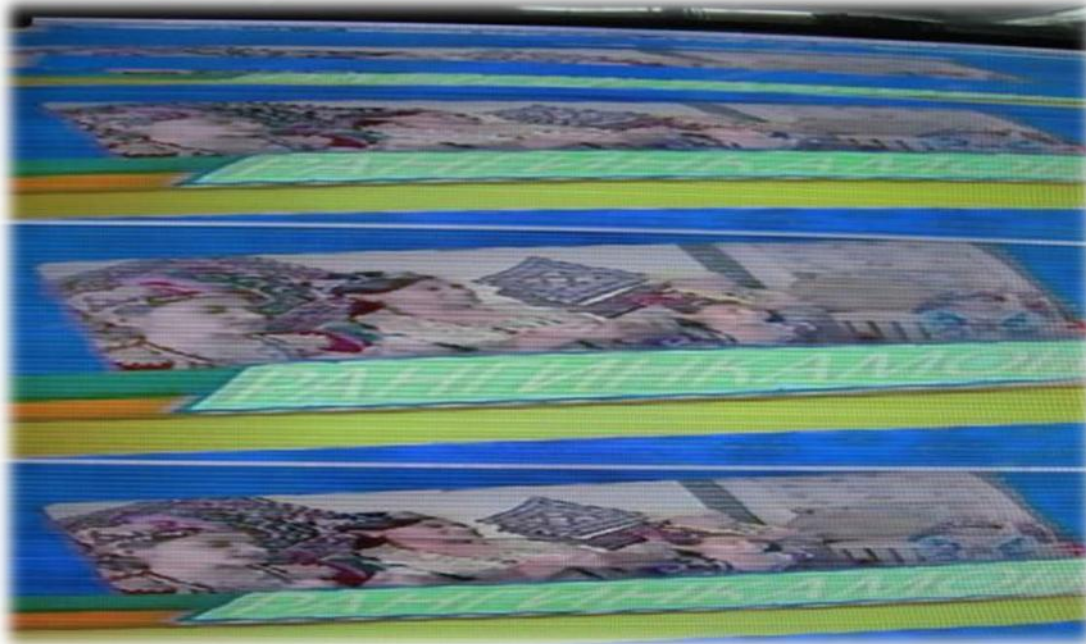
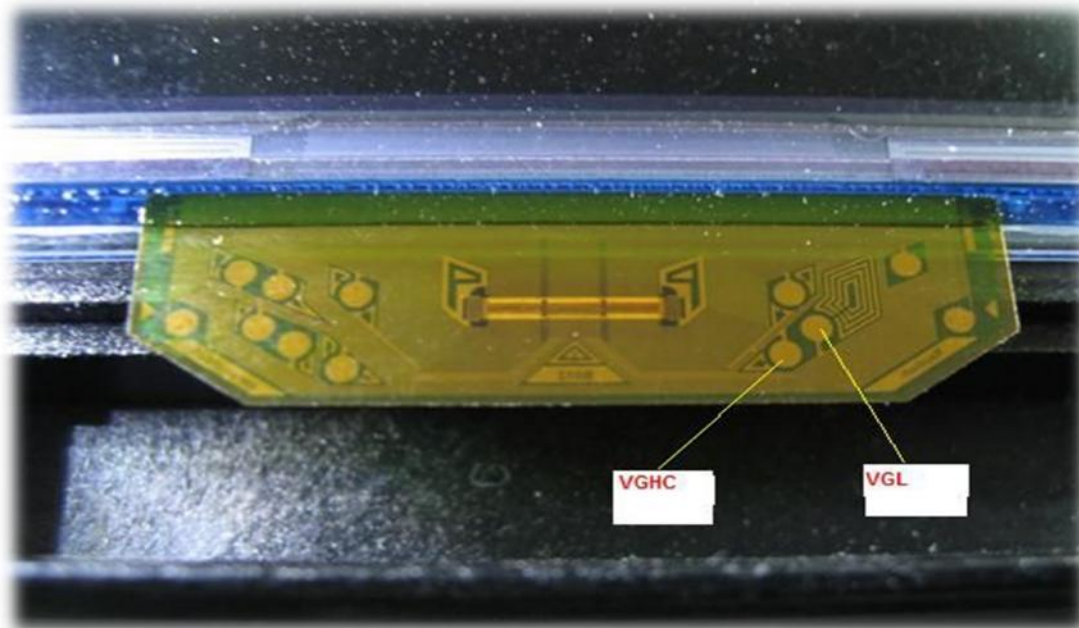
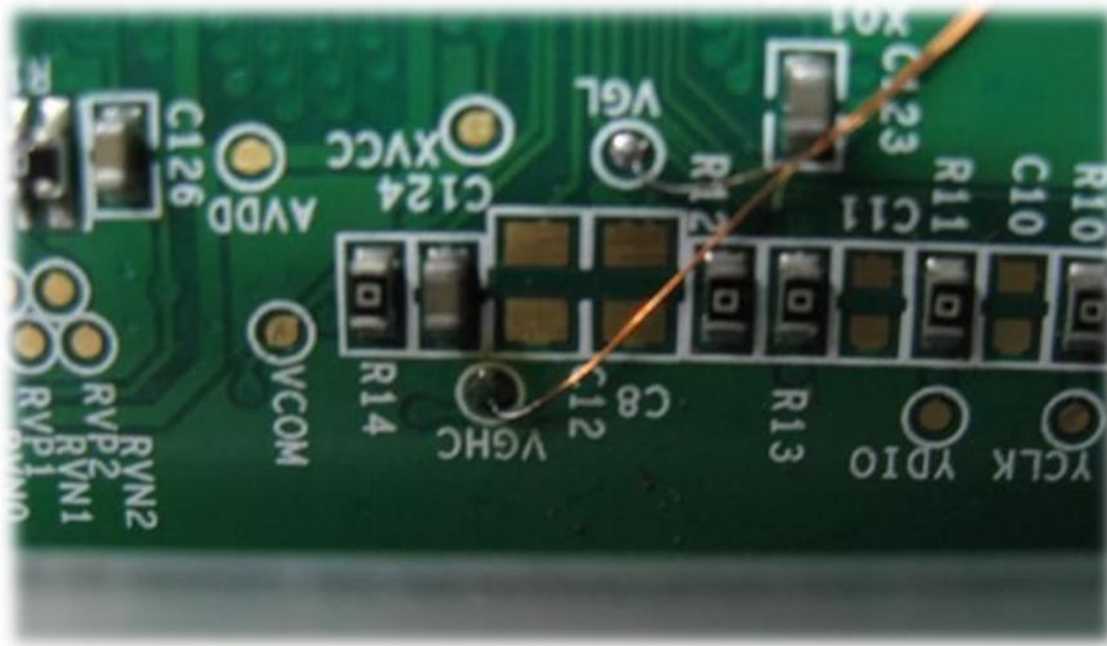
[Panel LTA320WT-L06 T-CON 320WTC2LV3.7 bracket 320WTS2LV2.6 SAMSUNG \(TV BLAUREN COMFORT 32\)](#)

The image long loops in dynamic objects, the effect of "icing" and "retardation" fine arts, when changing a new frame slow disappearance of the previous, OSD - similarly.

Defect: VON bus interruption in the glass.
