LCD LED T.V Panels Modification and Major Repairs

LCD LED Panel Failure and Cure

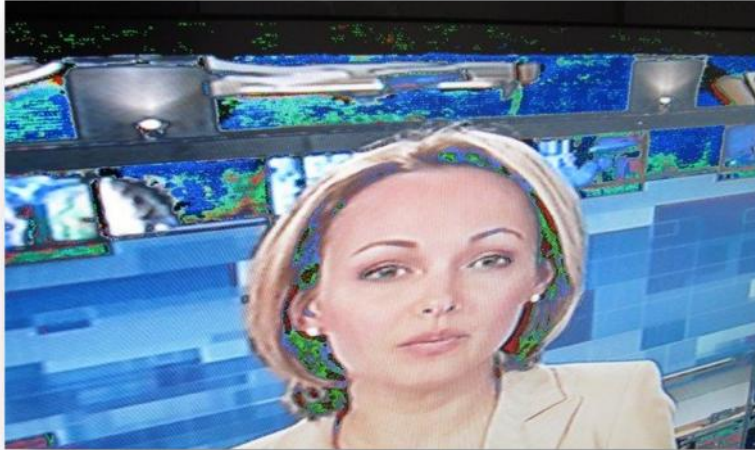
Model Samsung LE37M87BDX/BWT -Matrix T370HW02 v.2 T-con T370HW02 V0

After replacing the blown capacitors, including but distorted colors. Perhaps this characteristic picture when such a failure - measurements showed that died AS15-F - smooth top lighting on color raster, no clarification on smooth gray, white and black squares. Note the channels and VGMA9 VGMA10.

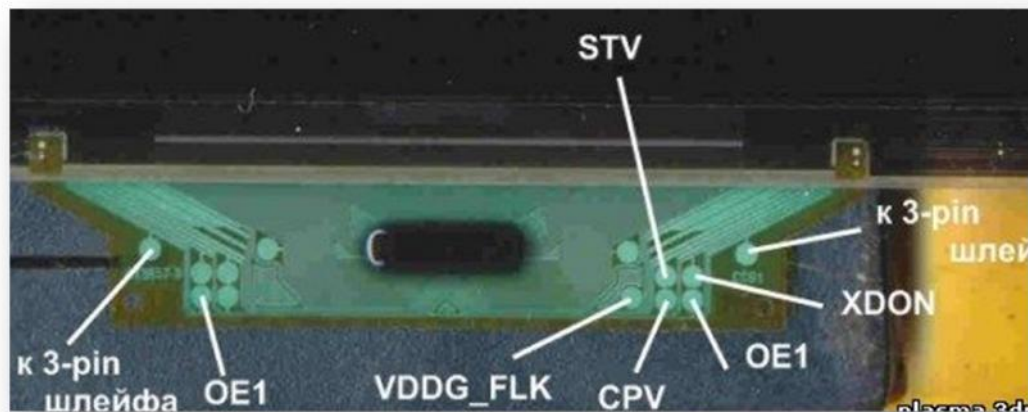
TCON - 215FA04S-2C Mark drivers - 002IILV0FM-00B - HX8657-B

Defect - greased, the brakes out due to lack of VDDG_FLK on the petal (served with 18 - 19 pin. loop)

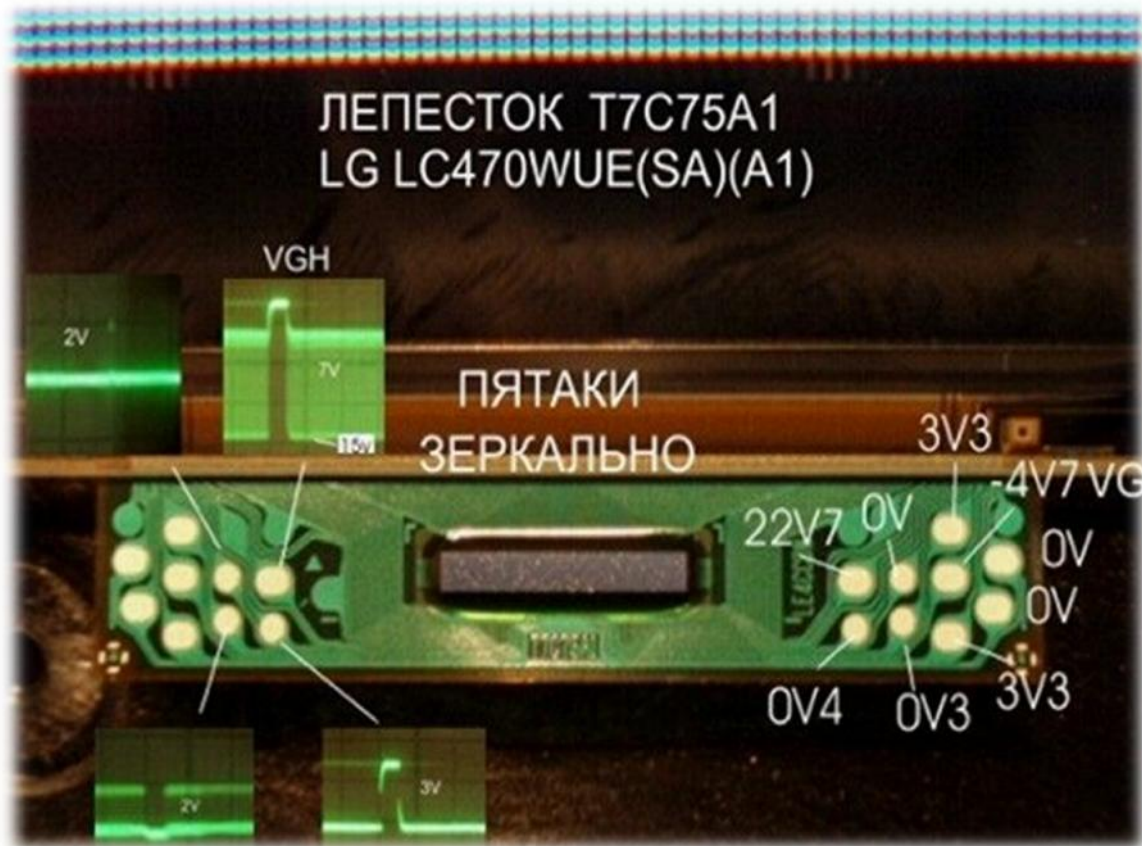
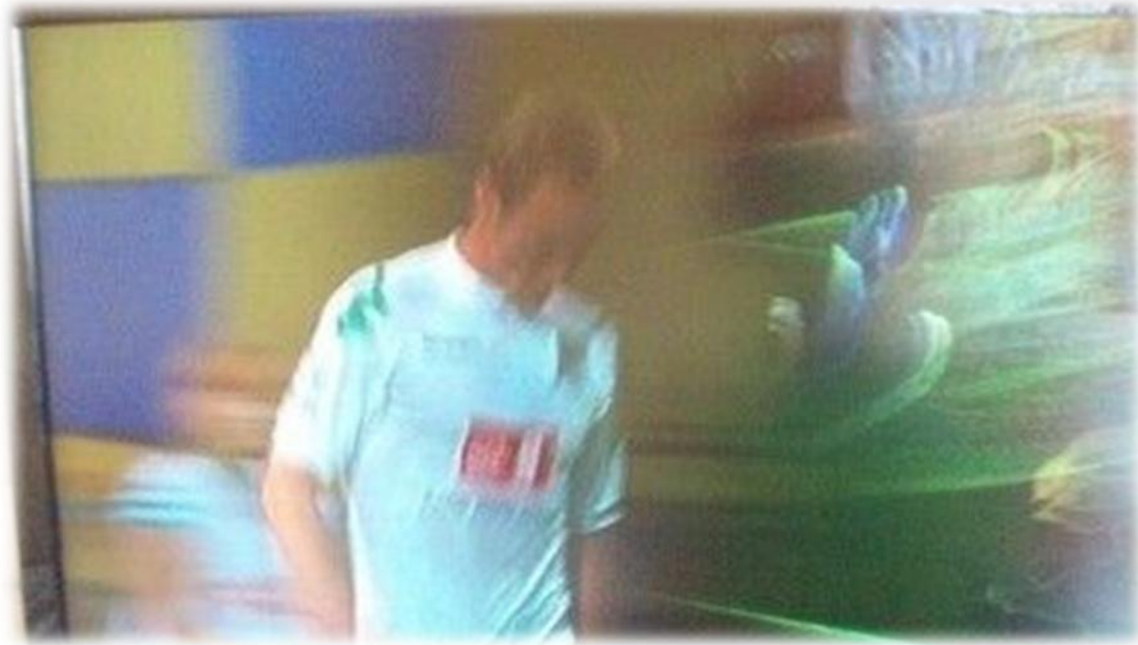
Matrix LG LC470WUE (SA) (A1).

Defect appears within half an hour in the right third of the screen.

Pictured are already showing football close-up, and right field is not yet disappeared. Also clearly seen when switching channels when screen goes blank, the remnants of a galloping right image.

Pads T7C75A1 Do matrix 4 lobe on each side. Photo painted with top drivers, working from the left side. On the right there is no lower petals 3V3, and feeding it the right side of the screen darkens. If you bind this point to ground via a resistor 200 3000m, the defect does not appear. The fault could touch the bottom of the instrument probe point 3V3 or heating hairdryer any of the four right drivers. After connecting with the earth, such a manifestation disappeared. It remains unclear what potential db at the lowest point in the right 3V3 drivers, same as in the left, or tied to ground?

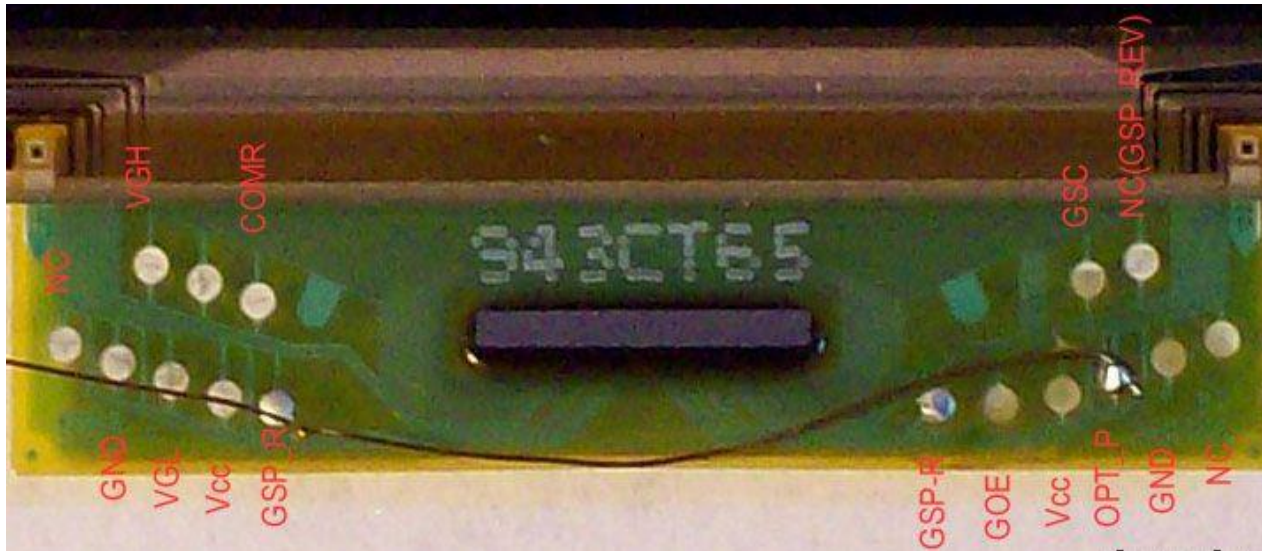
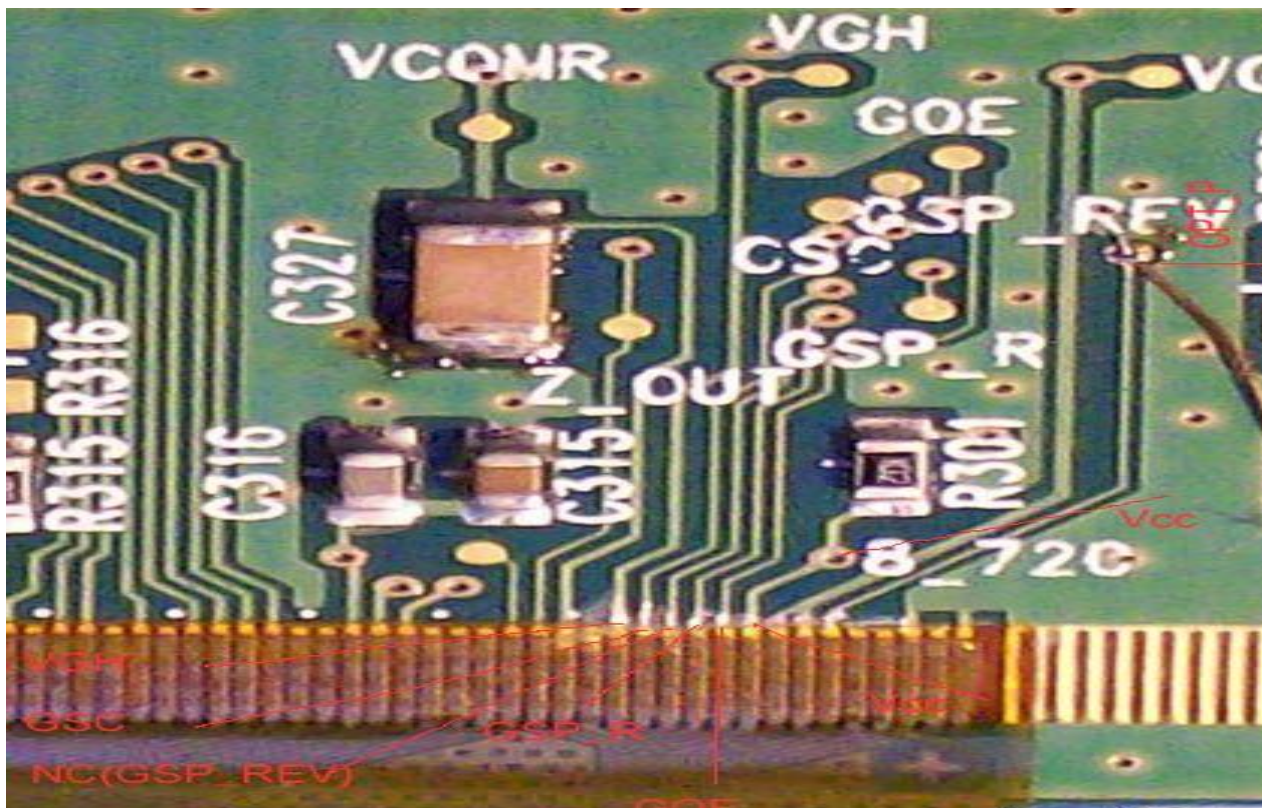
The white screen and with warming up vertical strips. Were in VGL break - 8.6v, VGH 19.4v, 3.3v. On an ear of the Piglet only two. It was necessary to solder to paths. I added a photo of drawing of side pad from my records. To the right of the driver to glass go some of paths, then the round patch, again the path following more widely to it we solder VGH19.4v, to the second wide VGL - 8.6v, to the third wide 3,3v. I hope with such

ingly, if you look at the ear (right side of the matrix) input signal GSP left out - right. And vice versa (for the left side of the matrix) input signal GSP right way - on the left.

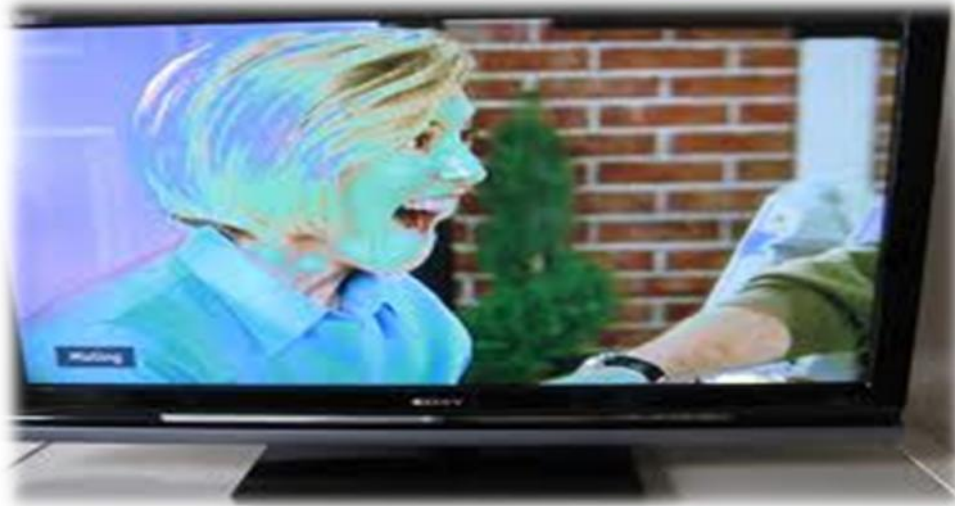
Fault: Negative Picture and also OSD is Negative.

Cure: Fault at T-con Board and found Faulty SMD I.C AS15-F

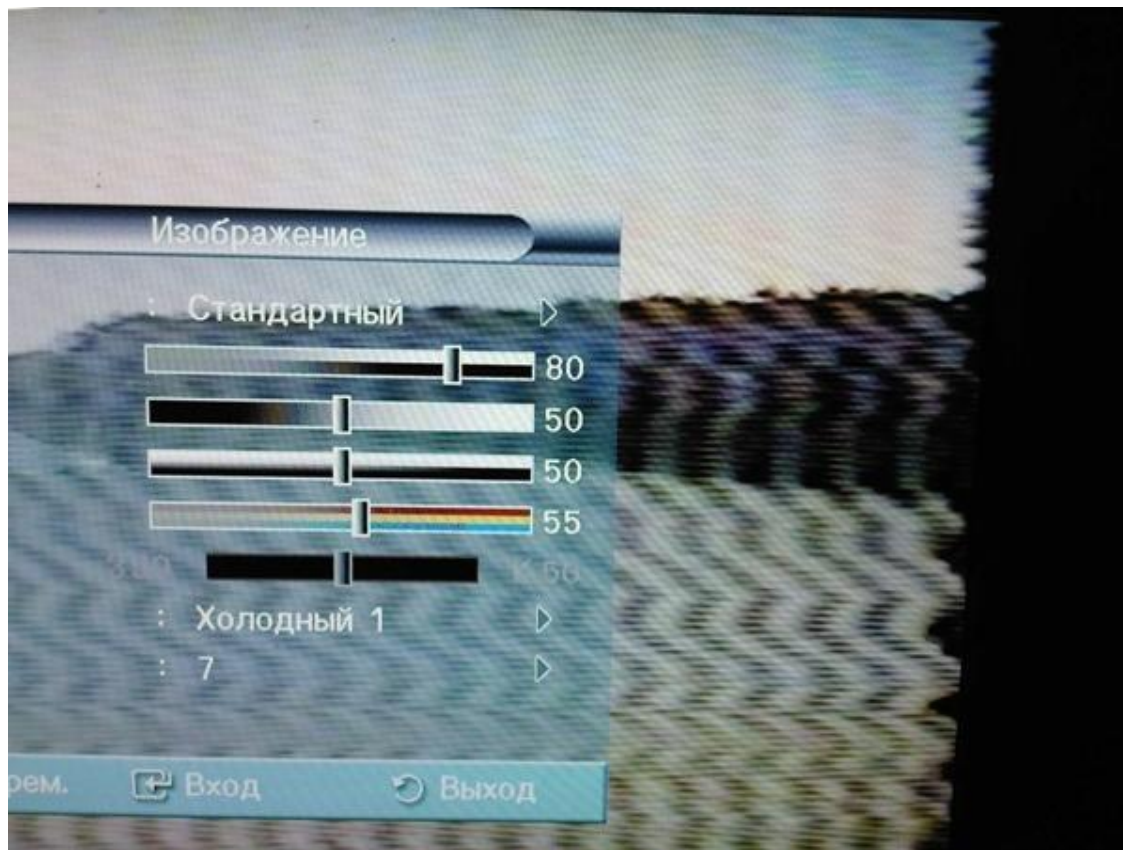
The failure of the synchronization is shown only when receiving a signal from the antenna, menus and AV signals reproduced without problems.

Cure: The fault on the circuit formation 5V power tuner S152.

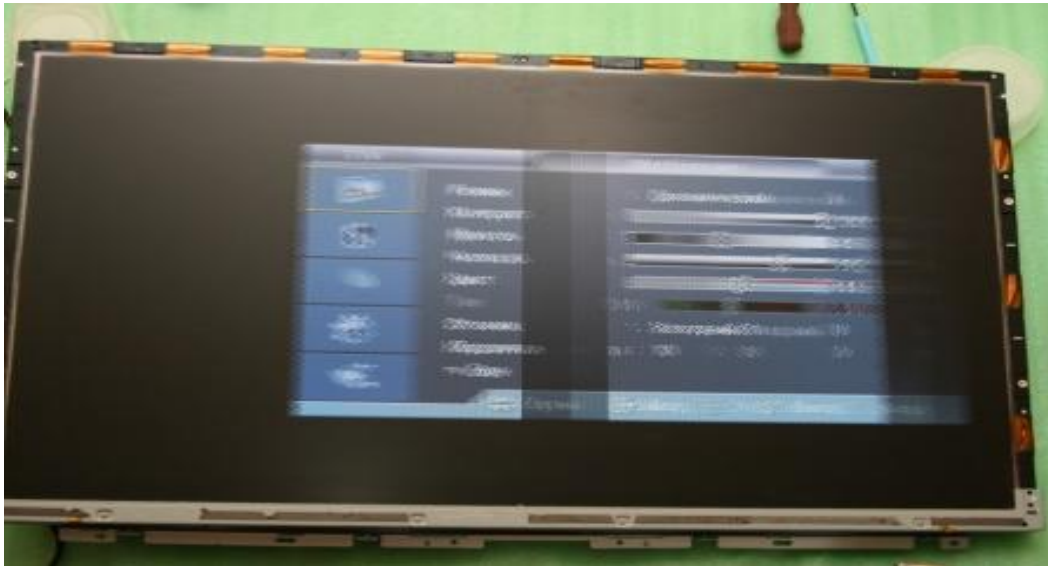
Samsung LE37S81BX / BWT

Fault : Image distortion

Cure: When you install an alternate panel BN07-00446A (CLAA370WA03SC), instead of the original BN07-00366A (CLAA370WA03S) possible occurrence of this problem with the image. TV must be attached to flash firmware and after flashing, change the value of Spread Spectrum -> FBE Spectrum to "0".

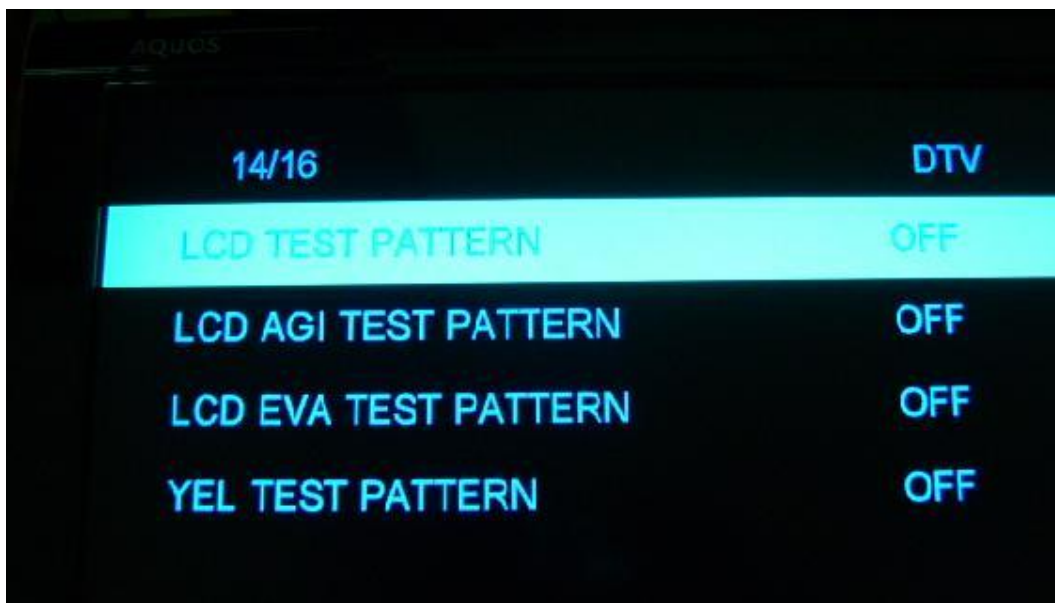
Sharp LC-42DH77RU,

Problem: There is a Test Pattern when start the LCD TV.

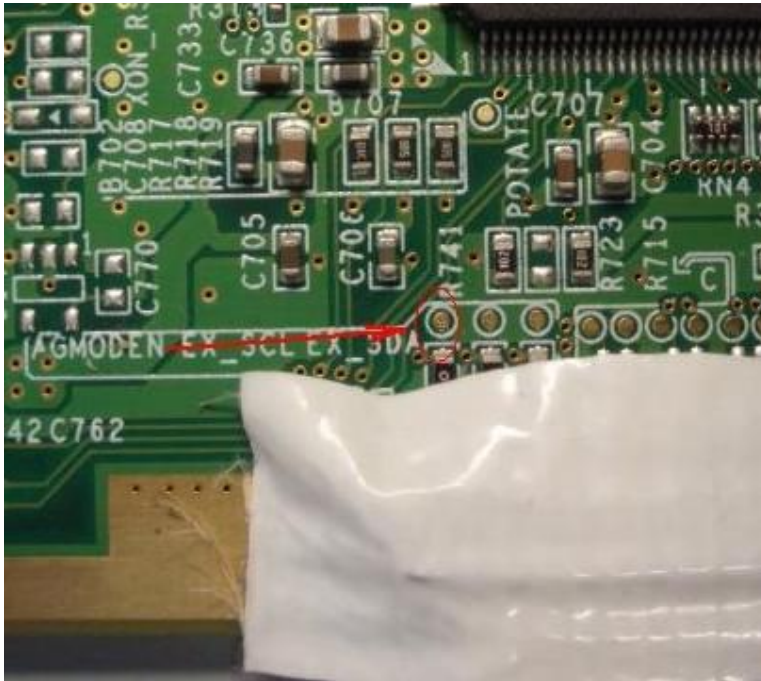
AU Optronics LCD panel T315XW01 V5

Panel Testing: Mode AGMODEN closed point on the ground - starts to finger test fields in a circle. To open the exit.
